ARCHAEOLOGICAL INVESTIGATIONS IN THE ZONE OF EARTHEN FORTIFICATIONS OF PÄRNU

RÜNNO VISSAK MTÜ AEG, Lutsu 16-26, 51006 Tartu, Estonia rynno.vissak@gmail.com

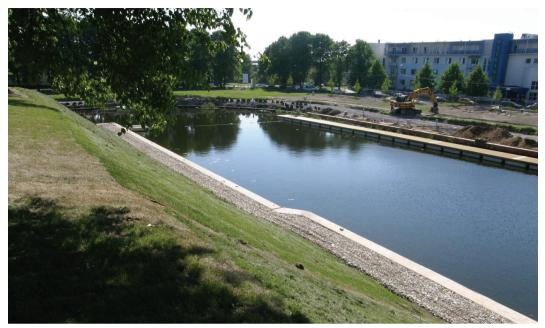
Fig. 3. New construction at the waterline shifted away from the wooden constructions by the western side of the bastion Luna.

to prevent the earlier preserved constructions from damaging. However, in winter 2010, while thrusting the sheet-pile wall, it appeared that somewhat to the north of the fixed planks the line of new bank fortifications intersected with the vertical posts and planks on the edge of the wooden constructions. In order to avoid damages to the wooden constructions, a decision was made in the course of the works to shift the new sheet-pile wall partly away from the bastion by one more meter (Fig. 3).

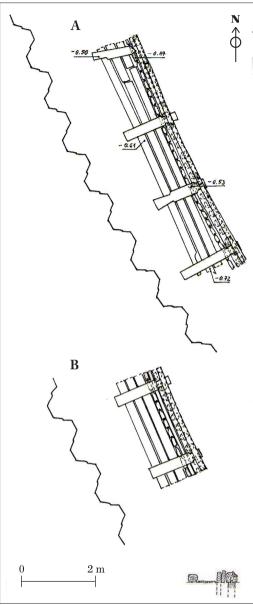
Fig. 4. A – construction of the second half of the 17th c bank fortifications, B – construction of the second half of the 17th c bank fortifications with the edgewise placed plank.

The waterside edge of earlier bank fortifications were formed by the row of upright posts rammed into the soil alongside the bank. On the average 30 cm wide hewed logs situated horizontally on the row of posts were attached to the posts by simple tenons. 136–145 cm long logs, joined together by dovetail, were transversely (with the gap of 156-178 cm between them) attached to the upper side of the hewn logs. Those logs helped to attach the edge log to the parallel framing log near the bank. In parts, a longer log was attached to the waterside edge log. An intersecting log, attached to the lower section of the bankside end of the longer log, had been anchored to the upright posts located in the distant part of the bank. In parallel to the waterside row of logs a sheet-pile wall, made of 10-12 cm thick and up to 30 cm wide upright planks (Fig. 4: A), was situated towards the bank (to the distance of 10-15 cm from the logs). In some passages an edgewise (6–8 cm thick and 22 cm wide) plank had been placed to the inner side of the edge log between the row of upright posts and the sheet-pile wall (Fig. 4: B). Similarly to the edge log, mortices were situated on the upper side of the plank. In the outer edge of the waterside log, a wooden element (edge moulding) with a triangular cross-section was attached to the upper side of the log by

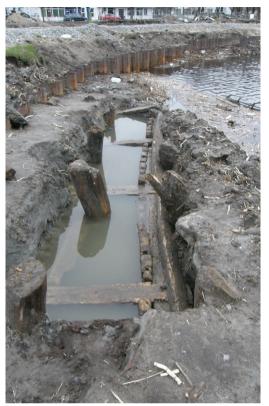
Fig. 5. Corner of the southern and western bank of the moat, the 17th c construction and the upright posts from the later construction period.

wooden pegs. The moulding additionally fastened the ends of the transversely located logs, attached by dovetail. The upper part of the described construction started in the corner of the southern and western bank of the moat from the absolute height of -0.50 m, while the ends of the upright posts rammed into the bank fortifications from the later construction period lay at the absolute height of +0.08 up to -0.23 m (Fig. 5).

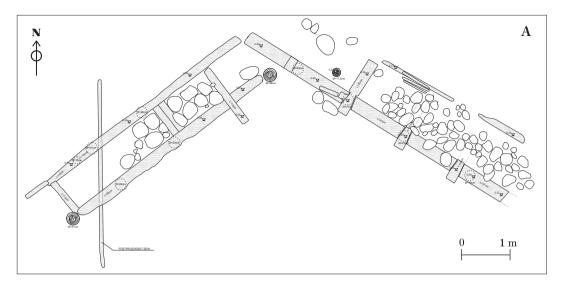
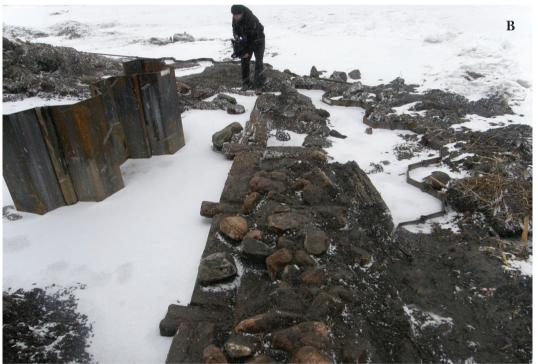
Fig. 6. A – construction of the second half of the 18th c bank fortifications, B – the 18th c bank construction at the corner of the southern bank of the moat and the western bank of the tributary moat.

the bridge erected on the corner of the southern bank of the moat and the western bank of the tributary moat, stout vertical posts (with the diameter between 28–32 cm and the average length between 1.7–1.8 m) were rammed into the ground on the average distance of 1.2–1.3 m from each other in two rows parallel to the bank (the distance between the rows being 80–90 cm). The upright posts supported the longer horizontal logs hewn on the upper side and shorter logs with hewn lower side, located in two rows alongside the bank. The logs were joined together directly above the posts or at a slightly shifted position by the transversely located logs. Shorter transverse logs had been joined together with the longer logs by dovetails located at the upper side of the latter. Boulders packed with soil were situated between and on top of the logs (Fig. 6: A, B).

The dendrochronological dates obtained from the wooden parts of the later bank fortifications resulted in 1776 and 1788 years AD.² According to the data from archives it is known that extensive renovation work was carried out near the earthen fortifications in the second half of the 18th century and both timber and stones were needed for this (Parek 1971, 12–13).

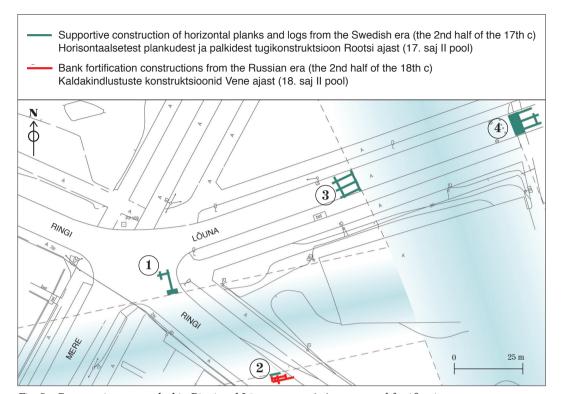
Fig. 7. Constructions unearthed in Ringi and Lõuna streets. 1–4 – excavated fortification structures. Jn 7. Ringi ja Lõuna tänaval välja kaevatud konstruktsioonid. 1–4 – uuritud kindlustusrajatised. Drawing / Joonis: Peeter Piirits, Andres Tepper

A construction was unearthed 2.65 m deeper from the present street level in the excavation plot of the pipeline planned to Lõuna street at the crossing of Ringi and Lõuna streets with the Mere avenue (Fig. 7: 1). The construction was composed of an edge log supported by a row of vertical posts rammed into the ground and the edge element with characteristic triangular cross-section attached to the outer edge of the edge log. The sheet-pile wall, which ran in parallel to the edge element and was made of vertical planks that were joined together with timber joggles, was rammed into the ground. Horizontal logs were situated crosswise to the planks and had been attached to the other elements (see Piirits 2010, 4, figs 1–3, photos 13–36). The north-east – south-west directed construction was situated on the brim of the ravelin in front of the Tallinn Gates on the northern bank of the tributary moat surrounding the ravelin. Two slightly over 5 m long logs were documented at the construction. The south-western ends of the logs had been placed between the upright posts and attached to the horizontal log on the south-western side of the posts. The south-eastern ends of the

The construction of the fortification on the opposite bank (outer bank) of the tributary moat was exposed 24 m southeast from the above described bank structure in the excavation of a trench of Ringi street (Fig. 7: 2). Here, similarly to the situation in the southern bank of the moat opposite to the bastion Luna, in the outer side of the tributary moat a later bank fortification supported by stakes and with two parallel rows of logs joined together by cross-beams and stones between and on top of the logs had been erected above the earlier construction in the distance of ca. 1 m from the waterline. The earlier construction originated from the 17th century and had been laid above the waterside row of posts and the sheet-pile wall of upright planks running in parallel to the posts and horizontal logs connected to the posts and planks.

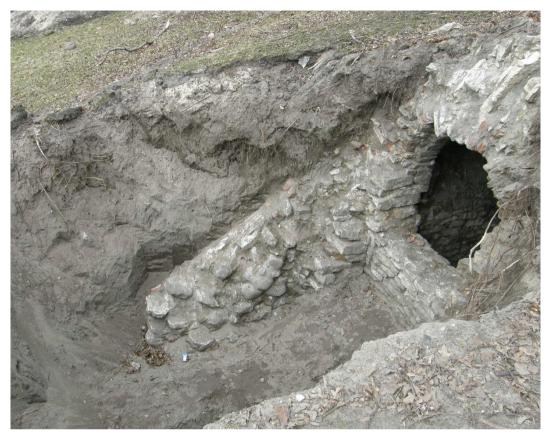
Fig. 8. Supportive walls in front of the outer side orifice of the sally port.

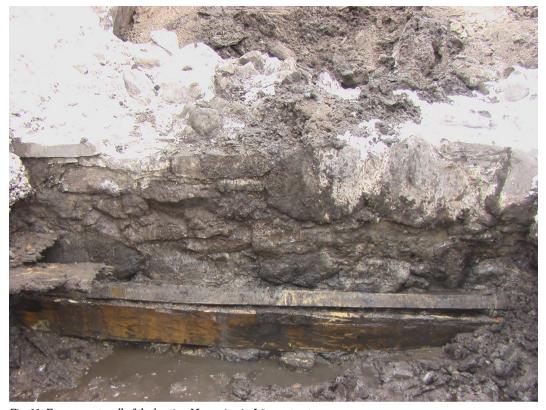
Fig. 11. Escarpment wall of the bastion Mercurius in Lõuna street. Jn 11. Bastioni Mercurius eskarpmüür Lõuna tänaval. Photo / Foto: Peeter Piirits

of the unearthed wall section traversing the trench was 3.5 m, the width of the wall was 2 m on the average and its preserved height reached 1.5 m (the higher part started at the absolute height of 0.94 m). The wall had been laid of limestones and boulders joined with lime mortar (Fig. 11).

After dismantling the wall a wooden supporting raft underneath was unearthed. Three parallel logs (length up to 640 cm, width 25–35 cm, thickness 30 cm) with the interval of 168 cm were situated crosswise to the wall. The western ends of the logs had been attached to the north-western – south-eastern directed frame log by dovetail, eastern ends had been fixed with cross-beams placed behind the vertical posts (Fig. 12). In addition to logs and dovetails the connection between the logs had been fixed with wooden pegs (4 × 4 cm in cross section). The ends of the dovetails located on the outer side had been sawn lower and an edge element with triangular cross-section had been attached above them (similarly to the construction of the bank fortifications). A baulk (11 cm wide and 35 cm thick) had been placed against the inner side of the log situated under the outer edge of the wall. A wall made of 10 cm thick vertical planks connected by joggle and rammed into the ground was located directly on the eastern side of the baulk. The wall was identical to the above-described sheet-pile wall found by the bank
