ARHEOLOOGILISED
VÄLITÖÖD EESTIS
ARCHAEOLOGICAL FIELD
WORKS IN ESTONIA IN
1996

ARCHAEOLOGICAL INVESTIGATION ON A MEDIEVAL MANOR-COMPLEX IN KEILA

Heikki PAUTS

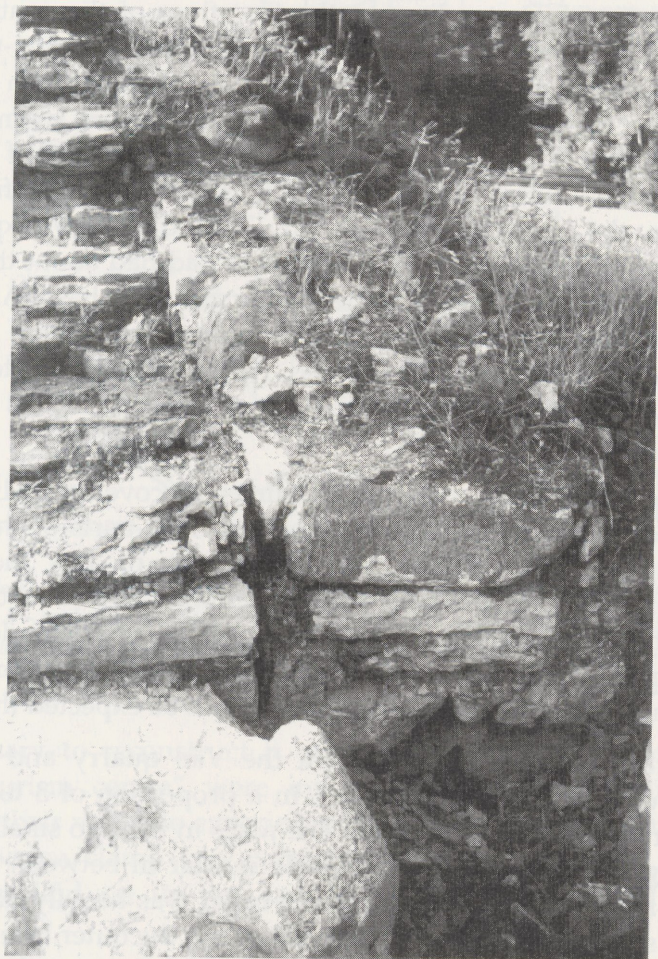
Fig. 1. Corner of early tower-stronghold.

The western part of the plot revealed remains of several walls, belonging to the earlier phases of the manor-complex. The deep wall, starting from the kitchen-corner, ended at the western part of the plot; therefore, the length of one side of that building could be measured – 9.7 meters. The outer wall of the two small chambers had been built later, on top of the deep wall. The two discovered parallel deep walls end ca. 2.1 meters further away, probably forming the entrance into one of the oldest buildings on the site of the later manor-complex. A *seestling* of Tallinn from 1367–1393 (HMK 4494:490) discovered at the foundation of the wall, dates the construction to the fourteenth century. This date is only a hypothesis in the present stage of excavations, and should be investigated in the future.

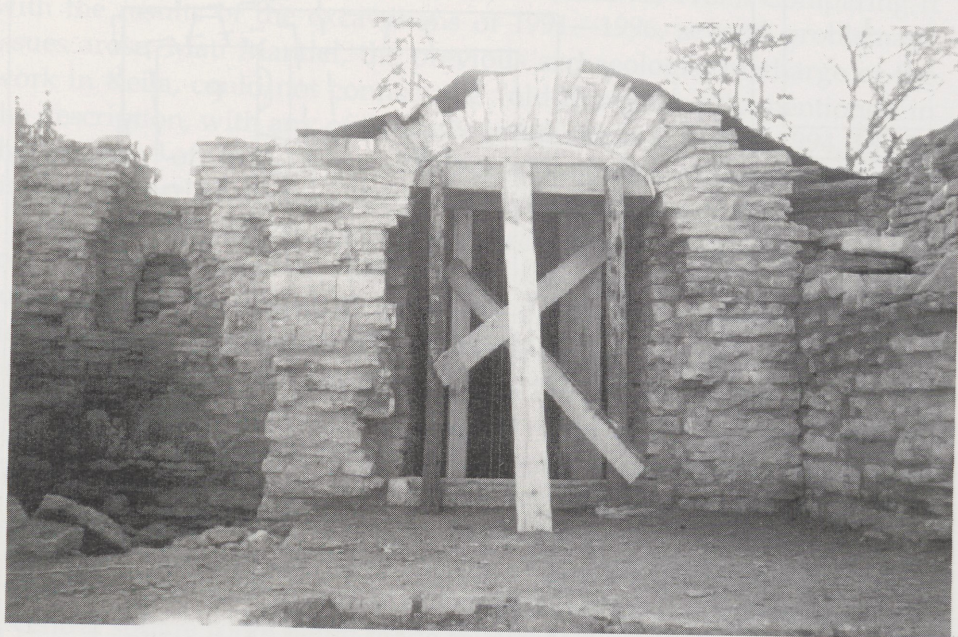
Fig. 3. The reconstructed vault.

Conservation work. Limestone from the Vão quarry and a mixture consisting of lime, sand and cement, in a proportion of 3 to 1.5 to 0.5, was used in all conservation work. The walls in the two small chambers were strengthened by replacing the old mortar in between the stones. The wall of the vaulted entrance to the cellar was heavily damaged by fire on the side of the kitchen corner; therefore, the outer layer had to be reconstructed. In 1996, work also started on top of the vaulted entrance to construct a viewing platform in the coming years. As the vault itself was on the verge of collapsing, caused by rainwater and vandalism, it

was necessary to reconstruct it quickly (Fig. 3). The workers of the "Padise tourism centre" were invited to provide professional help because of their valuable experience in restoring the Padise monastery. First, a wooden clamp was constructed for support, then the vault-stones were laid on its top and covered with horizontal layers of limestone.
