ARHEOLOOGILISED
VÄLITÖÖD
EESTIS

1998

BUILDING ARCHAEOLOGY INVESTIGATIONS IN THE CISTERCIANS ST. MICHAEL'S NUNNERY IN TALLINN

Jaan TAMM and Jaak MÄLL

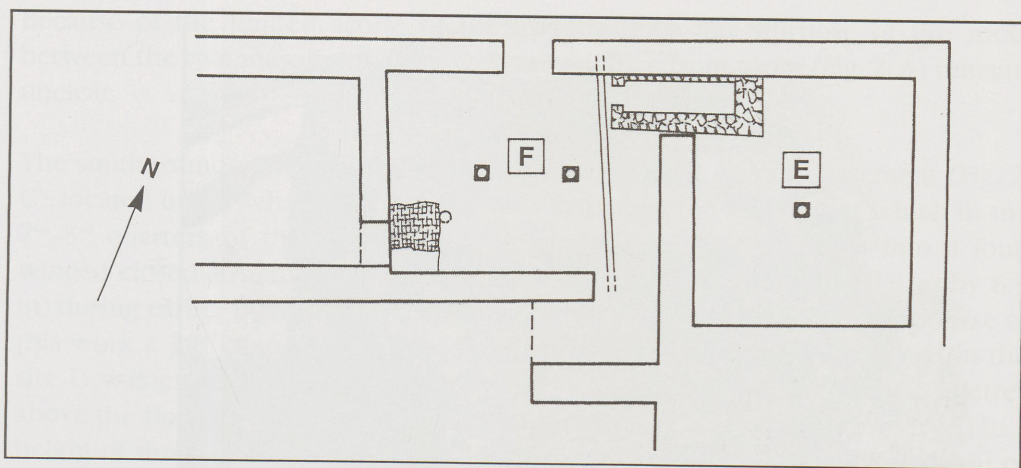
Fig. 3. St. Michael's Convent in Tallinn. Site IV, rooms E and F.
 Joon. 3. Tallinna Püha Miikaeli klooster. IV kaevand, ruumid E ja F.

The site IV (Figs. 1: IV; 3) was situated in the east part of the north wing of the nunnery at 2 Kooli Street. The goal of the investigations was to excavate the original floor level of the rooms. Still deeper layers were only investigated by means of probes and in places where sewage pipes were laid. Fortunately there were no layers containing finds or constructions below the oldest floor level. Local and imported pottery dominated the 248 artefacts (AI 6129) found from the fourth site. Of local pottery there were 7 fragments from the 13th-14th centuries, and 13 fragments of local *grapens* from the 2nd half of the 16th and the 17th centuries. Imported pottery included 13th-17th century fragments from Rheinland and 2nd half of the 16th to 17th century products from The Netherlands. There were also fragments of 17th-18th century clay pipes and of glaze stove tiles, a fragment of a bone comb (13th-14th century), a clay bead (15th-16th century), bone knife handles and a fragment of a vat tap (16th-17th century), fragments of lead window-frames (13th-17th century), as well as a tin spoon fragment (18th-19th century).

The kitchen (Fig. 3: F) on its western side was almost as big (72 sq m) in area; yet, it was different in many aspects in terms of its room layout. On the central axis of a somewhat narrower room there were two Romanesque pillars (Fig. 7) supporting a two-aisle vaulting. In the north wall were two window openings, to a certain extent analogous in proportion with the refectory windows.

Kaevand IV (joon. 1: IV; 3) asus kloostris põhjatiiva siseruumides. Tööde eesmärgiks oli välja selgitada ruumide algne põrandatase ja seejärel eemaldada hilisemad ladestused. Ruumide algsest põrandatasemest madalamale jäävaid ladestusi uuriti šurfidega nendes kohtades, kuhu paigaldati uued kanalisatsioonitrassid. Ka IV kaevandis oli šurfides paljandunud kasutusjälgedega mullatekkekiht samal kõrgusel kui eelmistes kaevandites. Sellest kihist võetud puiduproov andis C¹⁴ analüüsi tulemuseks aastad ajavahemikust 1259–1304 AD. Algne ruumide põrand koosnes mõrdist alusele laotud paeplaatidest sillutisest. Paest põrandatasemega võis seostada ka kahte ruumi (joon. 3: E ja F) eraldavat ahjualust, mille suue jäi köögiruumi (joon. 3: F) ja kus kerist kasutati vana refektooriumi (joon. 3: E) kütmiseks. Köögiruumi edelanurgas paljandus veel teinegi küttekolle - tellistest laotud leease koos mantelkorstna tugisambaga. Taoline, mitme tulekoldega köök on varem ehedamal kujul välja kaevatud Pirita kloostris idatiivas. Mõlema ruumi võlve kandsid romaani päraste kapiteelide ja baasidega sambad (vt. joon. 6 ja 7). Köögiruumis paljandunud põhja-lõuna suunaline puidust

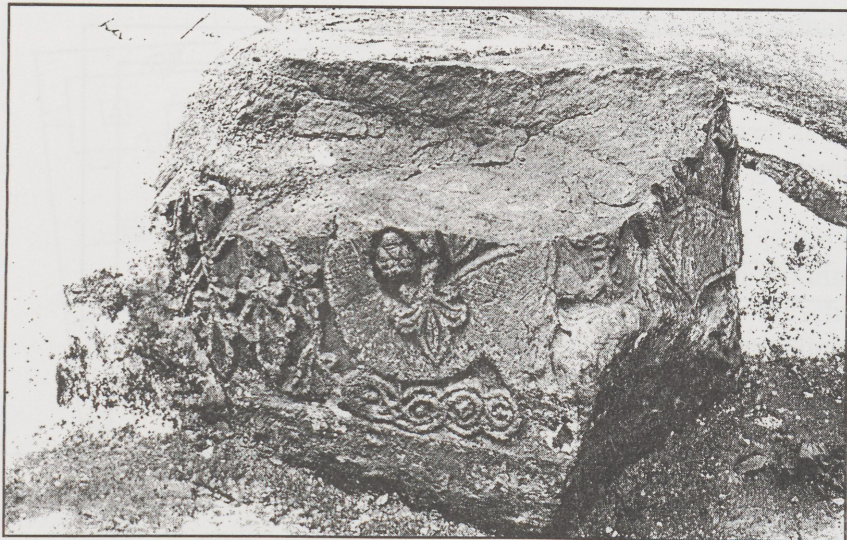
Fig. 4. Late romanesque style capital, found during the excavation of the new refectory's basement. Fourth quarter of the 13th century.

Finds were practically lacking in the filler of the above rooms, but separate mention should be made to five capitals of round pillars (Figs. 4; 5). By their shape and decor resemble those in the chapter hall and the north wing of the nunnery, and as a result they can be dated to the 4nd quarter of the 13th century. At the same time, it is very difficult to determine their original location. They did not belong to the rooms of the west wing, which, as we know, were completed in the 15th century, when such Romanesque form had long since fallen into disuse. Moreover, there were no vaults in the west wing. It is the most likely that the capitals were intended for the westernmost rooms of the north wing, which, however, never received such a vaulted shape. It was probably in the course of rebuilding after 1827 that they ended up in the filler of the basement rooms of the west wing. Alternatively, on the basis of a find from St. Mary's of Tartu in the Botanical Gardens, it cannot be ruled out that rubble from elsewhere in the city was also used in the building of the gymnasium.

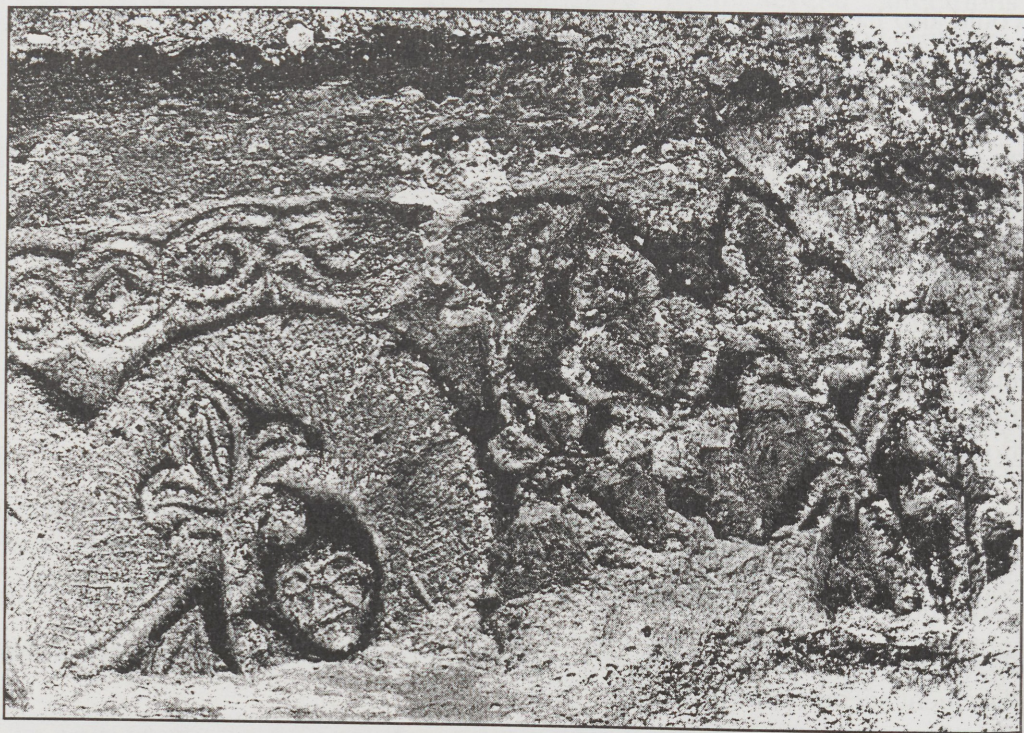
Fig. 5. Detail from the capital.

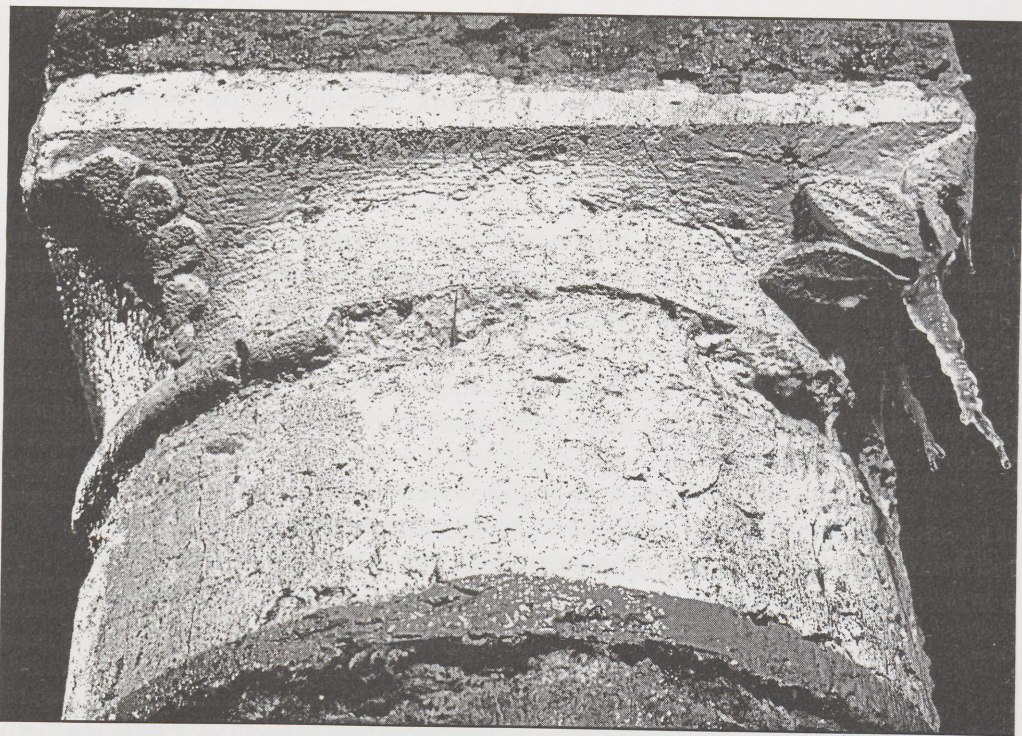
Fig. 6. Romanesque capital of the vaulting pillar in old refectory (E).
Joon. 6. Vana refektooriumi (E) völvide ümarsamba romaani kapiteel.

ogous frames. In the centre of the room, round pillar with a Romanesque base and capital (Fig. 6), supported vaults, which were rather high. Deciding by the somewhat flatter wall ribs, they were designed somewhat lower.

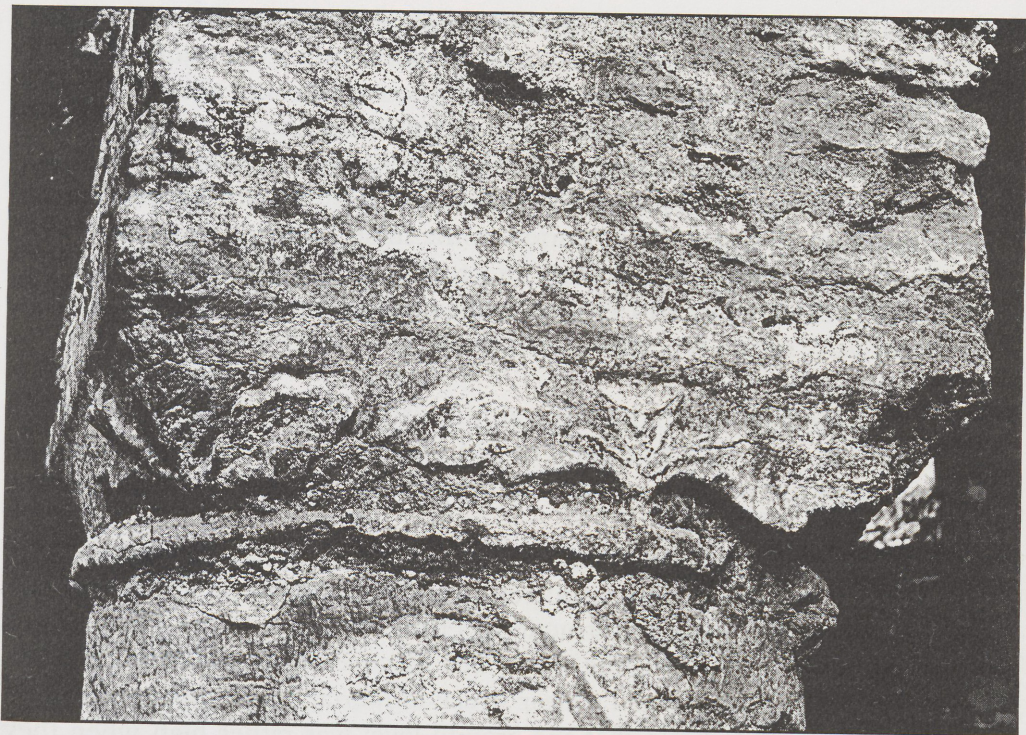
Fig. 7. Romanesque capital of the vaulting pillar in old refectory's kitchen (F).
Joon. 7. Vana refektooriumi köögi (F) völvide ümarsamba romaani kapiteel.
