# ARHEOLOOGILISED VÄLITÖÖD EESTIS

## ARCHAEOLOGICAL FIELDWORK IN ESTONIA

# ARCHAEOLOGICAL MONITORING ON THE CONSTRUCTION SITE OF ST. BRIDGET'S CENTRE IN PIRITA, TALLINN

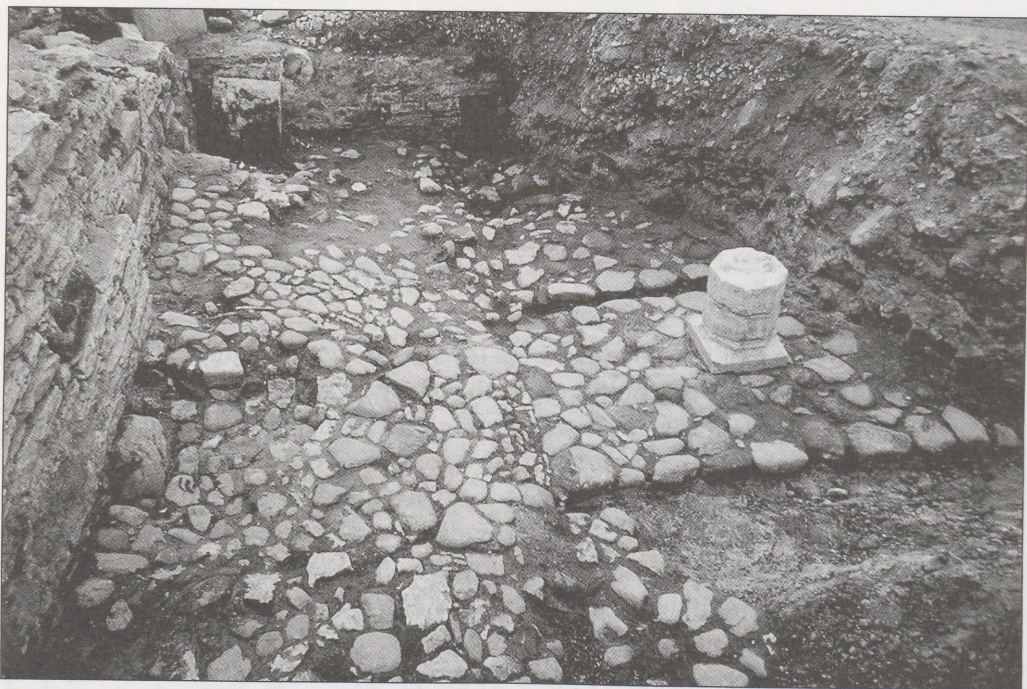
Fig. 3. The excavated part of the infirmary building. View from W.

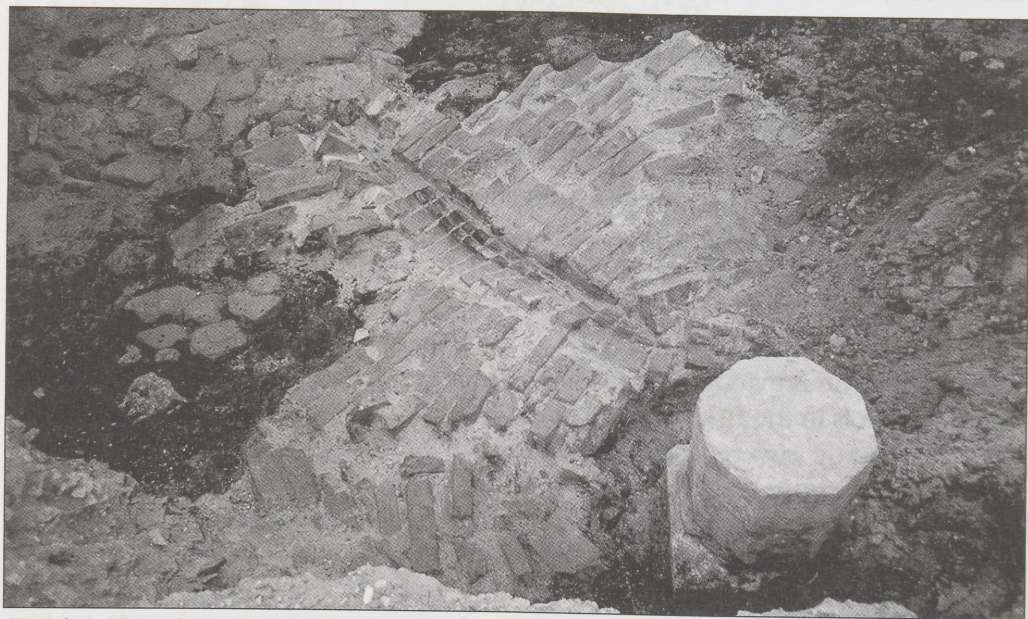
Fig. 4. The collapsed vaults. View from SE.

After the collapse of the vaults of the described basement (Fig. 4) and the resultant abandoning of the building, the preserved bricks from the ruin and the walls of the ground floor were used by the peasants of the neighbourhood for the construction of various new buildings. The latter is suggested by various foundation remains preserved on the ruins of the described building and at its NE side. The investigations on Pirita Kabelimägi (Tamm 2001, 89) revealed that similar heavily sooted bricks were used there also.

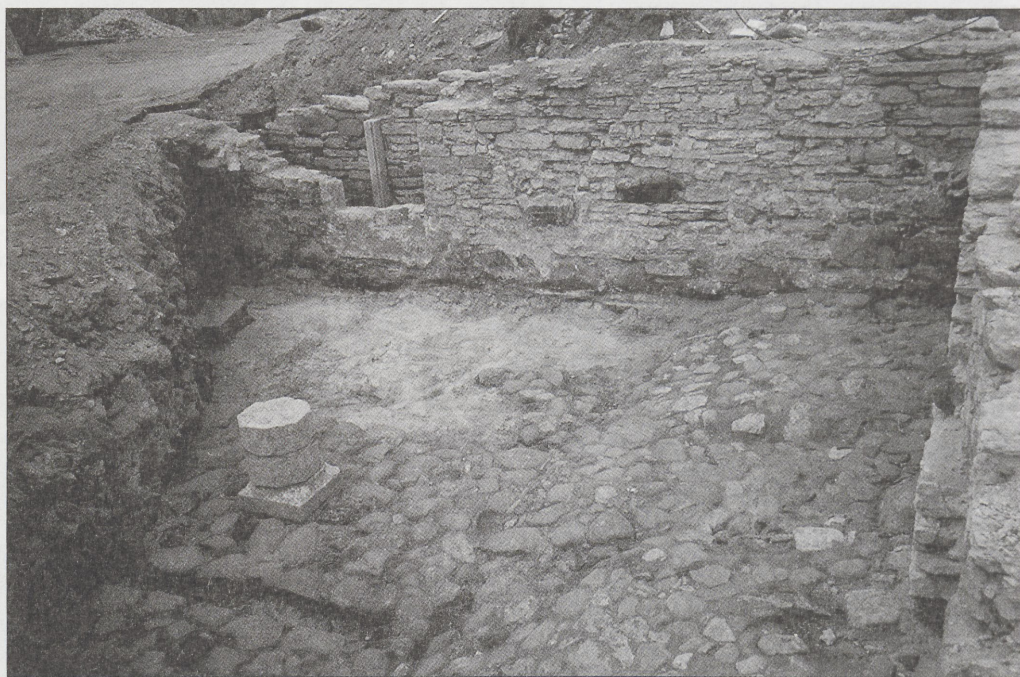
Fig. 6. The excavated part of the infirmary building. View from E.  
 Joon. 6. Väljakaevatud osa arvatavast haiglatoonest. Pildistatud idast.
