# ARHEOLOOGILISED VÄLITÖÖD EESTIS

## ARCHAEOLOGICAL FIELDWORK IN ESTONIA

## ARCHAEOLOGICAL INVESTIGATIONS OF THE LAIUSE CASTLE

**Rünno VISSAK**

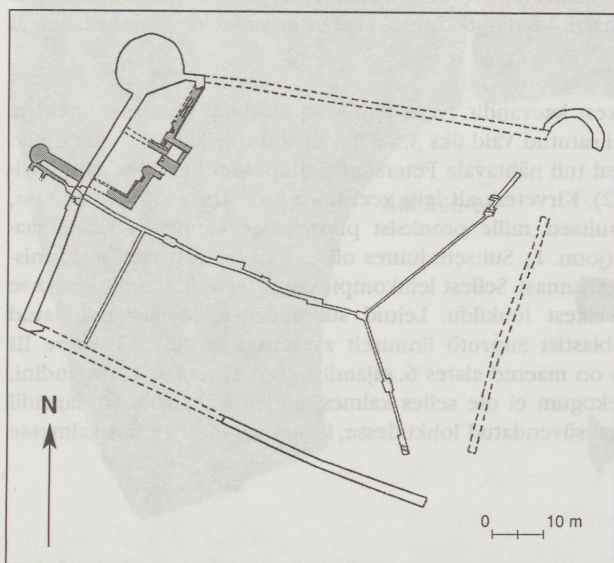
Fig. 1. The castle of Laiuse, the cable track and the excavated part of the wall.

Joon. 1. Laiuse linnus, kaablitrass ja väljakaevatud müürid.

The cable track ran into the territory of the castle through the gateway in the western wall, traversed the courtyard along its E-W axis and branched off into the four corners of the courtyard. The length of the track in the yard was 180 m and it was excavated by hand, beginning with the topmost layer beneath the sod. In the first stage trial pits were dug in the track, to establish the presence, thickness and nature of the cultural layer, its main deposits and the density of finds. It appeared that beneath the sod layer and the thin soil under it lay a darker brown layer, with a

southern one was preserved in a 4.3 m long section and was about 20 cm lower. It ended in the western part in two parallel north-south oriented transverse walls with a 2.2 m wide space between them (Fig. 1). The western transverse wall was 0.9 m thick; the eastern one, only 0.5 m thick. Since the western wall was the outer one and the thinner eastern wall was protected by side walls, such a difference in thickness is easily accounted for. The inner sides of

2002. aasta arheoloogilised uuringud ja kaevamised Laiuse keskaegsel ordulinnusel hõlmasid valguskaabli paigaldamiseks rajatava trassiala ja väravaehitise müüride väljakaevamist linnuse läänepoolsele ning linnuse sees paiknenud hoone müüride osalist väljapuhastamist õueala loodenurgas (joon. 1 ja 2). Kaablitrass kulges linnusesse läbi läänemüüris asuva väravaava, läbis linnusehoovi ligikaudu selle O–W teljel ja hargnes nelja haruna õueala nurkadesse. Trassi pikkus linnusehoovis oli 180 m. Trassi kaevamisel selgus, et kaasaegse mättakihi ja selle aluse õhukese kasvumulla all paikneb u. 20 cm paksune keskaegset leiuainest sisaldav tumepruun, väheste lisanditega kiht. Seetõttu kaevati kogu trassiala lahti üksnes käsitati.

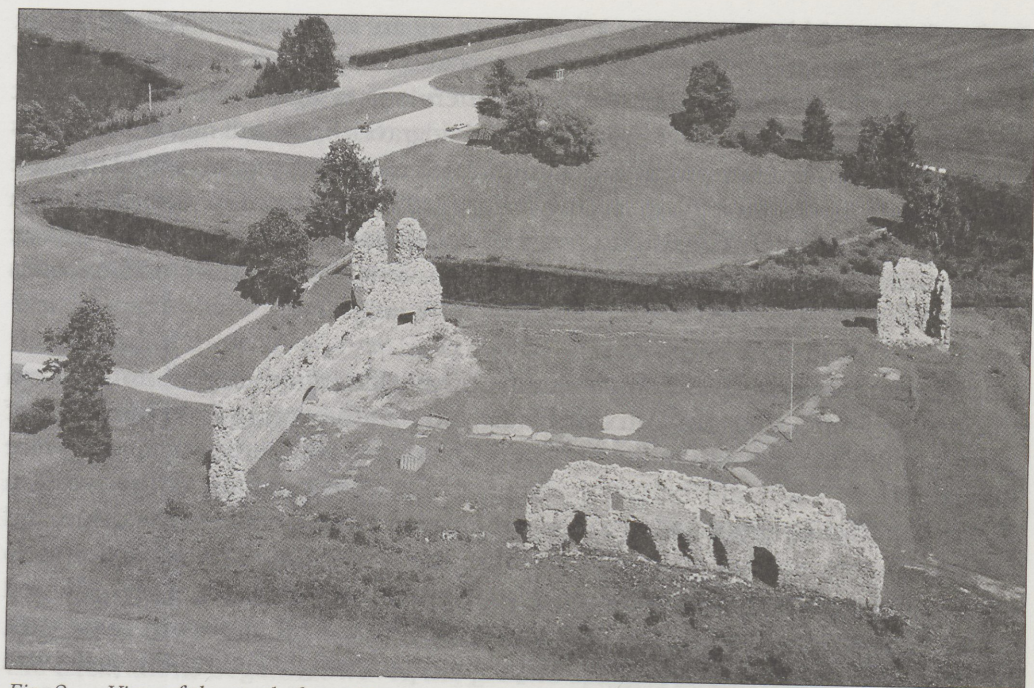
Fig. 2. View of the castle from W.  
Joon. 2. Vaade linnusele läänest.

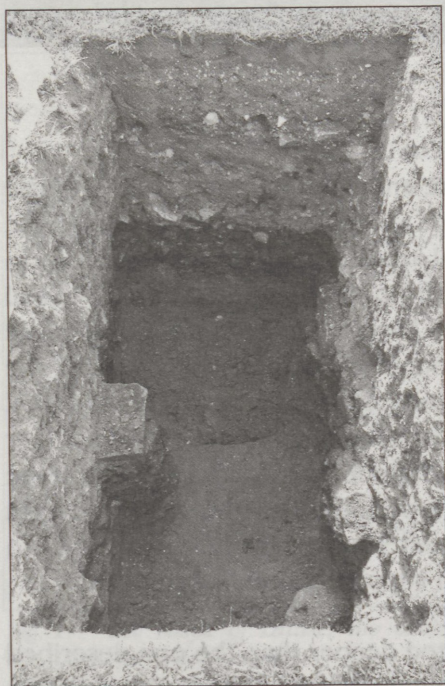
Fig. 3. Layer with burnt traces in the area of the cable track.

Joon. 3. Põlengujälgedega kiht kaabli-trassi alal.

track at 30, 50 and 60 metres. In these pits, deposits came to light below the yellowish levelling layer and the pavement layer. It is practical to divide these into deposits earlier and later than the 5–10 cm thick layer with burning traces discovered on the level of 82.70–82.45 m (Fig. 3).

At the 40<sup>th</sup>–55<sup>th</sup> metres of the track a 20–25 cm thick deposit of mixed brownish soil and yellowish sand lay upon the burnt layer. It contained limestone slabs measuring up to 50 x 30 x 10 cm, larger granite stones and a few brick fragments. This layer is most likely connected with extensive construction activities in the castle, the stones being a part of unused building material.

Below the burnt layer, sandy deposits and layers containing humus came to light, which could be ground levels of the earlier construction phases of the castle. Between the burnt layer and the earlier ground levels,

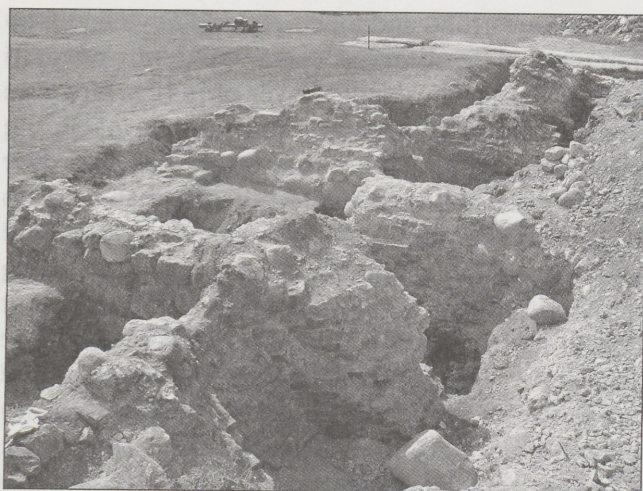
Fig. 4. Walls of the NW building. View from NW.  
Joon. 4. Loodepoolse hoone müürid. Vaade loodest.

Linnuse õueala loodeosas puhastati välja keskaegse hoone idamüür 29 meetri pikkuses lõigus kagunurgast kuni linnuse põhjapoolse ringmüüri siseküljeni. Hoone lõunaseinast 10,4 m kaugusel eendus 3,5 m võrra 6–6,5 m laiune hooneosa (joon. 4), mille idaseinas oli paiknenud ukseava. Eenduv hooneosa oli keldrita, kuid selle lääneseinas oli uksava, mis viis hoone keldritesse suunduvale trepile. Allapoole laienev trepikäik oli 1,15–1,3 m laiune, trepil oli neli tellistest trepiastet, mis laskusid poolkeldrikorruse tellistest ja maakividest põrandatasapinnani (joon. 5). Silmatorkavaks erinevuseks eenduvast hooneosast lõuna ja põhja poole paiknevate müüride juures oli see, et põhjapoolsel müüril oli 10 cm laiune sokkel. Lõunapoolsel müüril sokkel puudus.

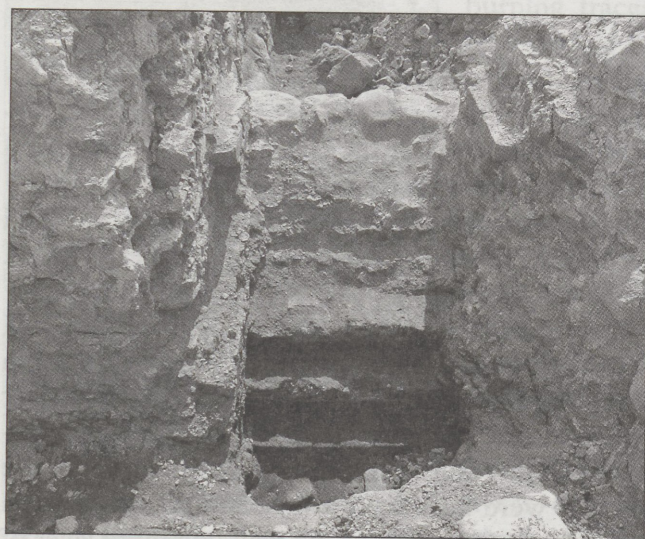
Fig. 5. Stairway with four steps in the W-wall of the protruding part of the building.  
Joon. 5. Nelja astmega trepp eenduva hoone lääneseinas.
