**ARCHAEOLOGICAL  
FIELDWORK  
IN ESTONIA**

## ARCHAEOLOGICAL INVESTIGATIONS IN PÄRNU

**Villu KADAKAS, Arvi HAAK, Erki RUSSOW,  
Ulla SALUÄÄR and Krista SARV**

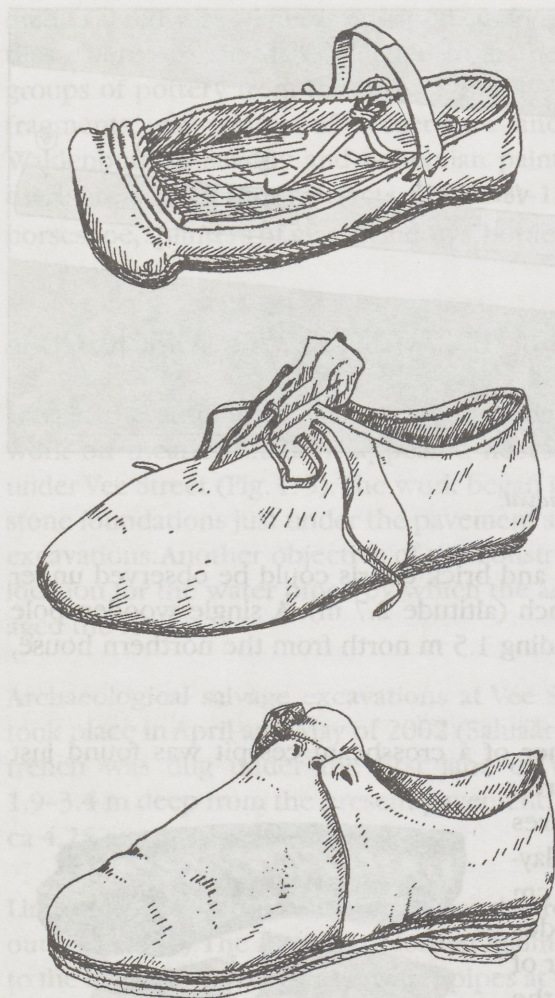
Fig. 5. Examples of shoe types found from Vee and Põhja Street: 1 - Cowmouth, 2 - Front-Laced Shoe, 3 - Laced Shoe (Redrawn after Goubitz, Driel-Murray & Groen-man-van Waateringe 2001, 276, Fig. 1a; 199, Fig. 14; 297, Fig. 1).

The cowmouth type can be dated with the greatest precision. This type (Fig. 5: 1) became fashionable at the beginning of the 16<sup>th</sup> century, peaking between 1510 and 1550 (Goubitz, Driel-Murray & Groenman-van Waateringe 2001, 275). Originally, this type of footwear was common among the *lansquenets*; however, it soon found its place among the preferences of the upper strata in the towns (Schnack 1993, 67). The supposition that cowmouth type was in use among the children, based on material from the Netherlands (Goubitz, Driel-Murray & Groenman-van Waateringe 2001, 275) can be proved by the soles (PäMu A 2559 N 2) and forepart of the upper, found at Vee Street in Pärnu and originating from children's footwear. The dating of latchet shoes is a question of greater uncer-

tainty. This type first appears during the 14<sup>th</sup> century, but remains in use until the 18<sup>th</sup> (Fig. 5: 3; Goubitz, Driel-Murray & Groen-man-van Waateringe 2001, 281). The sewing and nailing traces on the soles, uppers and welts allow tracing constructional and technical details that were used in the shoemakers' practise during the 16<sup>th</sup> century on the material from Vee Street. The use of multilayered soles does not allow an earlier dating than 1500. Two fragments of a latchet shoe (PäMu A 2559 A 10, 25) have a good parallel in the material from Nieuwe (Niedorp), dated between 1675 and 1725 (Goubitz, Driel-Murray & Groen-man-van Waateringe 2001, 297. Fig. 1), and in the ethnographic collections of Estonian History Museum (TAAM 9226 E121) dated to the 18<sup>th</sup> century. The front-laced shoes dom-

inated the footwear trends in North-Eastern Europe from the 14<sup>th</sup> century to 1550 (Fig. 5: 2; Goubitz, Driel-Murray & Groenman-van Waateringe 2001, 195), thus a longer period as well. The finds from Pärnu should be dated to its later usage on the basis of the way of connecting the sole with the upper, and the existence of cowmouth shoes in the same contexts. The dating of the leather finds from Pärnu to the 2<sup>nd</sup> half of the 16<sup>th</sup> century is indicated by the sole finds with typical characteristics (see Goubitz, 1987; Goubitz, Driel-Murray & Groenman-van Waateringe 2001).
