**ARCHAEOLOGICAL  
FIELDWORK  
IN ESTONIA**

# VARIOUS INVESTIGATIONS IN TALLINN AND HARJUMAA

**Villu KADAKAS and Hanno NILOV**

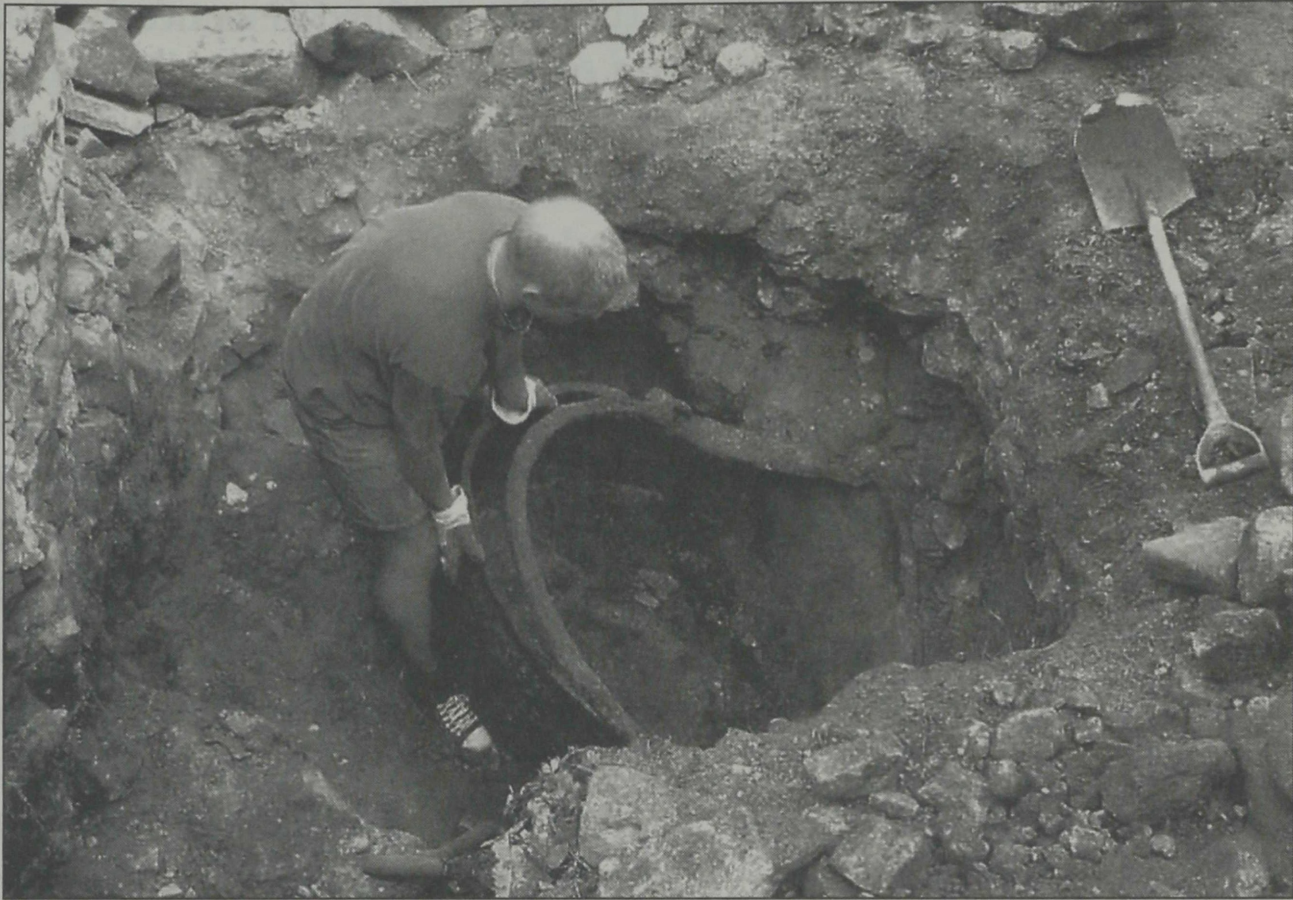
Fig. 8. Padise klooster. Pulling out the cauldron.  
Joon. 8. Padise klooster. Katelt välja tõmbamas.

From the debris filling the earlier rooms a single but notable artifact was uncovered. A huge intact riveted brass cauldron (Fig. 8) lay in the middle of one trial pit exactly as big as the planned pit. No metal detector was used or the existence of the cauldron presumed by any other means, but sheer luck must have been on the side of the archaeologists. The cauldron, found in somewhat battered condition, was made of flat bronze plates, including a flat bottom, riveted together. The cauldron stands ca. 60 cm high, with a diameter ranging from ca. 100 cm at the bottom to ca. 110 cm at the rim. Besides the big iron handle, a small scrolled bronze handle for pouring is the single remarkable detail.

Although a patch on one plate indicates long use, the cauldron was

probably still in a fair condition before getting into the debris. As the cauldron was sitting upright exactly on a corner of a buried wall, the weight of the overlaying debris has crushed its bottom and distorted its overall shape. The test pit gave no indications whether the cauldron had been once hidden intentionally or had just tumbled to the spot due to the building collapsing. One could hardly believe that such a thing would have been just abandoned or thrown away centuries ago, as the sheer amount of metal would be valuable even nowadays. It will probably be displayed in the Museum of Harjumaa in Keila until there will be satisfactory conditions to exhibit it at the ruins at Padise.
