ARCHAEOLOGICAL INVESTIGATIONS AT THE LATE IRON AGE SETTLEMENT SITE OF HUNTAUGU AND AT THE CASTLE OF TEUTONIC ORDER IN VILJANDI

ARCHAEOLOGICAL MONITORING AT THE PREHISTORIC SETTLEMENT SITE OF HUNTAUGU

EXCAVATIONS AND MONITORING AT THE CASTLE OF THE TEUTONIC ORDER

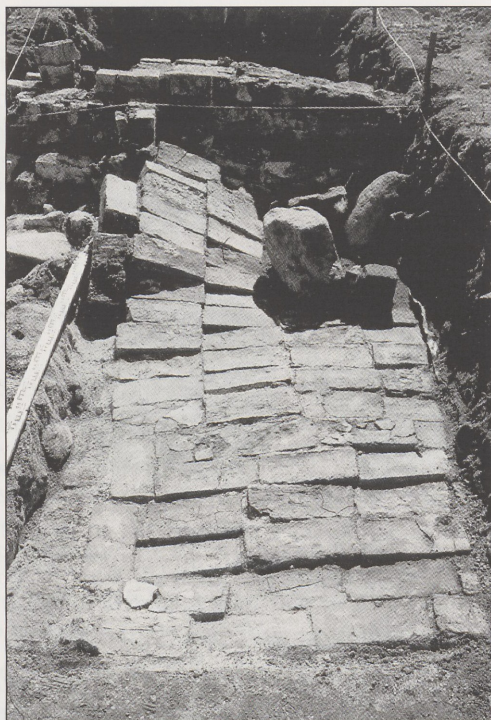
Fig. 3. Sections of the northern edge of the building with a brick floor.

Joon. 3. Osa tellispõrandaga hoone põhjaserast.

During the Livonian War, the area of the building witnessed a third period of usage. Two post-holes, scotched with granite stones, were dug through the layers inside the building, including the brick floor (Fig. 3). Stratification showed that these intrusions originated from the post-medieval period. During the excavations of 2004, it was possible for the first time to distinguish a layer connected with Russian or Polish presence in the castle (between 1560 and 1611). Two coins of Polish-Lithuanian origin, collected from the layer just below the debris, are the clearest indicators of this period during which the post-holes were dug through the floor. Finds of glazed redware, stoneware from Frechen and Raeren, are consistent with the dating. The debris just above the layer contained numerous fragments of pot-like stove tiles.

elutegevuskihi dateeringu põhjal peaks nimetatud sein olema rajatud hiljemalt 14. saj. keskpaigas. Eelmisel aastal avastatud tellistest hoonepõrand jätkus ka tänavuse kaevandi alal (joon. 3). Põrandat kattis lubjakiht, millele olid ladestunud prügitusliiva- ja lubimördiga eraldatud õhukesed elutegevuskihid. Hoone sisemusest kogutud leiumaterjali võib dateerida 14. saj. lõpust 16. saj. keskpaigani. Dateeringut kinnitab ka 15. saj. algul löödud Tallinna *lühbische*.

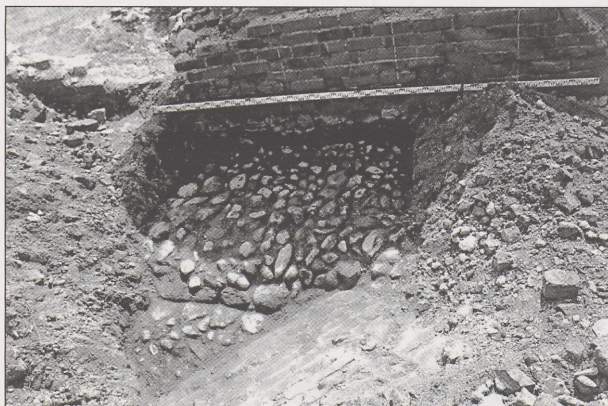
Fig. 8. Cobblestone pavement in the yard of the first outer bailey, and a section of the wall, which has been pressed almost to the level of the pavement. The gutter is indicated by an arrow.

Joon. 8. *Munakivisillutis I eeslinnuse hoovis ning müüritükk, mis on vajunud ülaseravaga praktiliselt silutise tasandini. Nool osutab veerennile.*

The latest pavement of the yard of the outer bailey consisted of granite stones up to 20 cm in diameter. In a 2 x 2 metre area where the pavement was cleaned, a section of a gutter was unearthed (Fig. 8). At some time during the second half of the 16th century, the pavement was covered with 5-12 cm of a sooty cultural layer, varying from dark brown to black in colour. Numerous fragments of window glass and window frames, as well as pottery with green and brown glaze, were gathered from this layer. The same layer, located next to the wall section

Esimese eeslinnuse põhjaosas toimunud järelevalvetöödega tuvastati, et sealne kuni 2,5 m paksune rusukiht on tekkinud mitme varinguperioodi käigus. Hoovi katnud maakivisillutisele, milles avastati rentselt (joon. 8), on ladestunud 5–12 cm paksune 16. saj. teise poole leide sisaldav kultuurkiht. Seejärel on varisenud konvendihoone müürid, mh. on üks 2 x 1,5 m suurune müürikatke vajunud peaaegu maakivisillutise ülapinna tasemele (joon. 8, esiplaanil), 1,5 tellise paksustest müüriosadest suurima mõõtmed olid 6 x 4 m. Rusukihi aläservast leiti ka paest kapiteel (joon. 5: a). Tundub, et konvendihoone põhjamüür on varisenud mingi plahvatuse tulemusel (seda kinnitab ka murdunud müüriinurk linnusekabeli põhjaseina üleminekukohal kooriosa seinaks). Plahvatuse järel on vähemalt eeslinnuse keskosa olnud läbitav: seal leiti 16. saj. lõpu või 17. saj. alguse leide sisaldav u. 1,5 m läbimõõduga tulease.
