ARCHAEOLOGICAL  
FIELDWORK  
IN ESTONIA

2004

# ARCHAEOLOGICAL INVESTIGATIONS AT THE MEDIEVAL BISHOPS'S CASTLE OF VARBEK (UUE-KASTRE) IN 2002–2004

**Andres TVAURI**

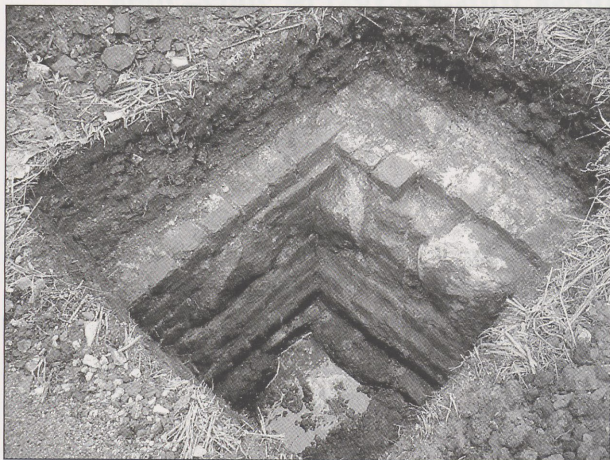
Fig. 2. Southwest corner of the main castle, opened in 2003.

Joon. 2. 2003. aastal avatud pealinnuse edelanurk.

wall layed of bricks with dimensions 30 x 14 x 9 cm and quarrystones was remarkably thick – the westward wall was 3 m and southward wall 2.5 m thick (Fig. 2). It was seen that after constructing the wall, a river sand fill was stacked inside of it, with a layer of red clay water proofing. Sand layers on the surface of the latter were apparently a former floor. From the remains on top of it, resulting from a collapse or dismantling, a stone cannonball (TÜ 1014: 242) and couple of fragments

2003. aastal rajati varasemate uurimistulemuste täpsustamiseks 1,6 x 1,3 m suurune proovišurf linnuse edelanurgale (joon. 2), uurimaks linnuse varaseima osa müüride ehitust ning rajamisaega. Selgus, et maakividest ja 30 x 14 x 9 cm suurustest tellistest laotud müür oli märkimisväärselt paks: läänepoolne müür oli 3 m ja lõunapoolne (jõepoolne) müür 2,5 m paksune. Tõdeti, et pärast müüri ehitamist oli selle siseküljele kuhjatud jõeliivast tätekiht, mille peale oli pandud punasest savist hüdroisolatsioonikiht. Viimase pinnal olid ilmselt kunagise põranda moodustanud liivakihid. Nende peal oli linnuse lagunemise või lammutamisega tekkinud rusukiht, kust saadi kivist kahurikuul ja paar 16.–17. sajandi glasuuritud punasest savist nõu kildu. Kahjuks ei saadud leide, mille abil dateerida müüri rajamist.

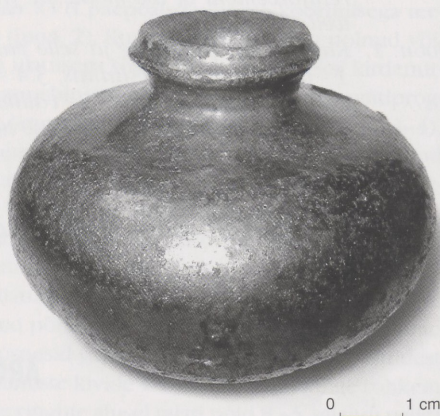
Fig. 3. Green-glazed greyware ink-well, found from the west side moat of the main castle.

Joon. 3. Robelise glasuuriga ballsavist tindipott, leitud pealinnuse läänepoolsest vallikraavist. (TÜ 1014: 263.)

mud rich in organic material. Finds from the 19<sup>th</sup> century fragments of tiles, bottles and vessels were also in that layer – probably in the mud accumulated at the bottom of the moat. Based on these finds, it seems that this part of the moat was cleaned in the 19<sup>th</sup> century or later. The oldest find from the mud bottom is a little green-glazed greyware vessel (Figs. 1: 6; 3). It was probably an ink-well. This vessel is of Russian origin, with parallels known from Pskov (Киљдюшевский 2002, Fig. 3: 25), for example. Green-glazed

greyware made in Pskov county was distributed in Estonia in the second half of 16<sup>th</sup> century and in 17<sup>th</sup> century (Tvauri 2004, 403–404).

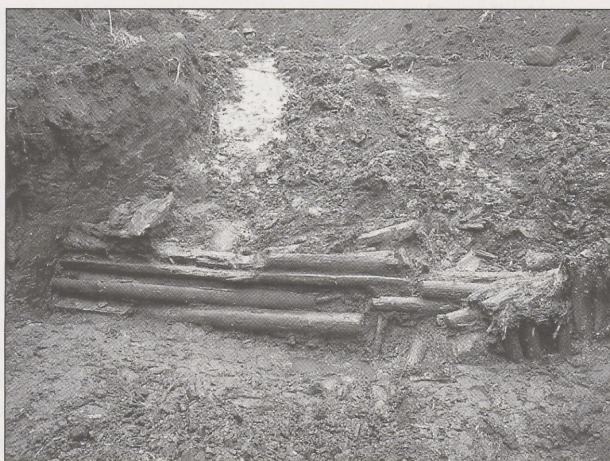
At the side of the outer bailey towards the main castle, a log reinforcement was found (Fig. 4). It consisted of up to five layers of slanting logs (10–30 cm thick) that were supported by piles. Some of the logs were hewn by axe; the ends of all the logs were hewn as well. After recording the remains of the reinforcement, it was covered with earth. There was a similar reinforcement of the moat also at the west side of the west side moat, as observed already in 2001 (Fig. 1: 2; Tvauri 2002, 156). Unfortunately the sections of the logs of the reinforcement were too small for dendrochronological dating (oral consultation with Alar Läänelaid).

Fig. 4. View of the timber reinforcement of the moat at the eastern side of the outer bailey.

Joon. 4. Vaade eeslinnuse idaküljel olevale vallikraavi palkidest kaldakindlustusele.

Eeslinnuse pealinnusepoolisel küljel leiti palkidest kaldakindlustus (joon. 4). See koosnes kuni viiest kihist poolviltu üksteise peale asetatud 10–30 cm paksustest palkidest, mida toetasid vaiad. Osa palkidest olid kirvega tahutud; tahutud olid ka kõikide palkide otsad. Pärast kaldakindlustuse jäänuste dokumenteerimist kaeti see uuesti pinnasega. Samalaadne vallikraavi kaldakindlustus on olnud ka eeslinnuse läänepoolse vallikraavi lääneküljel, nagu selgus juba 2001. aasta uuringute käigus. Kahjuks olid kaldakindlustuse palgid liiga peenikesed, et neist oleks saanud teha dendrokronoloogilist dateeringut (suuline teade Alar Läänelaidilt).
