ARCHAEOLOGICAL  
FIELDWORK  
IN ESTONIA

2004

# RESCUE EXCAVATION IN THE CHURCHYARD OF VIRU-NIGULA

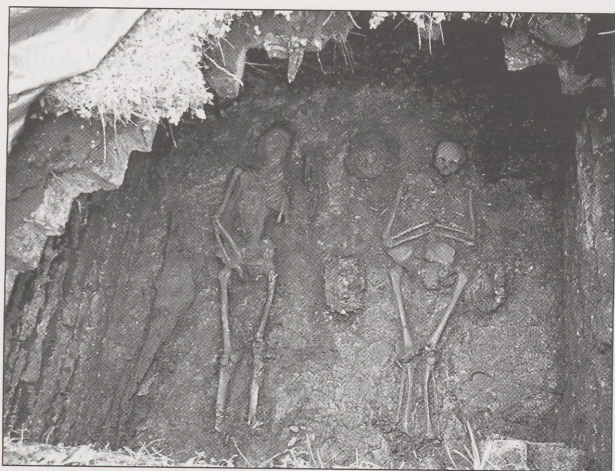
Fig 1. Burial chamber in Viru-Nigula churchyard with main burials. Female burial on right and male on left side. Remains of coffins have been removed but handles mark the coffins.

The two main burials were placed on the floor of the chamber (Fig 1). At first, the skeletons were cleaned together with the remains of the coffins. The coffin of the 2<sup>nd</sup> burial had been decayed to a large extent and it was possible to clean the skeleton at once. Also the coffin handles of nickel (possibly nickel covered with amalgamated silver) were unearthed, which were constructed of two parts – the handle and a plate attached to it. The handles associated with the two burials differed in form as well as elaboration – the plates that belonged to the handles of the 1<sup>st</sup> burial were relatively more elaborately crafted, decorated with flags and probably originally covered with coloured enamel. There were three handles by the long sides of both coffins, altogether eleven since one of the handles belonging to the 2<sup>nd</sup> burial was not located.

Kambri kaks põhimatust asetsesid kambri põrandal (joon. 1). Esialgu puhastati luustikud välja koos kirstujäänustega. II matuse kirst oli suures ulatuses kõdunenud ning luustiku sai välja puhastada kohe peaaegu terves ulatuses. Välja puhastati ka kirstude niklist (võimalik, et amalgaamhõbedaga ülehõbetatud niklist) kandesangad, mis koosnesid kahest osast – sangast ja selle külge kinnitatud plaadist.

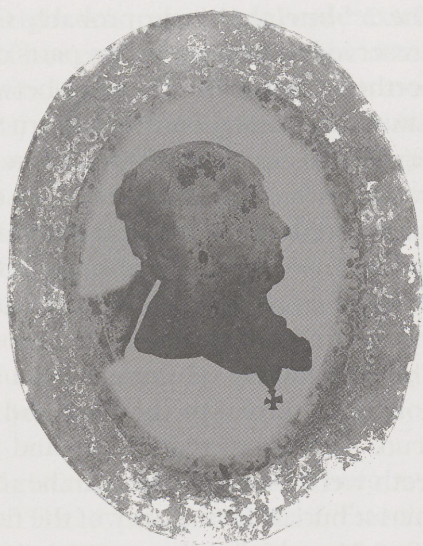
Fig 2. Glass oval with painting found beside the head of male burial. Most likely the painting depicts F.J.T. v Adlerberg. Note the cross at the neck.

After removal of the northernmost oval, another glass plate of the same shape was revealed underneath it, whereas unlike the others this one had a painting with black paint preserved on it that depicted the profile of a man (Fig 2). Considering the lower position of the painted glass it is likely that it had been placed inside the coffin, next to the head of the buried man, left of it. Most likely this is the profile of the buried man, Friedrich, J.T. von Adlerberg. The painting was preserved in a very bad condition and disappeared during conservation. Still it was possible to restore it. An interesting detail is the cross attached to the man's neck. Could this be a personal order, indicating his position as a major of the Russian Army? It is possible that the four upper glass plates were originally also with paintings which are not preserved, however. This is also suggested by an incised pattern on the rim of one oval plate. It will be possible to be more conclusive about the glass plates only after their conservation has been completed.

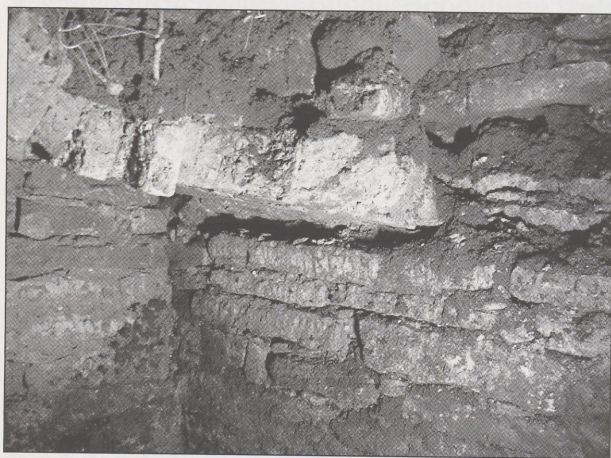
Fig. 3. Northwest corner of the chamber. Note the shallow arch of the brick vault, groove on the northern wall and gap in the corner.

The southern, northern and eastern walls of the chamber have been evenly laid from limestone and properly jointed. Another lay could be seen in the western wall, that has been separated from the northern and southern walls by a joint (Fig. 3). The gap between the stones here is imperfectly jointed and in places mortar covers the stones. In addition, soil has fallen into the chamber from both of the corner joints. The walls of chamber have been preserved to the height of 170 cm,

The vault has been laid of bricks, with limestones stuck between the bricks to lock them in place. Especially noteworthy is the extremely shallow arch of the vault. It seems as if during the construction of the vault an attempt was made to lay it as flat as possi-

ble, which resulted in an almost horizontal “ceiling”. Under the vault stones, in the mortar, it is possible to see traces of timber shoring boards. The vault is supported at a 30 cm wide and 5–10 cm deep groove, incised into the northern and southern wall, which begins 60 cm from the ground bottom edge of the walls. The vault did not rest on the eastern wall, since there is no trace of it in the wall. The connection of the western wall with the vault remained unclear, however, although in places it seemed possible that the vault actually was leaning on the western wall.

Hauakambri (joon. 3) lõuna-, põhja- ja idaseinad olid laotud ühtlaselt paest ja korralikult vuugitud. Teistsuguse laoga oli läänessein, mis oli põhja- ja lõunamüürist vuugiga eraldatud. Kivide vahe oli siin halvasti vuugitud ja mört kattis kohati ka kivide pinda. Lisaks oli müüri mõlemast nurgavuugist sisse varisenud mulda. Hauakambri müürid olid säilinud 170 cm kõrgusena, ulatudes maapinnani välja. Kambri põhi oli laotud paeplaatidest ja mördiga üle valatud; kohe põrandaplaatide all tuli vastu hallikas-kollane savi ning samal kõrgusel lõppesid ka müürid.

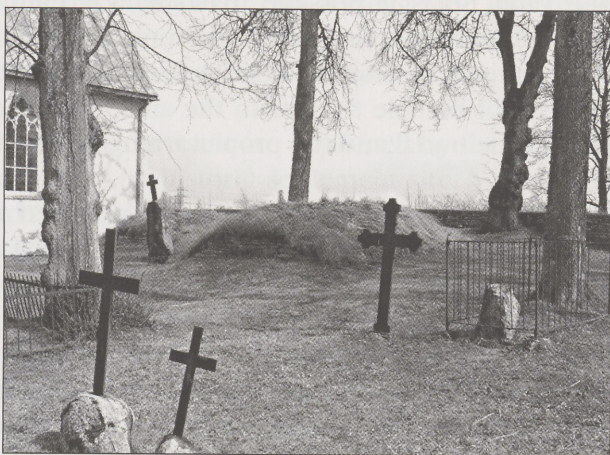
Fig. 4. Burial chambers with above ground vault at Lügänuuse churchyard.
