ARCHAEOLOGICAL EXCAVATIONS ON SUUR STREET, NARVA TOWN

Aivar KRIISKA and Mari LÕHMUS

Archaeological excavations in Narva, near the Town Hall (Figs. 1-3) on the sites Suur Street 22, 24 and partly on No. 26 were carried out in order to prepare the construction lot for a new building (Narva College of the University of Tartu). The excavated area measured a total of 1600 sq. m. The work began in November 2004, when most of the rubble originating from World War II and 1950's was removed (see Kriiska & Lõhmus 2005; Kriiska 2005). Work was continued in the spring and summer of 2005. Collection of finds, animal bone material and documentation are kept at Narva Museum (NLM 2420).

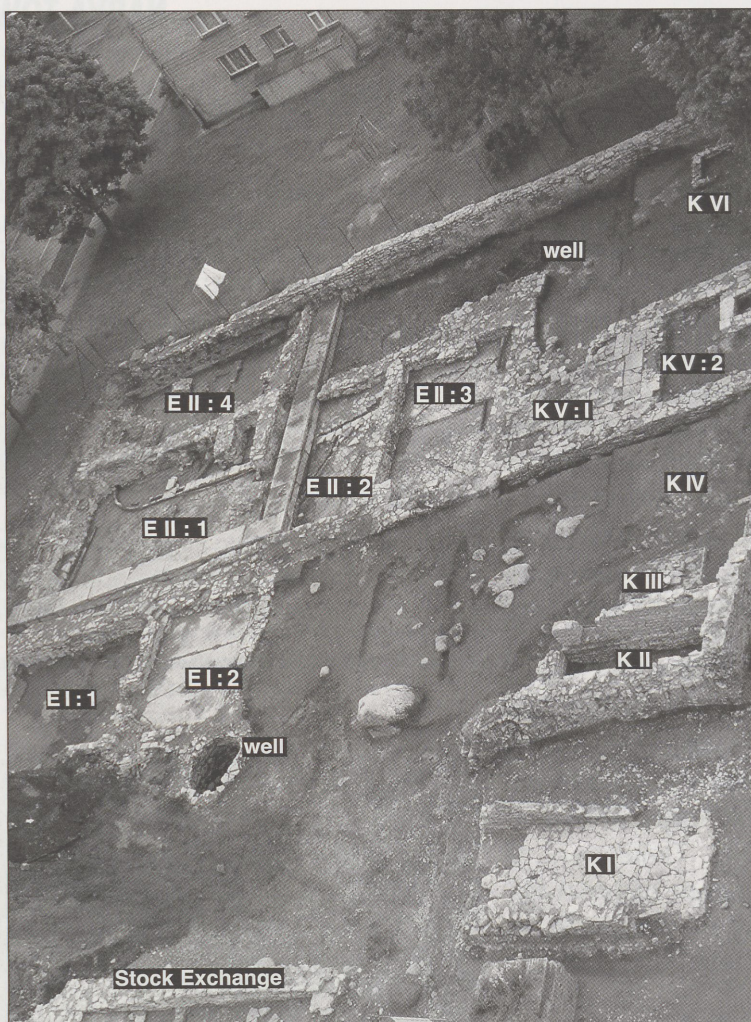
Fig. 3. General view of the excavation pit.
Buildings are indicated by E (dwelling houses) and
K (accessory houses).

Joon. 3. Üldvaade kaevandile.
E – elamud,
K – kõrvalhooned.

The remains of three dwelling houses were found on the excavated area (buildings E I, E II and E III; Fig. 3). The **dwelling E I** (Figs. 3; 14) on Suur Street 24 lot was built later than the stone well described above, as its corner extended on top of the well. Half-cellar of the building was located on top of the bedrock layer and was dug partly into it. It consisted of two rooms. Sand-mixed mortar was used for constructing the walls of limestone slabs of different size, partly also of brick pieces and granite. The first room (E I: 1) has had a wooden

Accessory building K I (Fig. 3) built of limestone was located in the NW-corner of the excavated area. Only two stone layers of the western wall of the building had persisted, the northern and southern walls had survived partially, the eastern wall was missing completely. The walls were constructed using a sand-mixed mortar and limestone slabs. Partly shaped granite boulders had been sporadically used in the construction of the northern and southern walls. The building had a limestone floor buried under debris and a layer of fire remains originating from World War II. A metal barrel hoop found on top of the limestone floor could indicate the possible (last) function of the building as a storage room.

Immediately south of the above described building was an **accessory building K II** with the longitudinal axis in the NWW-SEE direction (Fig. 3). This was also a small limestone building, the foundation of which was partly dug into the medieval cultural layer. The northern wall of the building had been built later than the western and southern walls, indicated by a dent in the NW-corner. A ditch had been dug for constructing the foundation of the northern wall and the lower layers of that wall were laid in an irregular pattern. The rest of the walls were laid according to a regular pattern both on the inside as well as on the outside, indicating that they had been laid on top of the ground level. In the middle of the northern wall there was a doorway (width: 1.4 m), that had been walled up later. A second doorway was located in the southern wall and it had been covered with

In alignment with the previously described two buildings and the drainage ditch there was still another building (**accessory building K III**, Fig. 3). That building measured 2.8 × 1.75 m – it had probably been a summer kitchen. The building (4.9 sq. m) had been constructed on top of the bedrock limestone layer. It had possibly been a light brick building with walls plastered on the inside.

The fourth light construction (**accessory building K IV**, Fig. 3) was located in the western section of the area under description. It was a wooden building with its longitudinal axis in the N–S direction. Fragments of its floor and lower logs of the wall had been preserved.

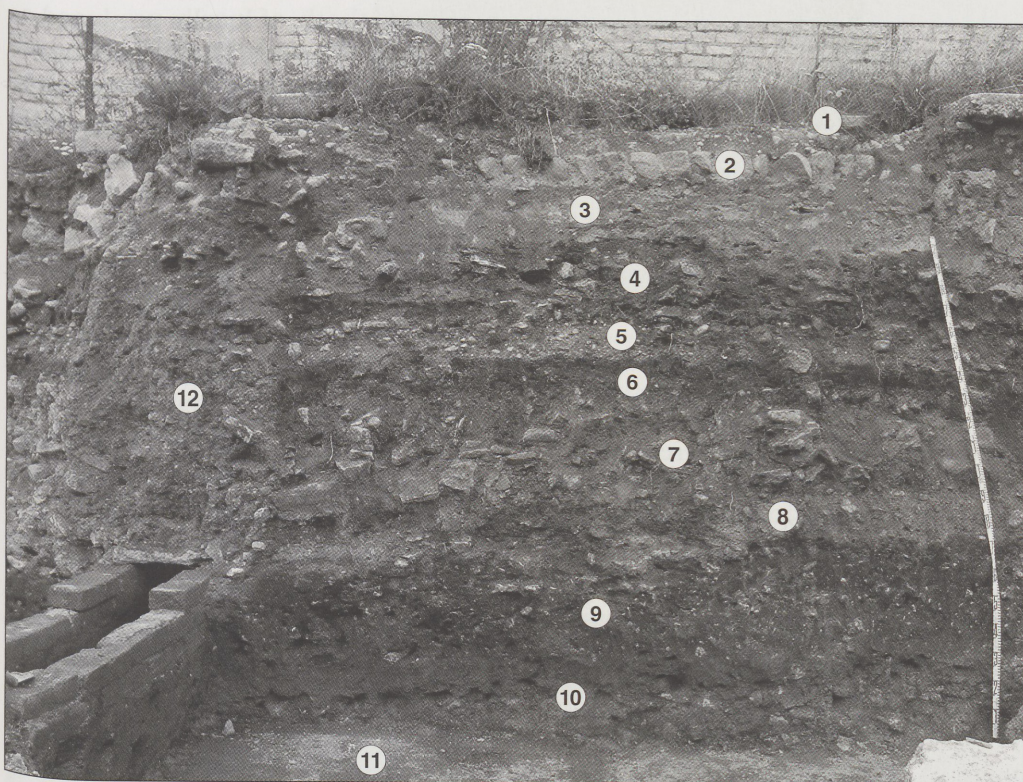
1 - ground level today / tänapäevane maapind

2 - pavement built in the first half of the 19th century / 19. sajandi I poolel rajatud sillutis

3 - sand, under the pavement / liiv, sillutise alune täitepinnas

4 - building rubble, levelling layer / ehituspraht, planeerimiskiht

5 - moraine, levelling layer / moreen, planeerimiskiht

6 - ground level in the past / omaaegne maapind

7 - building rubble, levelling layer / ehituspraht, planeerimiskiht

8 - moraine, levelling layer from the 2nd half of the 17th century / moreen, planeerimiskiht, 17. sajandi II pool

9 - cultural layer of the Medieval and Early Modern Era / kesk- ja varauusaegne kultuurikiht

10 - natural moraine / looduslik moreen

11 - limestone / paas

12 - 19th century entrenchment / 19. sajandi sissekaeve

Fig. 4. Stratigraphy of the western wall of the excavation pit.

Joon. 4. Kaevandi lääneseina stratigraafia.

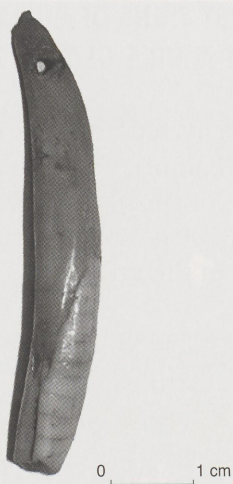
Fig. 5. Tooth pendant from the Medieval and Early Modern cultural layer.

Joon. 5. Hammasripats kesk- ja varauusaegsest kultuurikihist. (NLM 2420:224.)

Judging by ceramic fragments and a coin (an *artig* from Tallinn) from the 13th–14th centuries, the start of a permanent settlement in the excavated area may be dated to the Medieval period. In the researched area a dark, 30–50 cm thick cultural layer, rich in organics, appeared, that had been deposited during the Medieval and Early Modern period (Fig. 4). The layer contained animal bones, fragments of leather objects, potsherds (both, of locally produced as well as of imported vessels), also a few objects or fragments of metal and other material, including silver coins, tooth pendants, glass and amber beads *etc.* (Fig. 5).

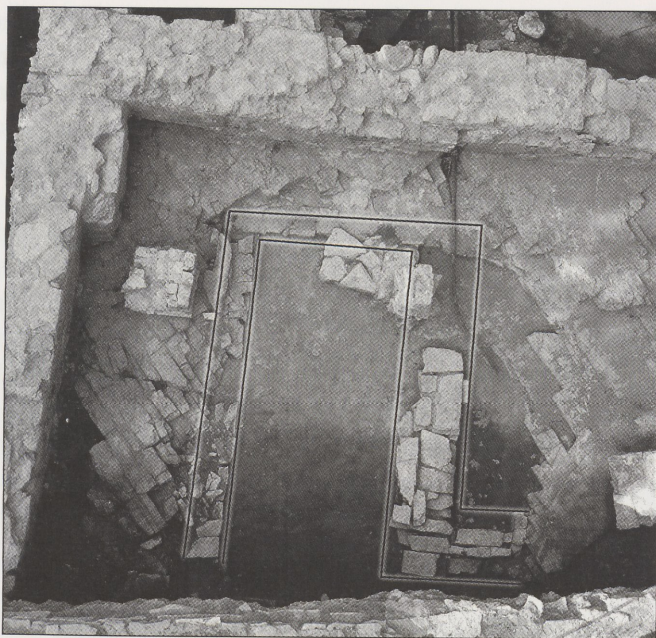
Fig. 6. Probable remains of a Medieval building on the area of a later building (E II: 4).

Joon. 6. Arvatav keskaegse ehitise jäänus hilisema hoone (E II: 4) alal.

The oldest building remains likewise dated from the Medieval period. **Remains of a limestone foundation**¹ (Fig. 6) were situated in the SE-corner of the excavation pit, in the confines of a later dwelling house (E II: 4), straight on top

of the limestone bedrock. The longitudinal axis of the foundation ran in a north-south direction and measured 4.5 × 3.3 m in the preserved section. The floor of the building had been dug 20–30 cm into the limestone bedrock. The foundation was laid out of limestone slabs without mortar being used. In the SW-part of the remains, the direction of the foundation changes – probably due to the north edge of a stairway located there. These remains are older than other excavated remains, concluding upon stratigraphical data and aspects of building technology. Remains similar in shape have been excavated in numerous German towns (e.g. Minden, Braunschweig *etc.* – Pärn 2005, 14 and references therein) as well as in Estonia – Haapsalu, Lihula and Tallinn (Pärn 2005, 11) and Latvia – Riga (Lõhmus 1984, 110–111, Fig. 90). These remains probably represent a two-section half-cellar house, consisting of a room with a stone foundation dug partly into the ground, preceded by a wooden structure. If that is the case, the wooden house was situated to the east of the stone foundation, in line with Suur Street, which was probably more or less on its current location already in the Medieval period (for example Коченовский 1991, 121). Judging by these facts the remains of the building could be dated to the end of the 13th century or the first half of the 14th century. But this is only a hypotheses, because the finds collected from this area

Vanimad ehitusjäänused pärinevad keskajast. Kaevandi kagunurgast (Suur t. 22) kaevati välja paekivist vundament (joon. 6), millele rajatud hoone põrand oli kuni 30 cm sügavuselt sisse murtud looduslikku paepõhja. Stratigraafia ja ehitustehnoloogiliste erijoonte järgi võib seda pidada kõige vanemaks väljakaevatud kivivundamendiks siinses kaevandis. Selle vundamenti näol võib olla tegemist kaheosalise poolkelderma ja vundamendiga, mille saab Eesti, Saksamaa ja Läti analoogide järgi dateerida 13. sajandi lõpu – 14. sajandi esimesse poolde. Keskaegsed on veel kaevandi edelaosast (krunt Suur t. 22) väljakaevatud kaks pihttara jäänust, kus tara palgid olid maasse lõõdud väikese nurga all ning toetatud paekiviveeriste ja -munakatega (joon. 7). Radiosüsiniku dateeringu põhjal pärineb põhjapoolne tara 13. sajandi lõpust ja lõunapoolne 14. sajandi algusest.

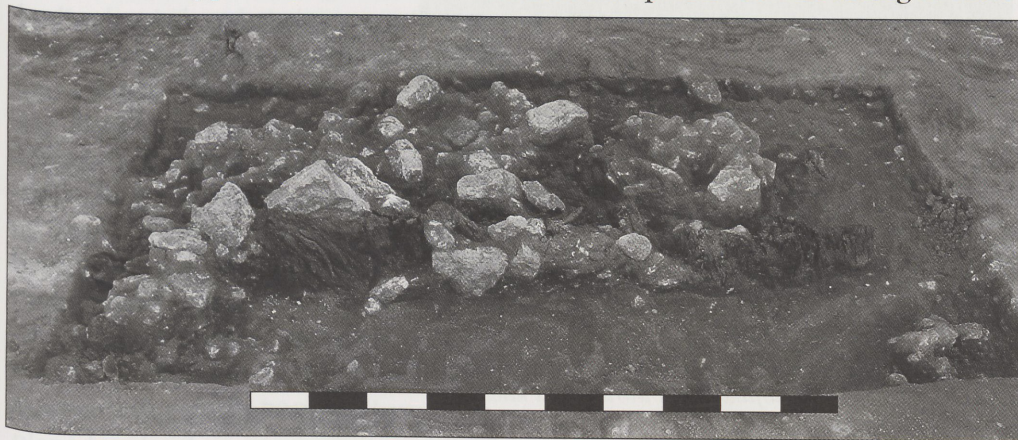
Fig. 7. Remains of the northern pole fence in the SW section of the excavated area.

Joon. 7. Põhjapoolse pibittara jäänus kaevandi edelaosas.

The remains of the northern pole fence consisted of 10 logs spread over 1.65 m (Fig. 7); only four logs had remained of the southern pole fence. However, it was possible to verify the existence of the southern pole fence up to a length of 5 m, because the supporting cobblestone structure had preserved. According to radio-

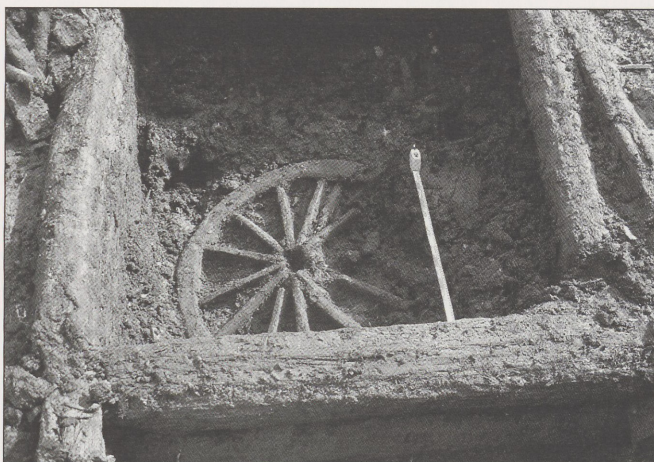
Fig. 8. A well with a wooden curb and a cartwheel found from it in the southern section of the excavated area.

Joon. 8. Puitraketega kaev ja sellest leitud vankriratas kaevandi lõunaosas.

Chronologically the next constructions were two wells. A **well with a wooden curb** (Fig. 8) was located in the southern section of the excavation lot. It was built into a concavity dug into the bed-rock layer – Middle Ordovician Aseri subdivision limestone (Luht 2005, 4) – which had been refilled after the wooden curb had been completed. The wooden curb contained 11 log rows. Eight lower rows consisted of logs, 25–30 cm in diameter, the upper three rows were

arranged in a conical fashion and contained smaller logs (8–10 cm). The well measured 2.5 m in breath on the inside and 2.5 m high. The items found in the well were mostly from the Modern era (a wooden cartwheel – Fig. 8; big cannon ball made of limestone, an abundance of potsherds, glazed stove-tiles – Fig. 9; a bowl made of bronze sheet – Fig. 10; fragments of leather footwear, animal bones, etc.). The well was probably created in the middle of the 17th century and filled up during the 18th century. Wood from the lower section of the curb was dated to 1640–1670 AD (230 ± 20 ¹⁴C-years, Le-7374) with 51.1% probability. The wood from the conical section of the curb (located above ground level at that time) was dated to a somewhat earlier period – 1490–1650 AD (315 ± 16 ¹⁴C-years, Le-7372) with 95.4% probability. We must keep in mind, that second-hand use of the wood cannot be ruled out here.

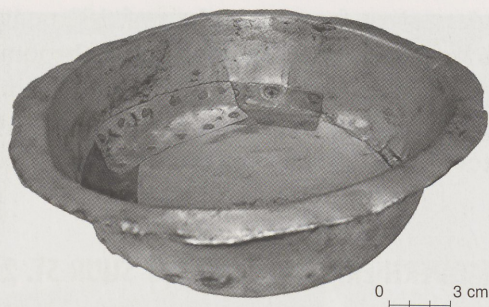
Fig. 10. Bronze sheet bowl from the well with a wooden curb.

Joon. 10. Pronksplekist kauss puitraketega kae vust. (NLM 2420:1210.)

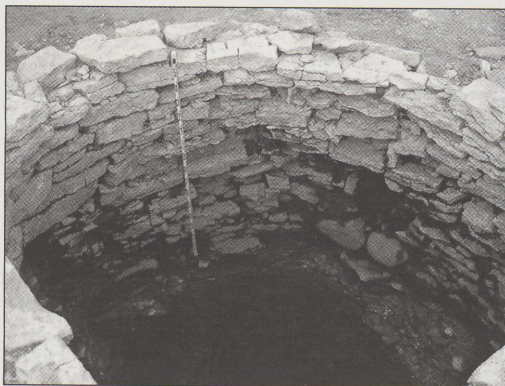
Fig. 11. Stone well in the middle of the excavated area.

Joon. 11. Kiviraketega kae vust. (NLM 2420:1210.)

A circular **stone well** (Fig. 11), situated in the middle of the excavation pit dates to approximately the same period, or a little bit earlier. It was dug into the limestone bedrock layer as well. The oldest finds from inside the well date to 17th–18th century, the latest are as late as 19th or even 20th century, when the well was filled up with rubbish. A rich collection of finds was obtained from inside the well: in addition to ceramics (including one intact *grapen* – Fig. 12, glazed redware, unglazed wheel pottery, faience and porcelain) and glass vessels (bottles,

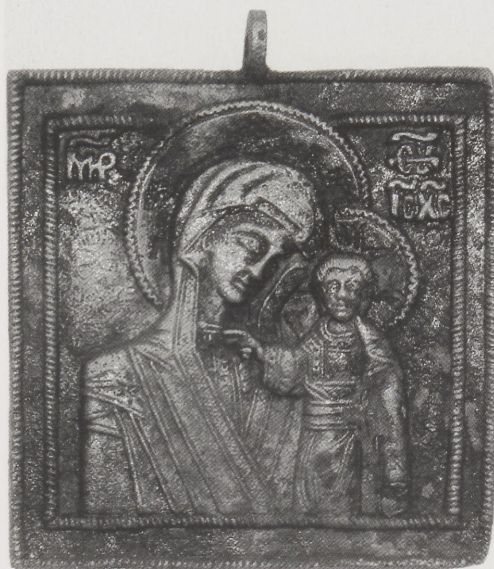
Fig. 13. Bronze icon pendant from the stone well.
Joon. 13. Pronksist ikoonripats kiviraketega kaevust. (NLM 2420:329.)

glasses) or fragments thereof, 18th century Russian coins, leather (footwear, etc.) fragments and wooden objects (broom, trough), textile fragments, a bronze icon pendant (Fig. 13), etc. were found. Similarly to the previous well this one contained lots of material common to cesspits: excrements, branches, nutshells, oyster shells, animal bones, animal fur, human hair, eggshells, etc.

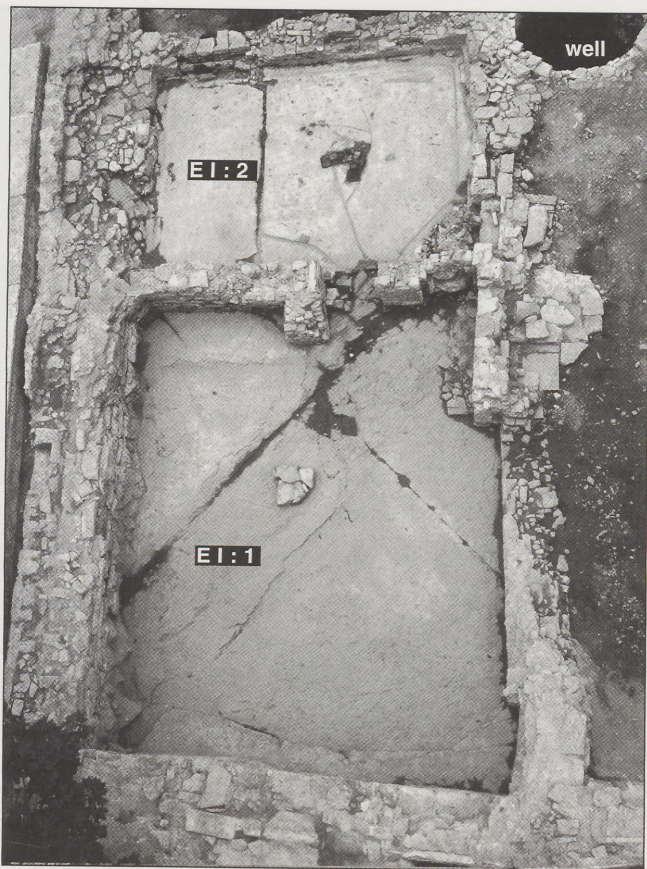
Fig. 14. Dwelling house (E I) on Suur Street 24.
Joon. 14. Elamu (E I) Suur t. 24.

floor at least in the final phase of its use. A fragment of the wooden floor was preserved in the SE section of the room. In the NW-corner and in the middle of the room two bases built of limestone and bricks were preserved. The latter was probably a base for a pillar. The floor of the second room (E I: 2) was cast of cement in the final phase of its use. In the western wall there were two openings - doorways leading into the yard (widths of 1.8 m and 1.45 m). In the southern doorway the lower part of the doorframe was preserved. The two rooms were also connected by a door (width 1.1 m, southern edge laid of bricks), a door was also present in the northern outer wall (side door opening into the yard, 1.2 m

wide). In the SE-corner of this room there was a staircase, 4 steps of which were preserved (width of the stairway 50-75 cm). In the NE-corner of the room remains of a semicircle-shaped stove built of bricks (7 brick rows were preserved at the most) were found. The stove, which probably was built not earlier than in the 19th century, had not been used during the final phase of the dwelling, since its opening (located in room E I: 1) was bricked up and covered with plaster, like the rest of the walls in the room.

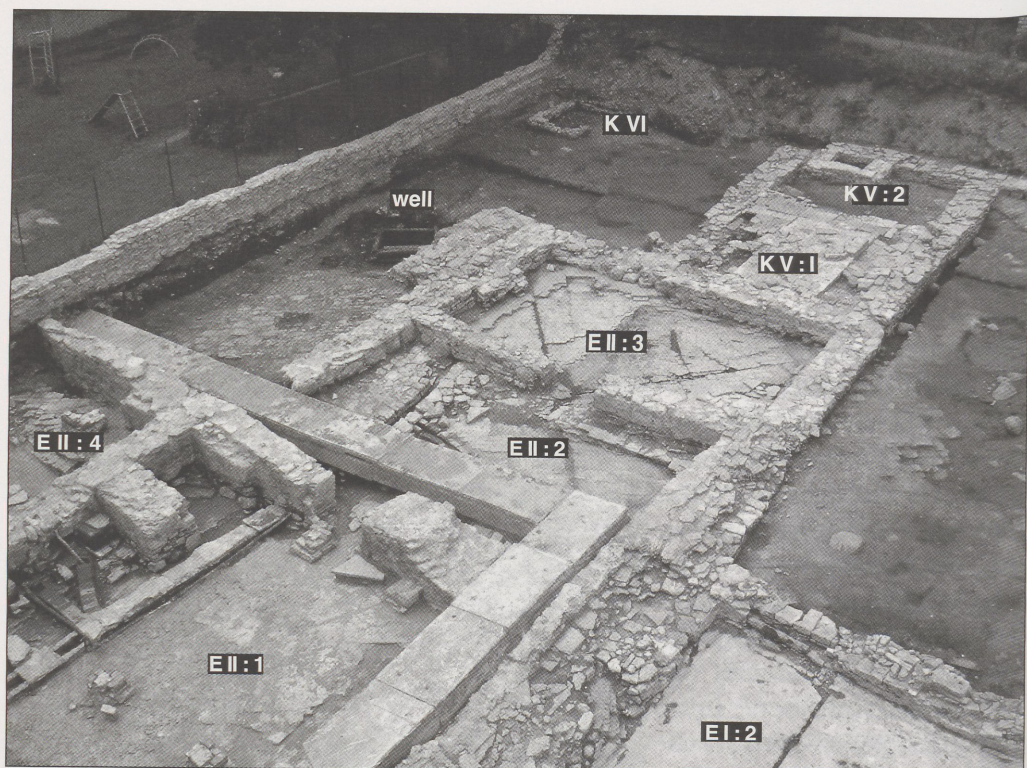
Fig. 15. Dwelling houses (E I and E II) on Suur Street 22 and 24; accessory buildings connected to E II (K V and K VI).

Joon. 15. Elamud (E I ja E II) Suur t. 22 ja 24 ning E II-ga liituvad kõrvalhooned (K V ja K VI).

Next to the above described building there was a half-cellar stone house containing four rooms (**dwelling house E II**, Figs. 3; 6; 15). Like the previous house, this one also featured a cellar halfway dug into the bedrock layer, two limestone breaking marks were preserved in the floor. In the preserved sections of the building, the walls were laid mostly of limestone, but in rooms E II: 1 and E II: 2

granite boulders had also been used. In the SW-corner of the room E II: 1 there was a small, 1 × 1.6 m enclosure. All the rooms had doors and were connected. E II: 2 and E II: 3 had had wooden floors in the final phases of their use. The room E II: 1 contained seven pillar bases laid of bricks (one of which was located in front of the doorway leading to room II: 2); E II: 2 contained a drainage ditch laid of bricks and limestone slabs. On this location there had been an earlier wall constructed before the four-roomed stone house. This was indicated in the northern wall of room E II: 3 of the four-roomed stone house, where remains of an earlier wall could clearly be seen. The earlier wall had been situated more in a NE-SW direction. The remains of this earlier wall were made use of while building the later wall; its remains were also included in the walls of the building E II, rooms 1 and 2. A small stone construction opening to the east was located in the NE-corner of E II: 4, against the facade of the building. The function and relation of this construction to the construction time of the building remain unknown and demand a closer analysis. The wall connecting E II: 1 and E II: 4 contained two

doorways, one bricked up (width 0.9 m) and the other broken through the limestone wall (width 1.5 m). Since the wall connecting E II: 1 and E II: 4 and the western wall of E II: 4 have no connecting corner, they probably were not constructed at the same time. It is possible that room E II: 4 was added to the building later.

Accessory building K V (Figs. 3; 15) was a two-roomed production facility, with its eastern wall connected to the dwelling house E II. The foundation ditch of at least the northern wall was dug into the Medieval and Early Modern Era cultural layer. The floor of one room (K V: 1) was covered with limestone slabs, forming a 4.7 × 2.5 m platform slightly higher than the corridor-like passageway surrounding it on the northern, southern and western sides. The floor of the second room (K V: 2) was covered with a wooden planking which was placed on a surface that had been levelled using sand and construction debris. In the SW-corner of this room there was the bottom of a stone cesspit.

In the SW-section of the excavation pit there was the foundation of another building (**accessory building K VI**, Figs. 3; 15), that had been constructed on top of the natural moraine layer without a foundation ditch. The building measured 2.1/2.2 × 2.9 m (6.38 sq. m) and remained partly inside the western profile of the excavated area. The walls were laid of limestone slabs and sand-mixed mortar.
