ARHEOLOOGILISED
VÄLITÖÖD
EESTIS

2006

ARCHAEOLOGICAL INVESTIGATIONS IN MEDIEVAL VILJANDI THE CASTLE AND ITS SURROUNDINGS

Arvi HAAK and Riina JUURIK

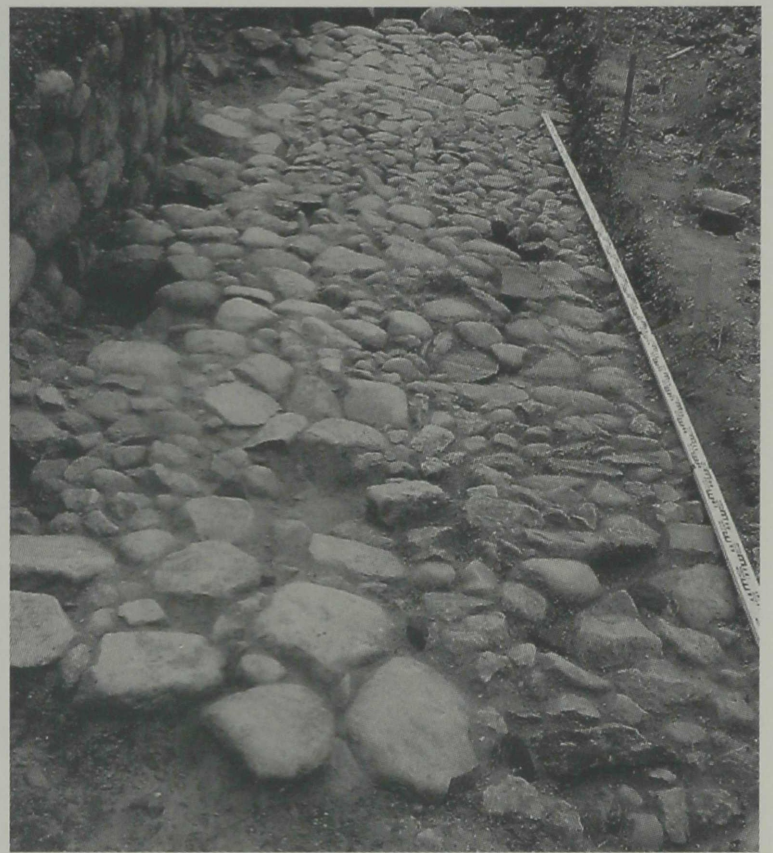
It soon became evident that most of the excavations in the yard really unearthed a cobblestone pavement. It was formed of cobbles of different sizes (from 8 x 6 to 20 x 20 cm, Fig. 2). A canal for draining water from the yard was situated in the central part of the yard, leading water away from the building. It is possible that another drainage canal had existed in the western part of the yard, as the location of displaced stones is of similar width and direction. Next to the cobbled pavement of the entrance to the castle, an intrusion was found. As it contained fragments of glass bottles from the Soviet period, it might be a test pit for architectural studies. However, no documentation of such a pit exists.

Fig. 2. Cobblestone pavement in the yard of the castle, in the first outer bailey.
Jn 2. Munakivisillutis I eeslinnuse hoovialal.

I kaevandis jõuti nüüdisaegsest maapinnast 30–50 cm sügavusel maakividest vihmaveerennidega hoovisillutiseni (jn 2). Sillutisele ladestunud rusukiht sisaldas muuhulgas relvade katkeid (jn 5: 2, 3). Vaimulikehoone edelanurgas satuti sillutist läbinud 20. saj teise poole sissekaevele, mille profiilis dokumenteeriti sillutisest varasemad ladestused, s.h muinaskiht, ning jõuti vaimulikehoone lõunamüüri rajamissügavuseni (84.10 m ümp). Kaevandi idaots asus vaimulikehoone lõunamüüri ääres paiknenud, varingurusuga täidetud keldriruumi sisemuses. 6 × 4 m suurune ruum jäi vaimulikehoone lõunaseina ning hoovi keskosas 2003. a avastatud võlvikanna vahele. Kuna ressursside ning konserveerimisvõimaluste nappusel ruumi edelanurka ei avatud, jäi selle ehitusviis ebaselgeks. Tellistest lääneseinas paiknes orv, ruumi idaosa kohal olnud massiivse võlvkaare alt läks trepikäik keldrisse ja küttekolde juurde. Viimane oli rajatud nähtavasti kahes järgus – varasemast kaminast oli II kasutusperioodil tehtud leega ahi, mille tarbeks oli kaminat laiendatud. Keldriruumi põhjaseinaks olnud maakivimüür moodustas ühtlasi vaimulikehoone lõunaseina; selle lõunaküljel olid säilinud lubikrohviga kaetud alad, samuti avastati kinnimüüritud läbikäik või orv (1,3 × 1,2 m).

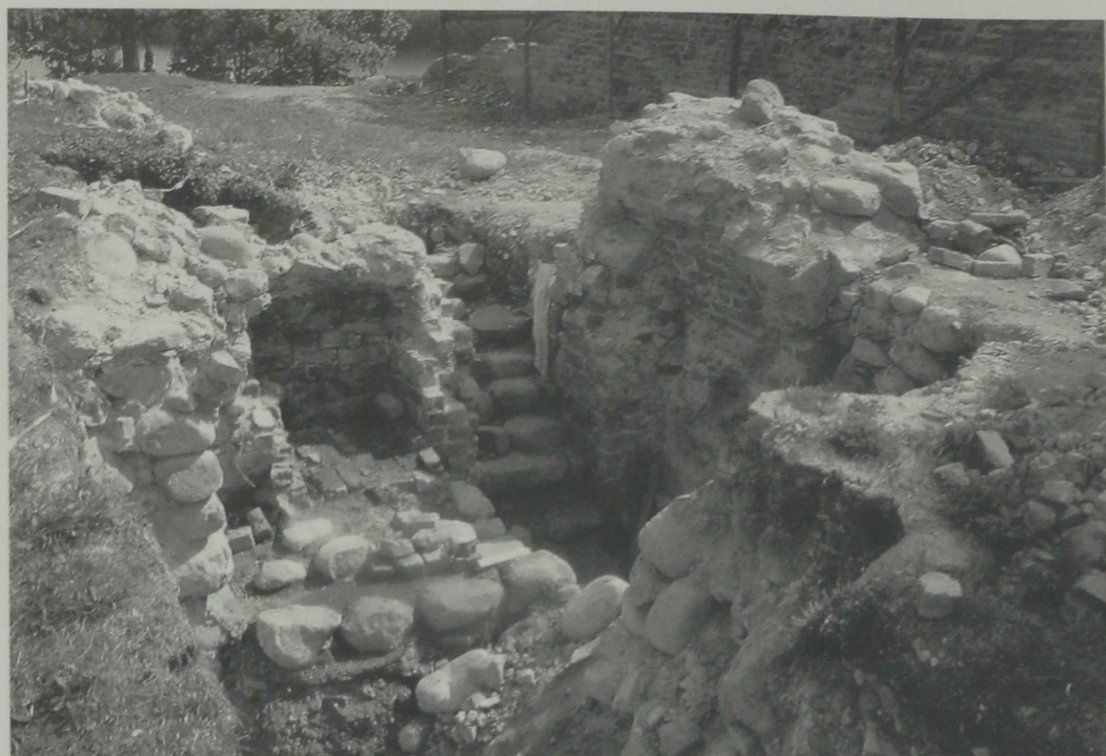
Fig. 3. Eastern part of the cellar room unearthed, with remains of a massive vault, fireplace below it, and the staircase.

Jn 3. Välja puhastatud keldriruumi idaosa massiivse silindrivõlvi jäänustega, mille all tulease ning trepikäik.

a staircase of granite stones and a few supporting bricks led to the castle yard (Fig. 3). The part of the northern wall west of the massive vault, which also formed the southern wall of the so-called Building of Clergy, had been plastered: remains of plaster had been preserved *in situ*. A walled-up vaulted opening (1.3 × 1.2 m) could

It soon became evident that the cellar room had been inhabited in two stages. During the later stage, an oven had been built in its eastern part, below the massive vault. It had a cooking place in front of it, surrounded with larger granite stones. The cultural layer connected to that period, was dark grey, with traces of burning on top of it, and contained numerous iron items including an iron ball (Fig. 5: 1), as well as large fragments of field flasks of Northwest Russian origin, also a *killing* by Johan III

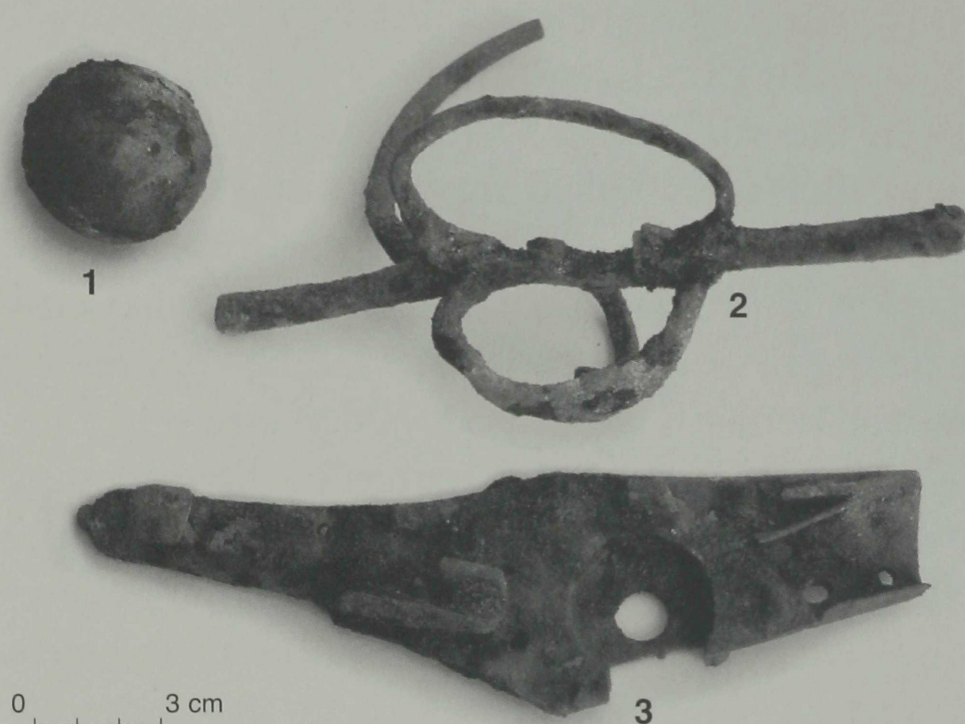
Fig. 5. Arms and iron items from the castle: 1 - iron ball, 2 - handle of a sword, 3 - remains of a wheel-lock.
 Jn 5. Linnuselt leitud relvad ja raudesemed: 1 - raudkuul, 2 - mõõga käepide, 3 - ratasluku jäänused.
 (VM 11167: 157, 31, 10.)

In the profile of the pit, stratigraphic sequence of the deposits below the cobbled pavement could be traced. Just above the virgin soil, a dark grey cultural layer had deposited, which contained neither brick fragments nor any traces of lime mortar. During sieving, a fragment of hand-made pottery presumably from the Viking Age was found. It thus seems that the layer corresponds to the Viking Age layer documented earlier (Tvauri 1999, 26; Haak 2003, 73–75). Above that layer, strata containing lime mortar had deposited. However, no material suitable for dating was obtained from the profile. A cobblestone pavement had been placed on a layer of reddish yellow sand. The uppermost layer above the pavement, mostly containing brick debris, yielded finds from the second half of the 16th century. A wheel-lock for a gun or a pistol and a handle for a sword (Fig. 5: 2, 3) are the most notable finds.

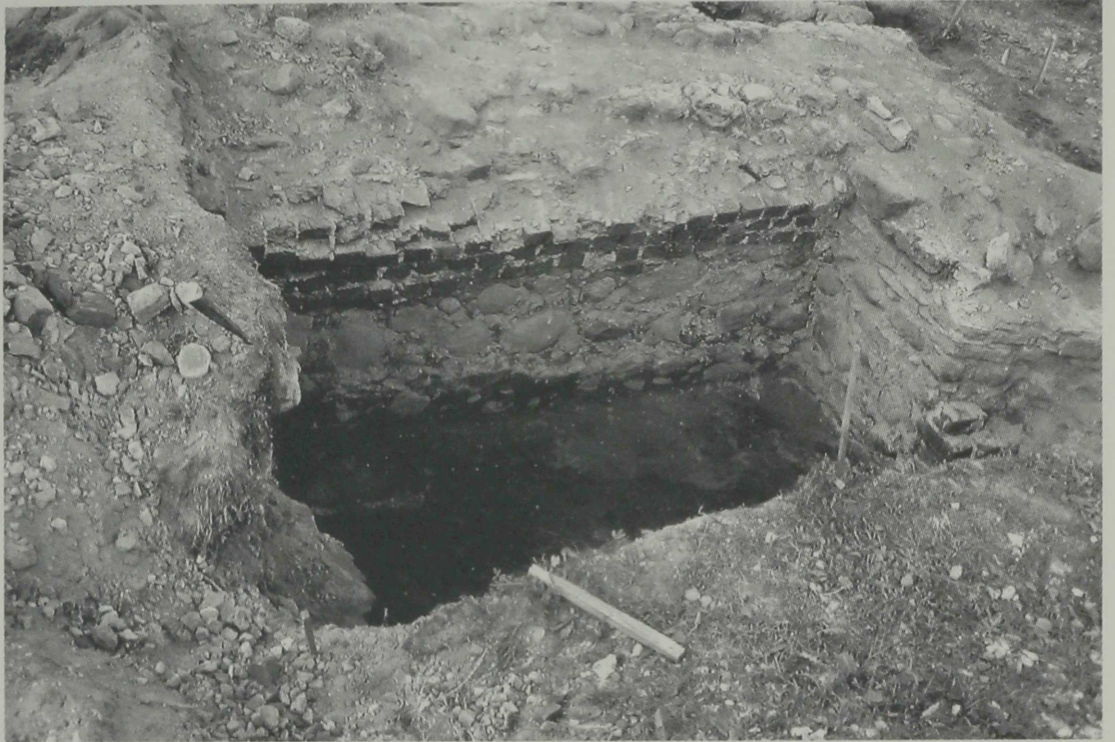
As in the southern wall, fragments of a tubular vault had been preserved in the northern wall of the choir (Fig. 6). Up to six rows of bricks of the support and lower part of the tubular vault had been preserved. A window or embrasure was unearthed in the eastern wall of the choir, the southern edge of which was found

Fig. 6. Northern part of the choir of the castle chapel, with remains of the brick vault.

Jn 6. Tellisvõlvi jäänustega linnusekabeli kooriosa põhjasein.

põhjaseina välisservast 2,5 m tagasi ja kooriosa sisemõõtmed on 5,8 x 4 m. Kultuurkihi iseloom määratleti 2001. a uuringutel kabeli lõunaosas; 2006. a kaevandis ilmnes, et kabeli keldriruumi täitnud rusukihi all ei paikne ühtne elutegevuskiht, vaid see liigendub mitmete õhukeste (alla 1 cm) liivast ja lubimördist prügistasanditega. Kogutud leiumaterjal oli napp ja sisaldas lisaks aknaklaasikildudele ühe klaasnõu- ning mõned 16. saj keraamikakatked. Kabeli põhjaseinas fikseeriti analoogselt 2001. a nähtud lõunaseinaga tellistest silindervõlvi kand ning alaosa kuni 6 telliserea kõrguseni (jn 6). Kooriosa idaseinas on olnud väljapoole ahenev aken (laskeava?).

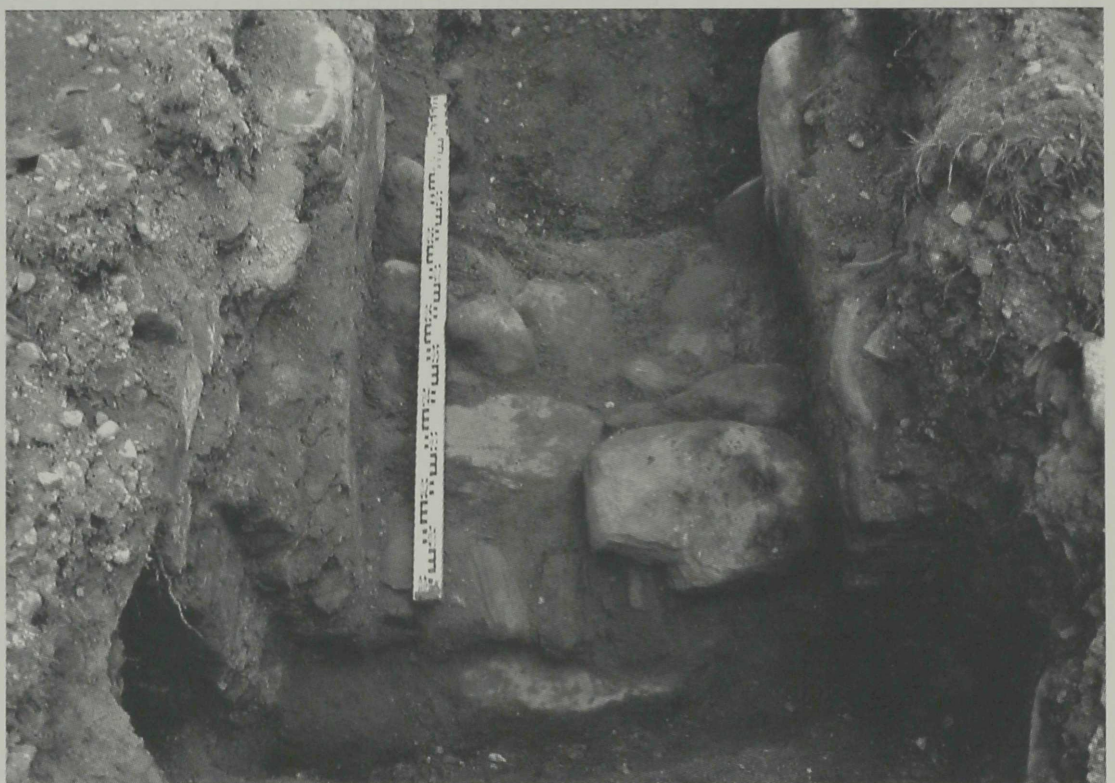
these had not been located archaeologically. The investigations revealed an east-west directed 1.9 m wide stone wall with the minimum remaining height of 1.3 m, which yielded a small pass-way (ca. 85 cm wide) (Fig. 7). The lower edge of its foundation could not be reached. From inside the construction, a few protecting nails (*Panzer-nadel*) were collected (Fig. 8).

Fig. 7. Wall of the castle gate, with the pedestrian entrance in it.

Jn 7. Linnuse peavärava lõunasein jalgväravaavaga.

Aida kagunurgas satuti linnuse välismüürile, millega lääne- resp. välisküljel liitus veel üks teadmata funktsiooniga lubimördiga seotud müür. Dateerivaid leide ei saadud. Aida läänekülje põhjapoolse osa pikendusel avastati ida-lääne-suunaline 1,9 m paksune ja 85 cm laiuse avaga müür – see on olnud linnuse peaväravakäigu lõunamüür ning selles asunud jalgvärava koht (jn 7). Leiti ka väravaga seostuvad pantsernaelad (jn 8).

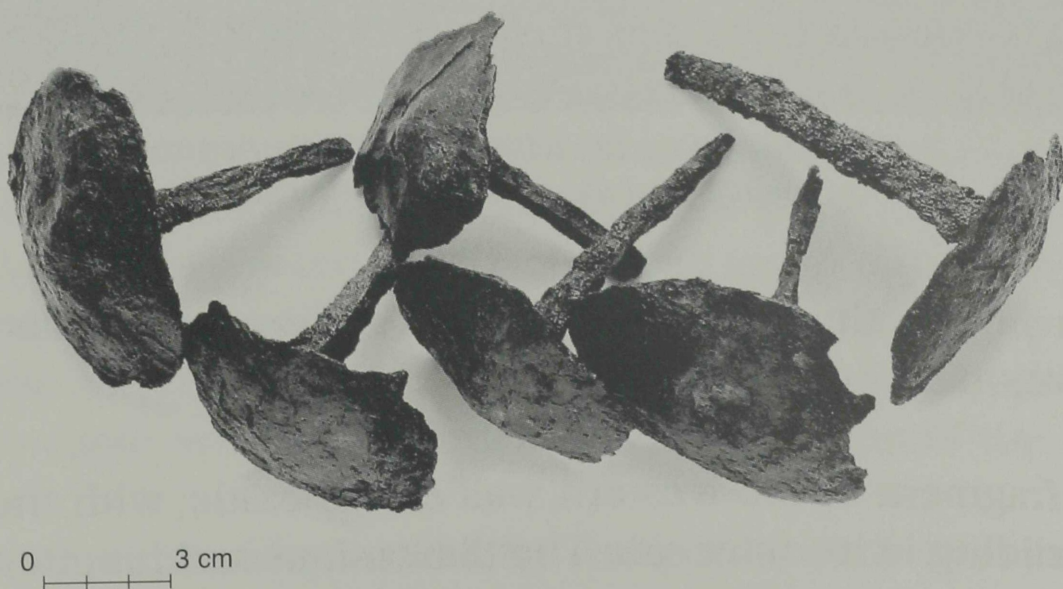
Fig. 8. Protecting nails from the gate of the castle.
Jn 8. *Pantsernaelad ordulinnuse peavärava sisemusest.*
(VM 11145: 1–6.)
