ARCHAEOLOGICAL
FIELDWORK
IN ESTONIA

2006

INVESTIGATIONS IN TALLINN, AND THE COUNTIES OF HARJUMAA, VIRUMAA AND PÄRNUMAA

Villu KADAKAS

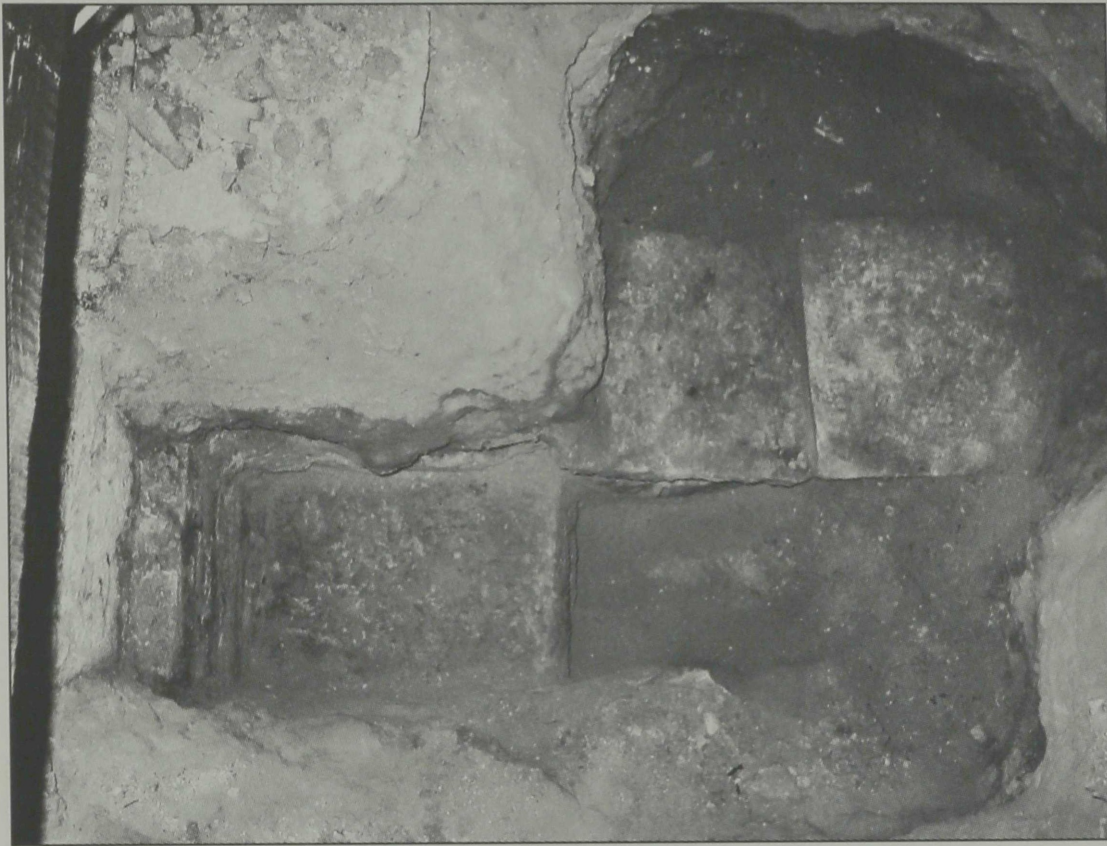
Digging a trial pit was monitored in a nave of the former St Michael's church of the Cistercian Abbey, transformed into an orthodox church in 1732. The pit was dug on the eastern side of the central pillar of the church (Fig. 1). The medieval 12-faceted limestone pillar and its original base could be observed under the present floor as the pillar above the floor level has been hidden under a wooden

Fig. 1. Orthodox Church of the Transfiguration of Our Lord. Medieval floor.

cover during the 19th century redecoration. It appeared that the pillar has been built on a wide quadrangular foundation, which may belong to the remains of the original western wall of the church. The church was supposedly extended towards west during the 14th century. According to this hypothesis the original western wall was positioned exactly under the pillar studied in the pit. A contemporary floor of hewn limestone slabs was found *ca.* 130 cm

deeper from the present wooden floor. As the objectives of the study were fulfilled, the slab floor was not removed and the excavation was stopped. The church interior has never been archaeologically studied before. Thus it provided the first information about the former floor levels.

Suur-Kloostri tänaval, end. naistsistertslaste Mihkli kloostri kirikus, mida varem pole arheoloogiliselt uuritud, dokumenteeriti keskmise piilari juurde kaevatud šurfi. Praeguse põrand all paljandus keskaegne 12-tahuline piilar ning paeplaatidest põrand (jn 1).

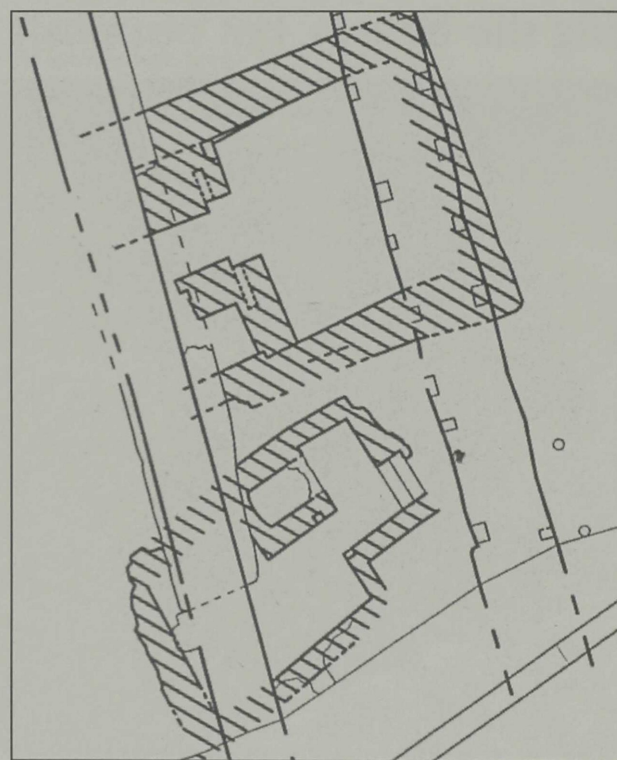
Fig. 2. Kreutzwaldi 2a, Rakvere. Plan of medieval cellars.
Jn 2. Kreutzwaldi 2a, Rakvere. Keskaegsete keldrite plaan.

From the SW-corner of the site two stone cellars (Fig. 2). were partly excavated. They probably come from two separate buildings erected next to each other on different plots. No proper data could be gathered to establish the dates of building the houses, but obviously the houses were demolished and the cellars filled

during the late 16th century. The cellars were built of boulders and round limestones gathered from the fields, not from a quarry, and built using clay instead of lime mortar. The southernmost cellar has a rather well preserved (Fig. 4) oven and an outside staircase towards east, i.e. probably in the backyard direction. It seems, that the street has been positioned to the west of the buildings, i.e. between the houses and the monastery. The excavated cellars were probably not posi-

tioned close to the street, but in the backyards, and may be interpreted as the cellars under *dornse* of the dwelling house. Thus the *dieles*, possibly without cellars, could have been positioned near the street, west of the excavated cellars. It is impossible to tell anything about the once above ground parts of the buildings as nothing of them has preserved. The cellars might have been the only stone parts of the buildings – the rest might have been built as wooden crossbeam or framework buildings.

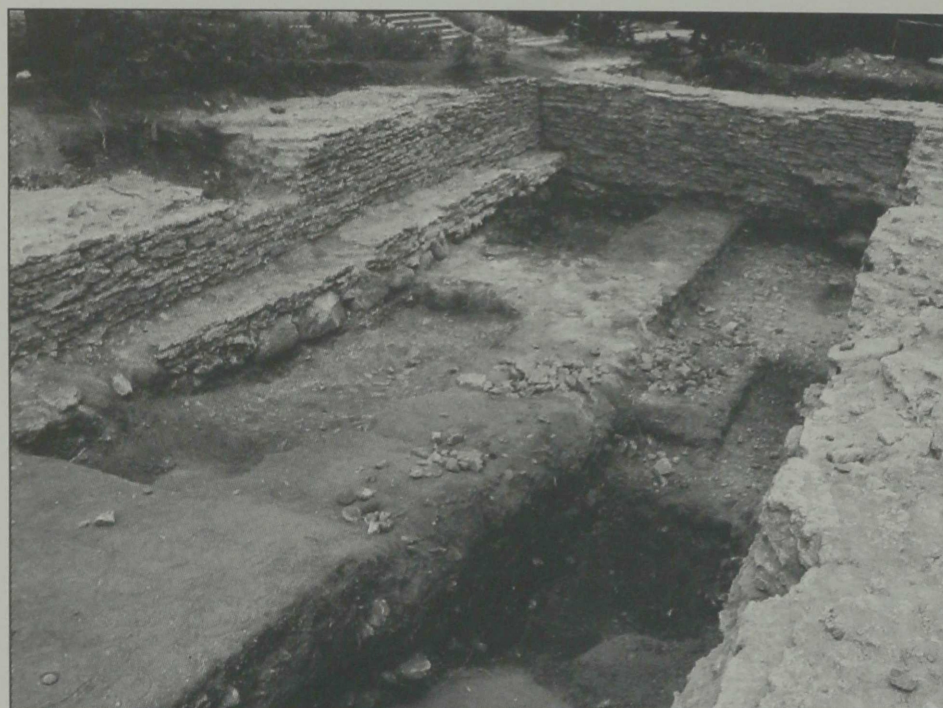
First, the foundations of the stables were opened. Then the cultural layer was removed from between these foundations (Fig. 3). Most of it was

Fig. 3. Kreutzwaldi 2a, Rakvere. Thick cultural layer in a former stream bed.

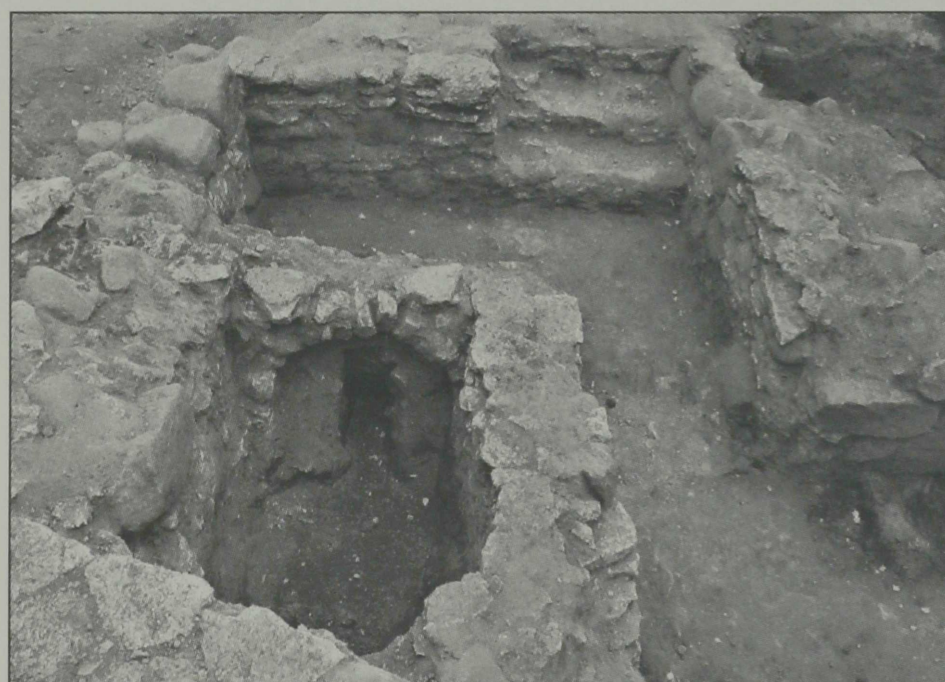
Fig. 4. Kreutzwaldi 2a, Rakvere. Southern medieval cellar from west.

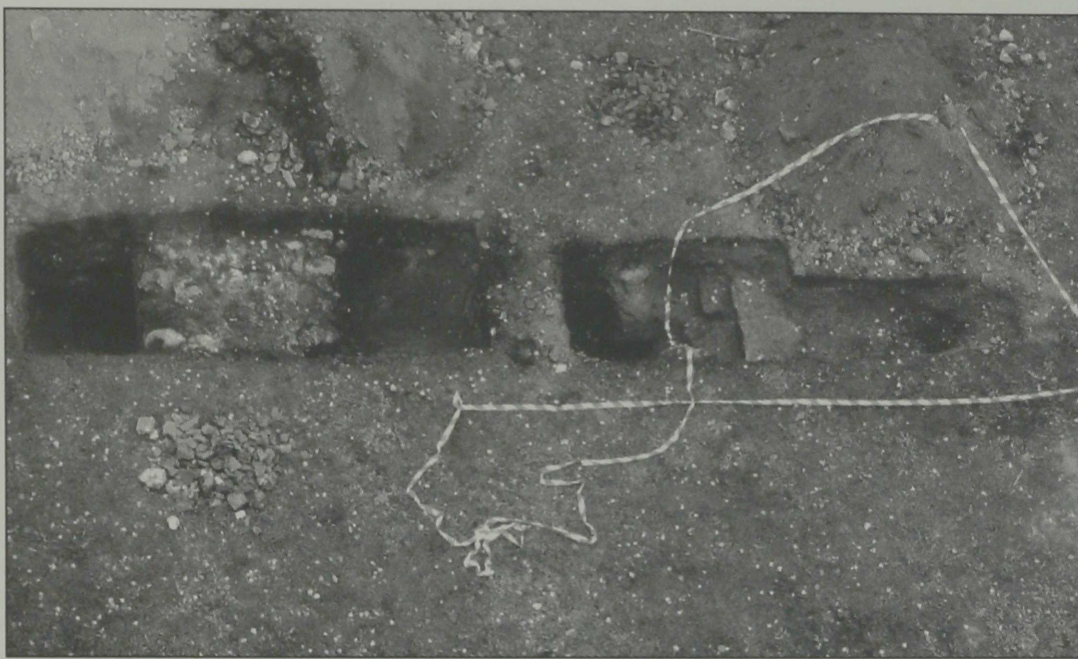
Fig. 6. Porkuni Castle. Foundations of the southern outer wall
Jn 6. Porkuni linnus. Lõunapoolse ringmüüri vundament.

The outer wall was observed in several test pits on the perimeter. The 1.2 m thick northern and western walls are rather well preserved, standing about 1.5 m high under debris. Only the foundations have been preserved of the southern (Fig. 6) and eastern walls. Accidentally an inside perimeter of a round tower with ca. 2.5 m inner diameter, in the NW corner of the castle, was observed and documented. The 1.2 m thick walls of the quadrangular nave, ca. 11 m wide, the chancel and the apse of the chapel were observed in several test pits. The apse, sur-

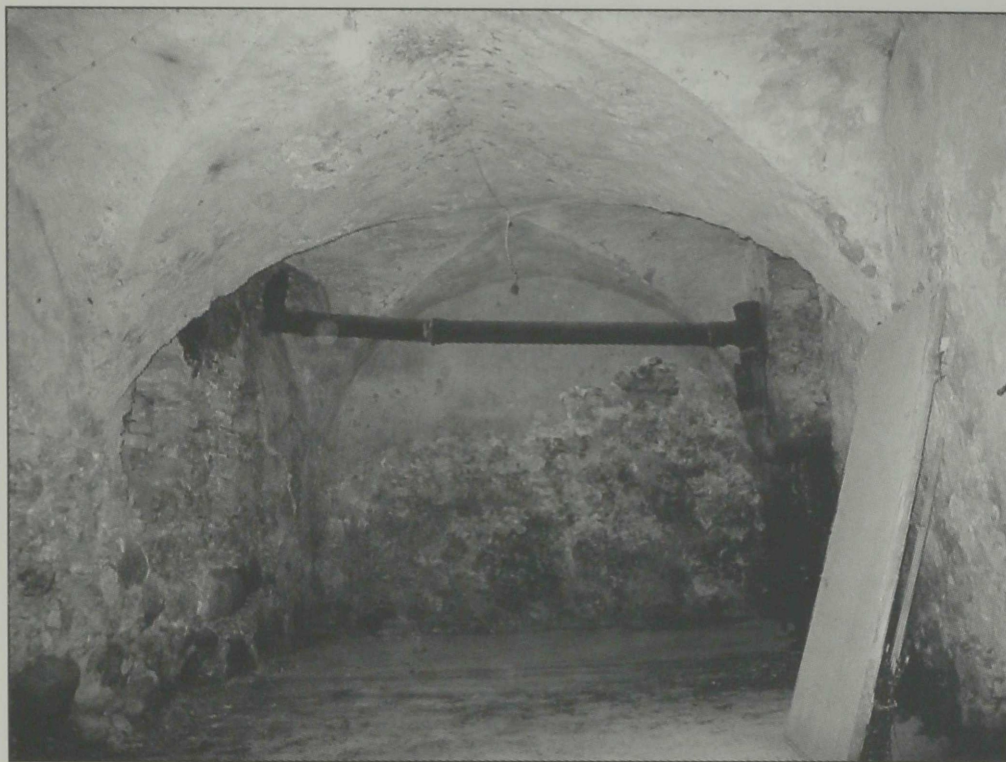
Fig. 8 Kose-Uuemõisa manor house. North-eastern room with a medieval vault in the basement storey.

The medieval house probably had two storeys in addition to the basement storey but these have been thoroughly rebuilt and only the outer walls can still include medieval parts. The basement storey has generally preserved its medieval layout (Fig. 7: B). In brief, it included four rooms of different sizes, without outer exits but narrow staircases in walls up to the ground floor. The biggest room, probably under the hall of the ground floor, included a hypocaust oven in its SE-corner. The vault of the hypocaust with six holes for the heat to move up, has preserved as the main proof for the medieval origin of the house. The big room has had a wooden roof, cross vaults are still preserved in the small rooms (Fig. 8). The test pits unfortunately proved that the historical floors of the basement storey have been completely removed to natural soil during the 2nd half of the 20th century. Occasional underground constuctions like a well or a drainage system might be still preserved under the present concrete floor. Hopefully field studies will proceed in future.

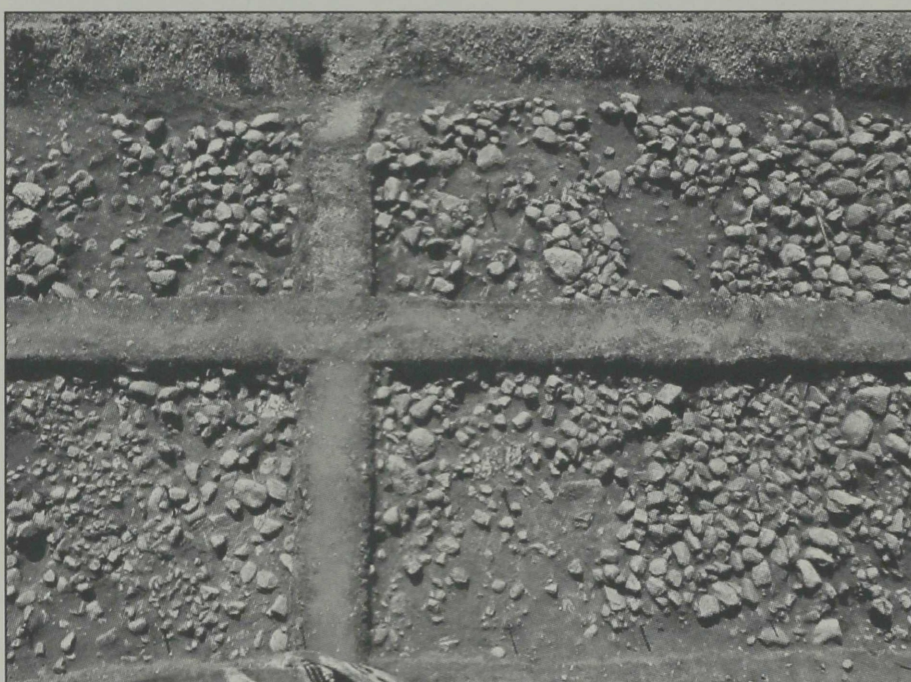
Remains of a prehistoric stone grave (Figs. 9, 10) were studied and completely removed in the territory of the former Sinikivi farm in Lehmja village in Rae municipality, Harjumaa, some kilometers south of Tallinn in immediate vicinity of the former Tallinn–Tartu road. The site was first found probably by Vello Lõugas and Oskar Raudmets in the beginning of the 1970s and taken under protection thereafter as a “bottom part” of a stone grave, i.e. a seriously damaged grave. By that time the site had been ploughed for decades already. The salvage excavations were triggered by building a bus station platform near the road and it was decided to remove the grave rather than plan the bus station some distance away.

Fig. 9. Sinikivi stone grave. Area of the stone circle during excavation.

During the first weeks of the excavations it was not sure if the low stone heap was a grave at all, but finally it proved to be one indeed. The grave was built almost exclusively from round stones, limestone was almost absent. A segment of a stone ring with *ca.* 15 m diameter appeared after clearing the ploughed topsoil and the upper layer of stones, which had been removed from their original place during melioration. These upper levels included no finds relevant to a stone grave, only some animal bone fragments and 20th century junk.

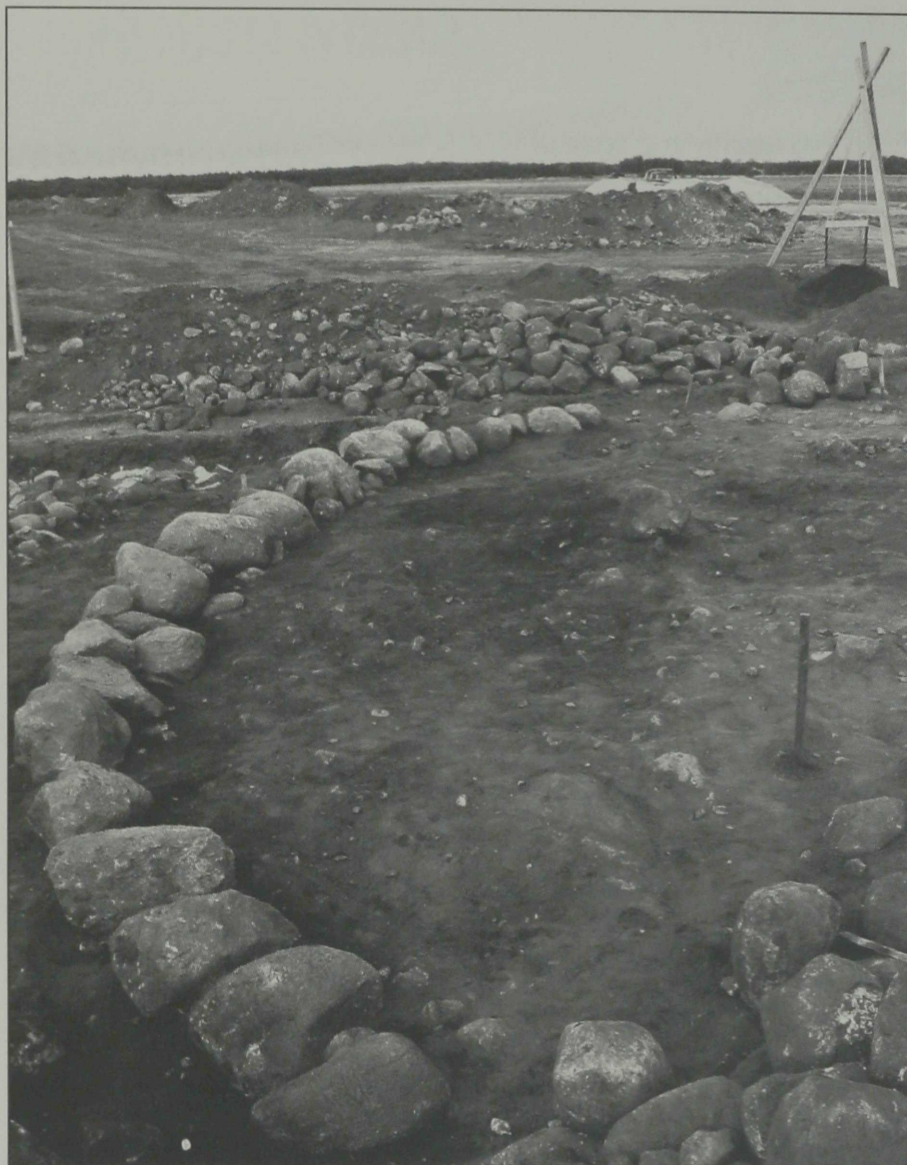
Fig. 10. Sinikivi stone grave. Stone circle after removal of filling stones.

The lower *ca.* 30 cm thick layer of stones and soil above natural ground included fragments of simple hand made pottery in some spots. In the middle of the supposed stone ring in an area with a diameter of *ca.* 1 m small fragments of burnt bones were found, but not elsewhere. Almost all the fragments of several metal artefacts were found in this central area as well. The find material included some fragments of bronze spirals, a simple bronze ring etc. There had been iron artefacts in the middle part of the grave as well, but they had long before deteriorated into fragments measuring 2–3 cm probably because of age and harmful natural conditions. Some round fragments could be identified as parts of a shaft, some probably came from flat iron plates or knives. Most of the pottery was not found from the middle part, but was scattered in several spots, partly even outside the stone ring. It was probably all of the same type, undecorated pots with a flat bottom.

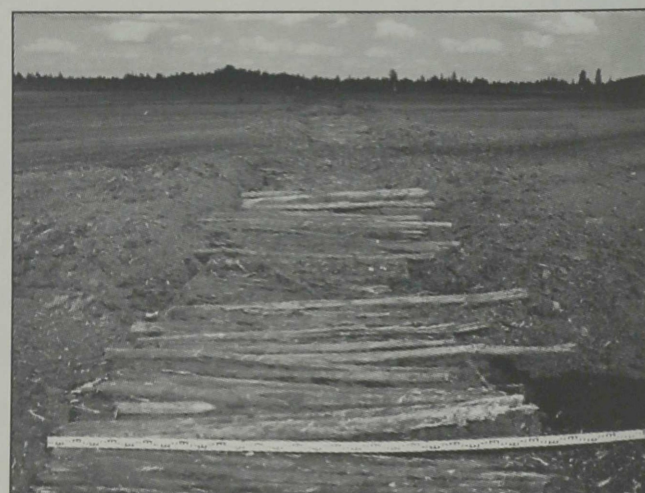
A *ca.* 200 m long fragment of a log trackway (Fig. 11) was uncovered in Lehu bog in Kaisma municipality in Pärnumaa county in connection with taking new areas of turf into use for mining. Close by in the same bog similar log trackways have been found and described before (Lavi & Roio 2005). The track under study has been previously described under No.V. It runs roughly in the NW-SE direction. It has been previously dated to the 14th century according to radiocarbon analysis. During the excavation of the *ca.* 2 m wide trackway no finds which could help the dating were found. Results of dendrochronological analysis are unknown yet.

Fig. 11. Lehu bog. Log trackway.
Jn 11. Lehu raba pakktee.

Pärnumaal Lehu rabas avati uue turbavälja kaevandamise eel u 200 m pikkuses lõigus pakktee (jn 11), mis varasemates uuringutes kannab numbrit V ja on dateeritud ¹⁴C-analüüsi põhjal 14. sajandisse. Leide, mis kinnitaks või lükkaks ümber selle dateeringu, ei saadud. Palkidest võetud dendroproovid ootavad analüüsimist.
