ARHEOLOOGILISED
VÄLITÖÖD
EESTIS

ARCHAEOLOGICAL
FIELDWORK
IN ESTONIA

AN ARCHAEOLOGICAL COMPLEX OF RIVER HARBOUR AND 16TH–17TH - CENTURY STONE BUILDINGS AT PÄLLAMÕIS ON THE SOUTHERN COAST OF SAAREMAA

Marika MÄGI and Ragnar NURK

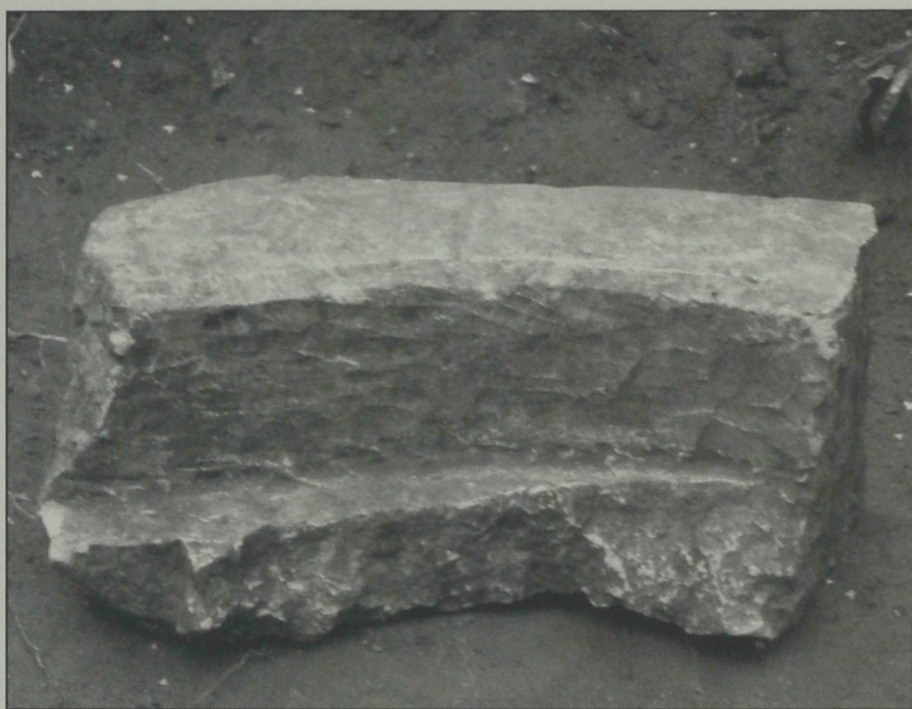
Fig. 3. Portal stone from the trench of 2006.
Jn 3. Portaalikivi 2006. aasta kaevandist.

The appearance of either the wing or the main house can be reconstructed with the help of some finds from the collapse debris: pieces of S-shaped roof tiles, fragments of tin window frame, broken window glass, the detail of a portal stone above a doorway (Fig. 3). The rest of the finds consisted mainly of 16th–17th century ceramic and fragments of metal artefacts.

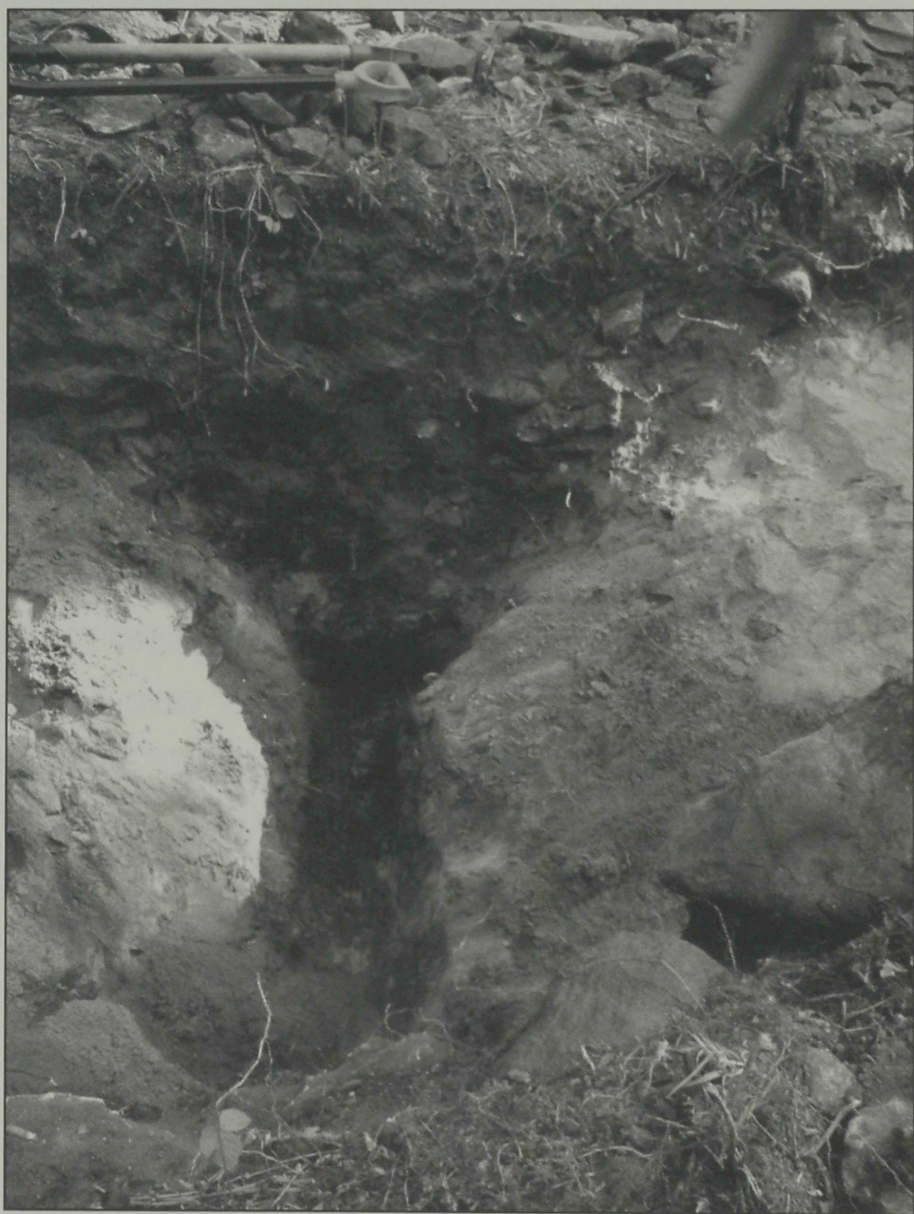
Fig. 4. Drainage ditch in the trench of 2006.
Jn 4. Kuivenduskraav 2006. aasta kaevandis.

Through the central part of the excavated area ran a narrow ditch, filled with intensively black soil – probably a former drainage ditch (Fig. 4). It seemed to run from the ruins of the central building in direction of the river, present brook. The excavations of 2006 had unearthed the area where the distance between these two was the shortest. The drainage ditch had been dug in sand, and the upper part of it was lined with stones.

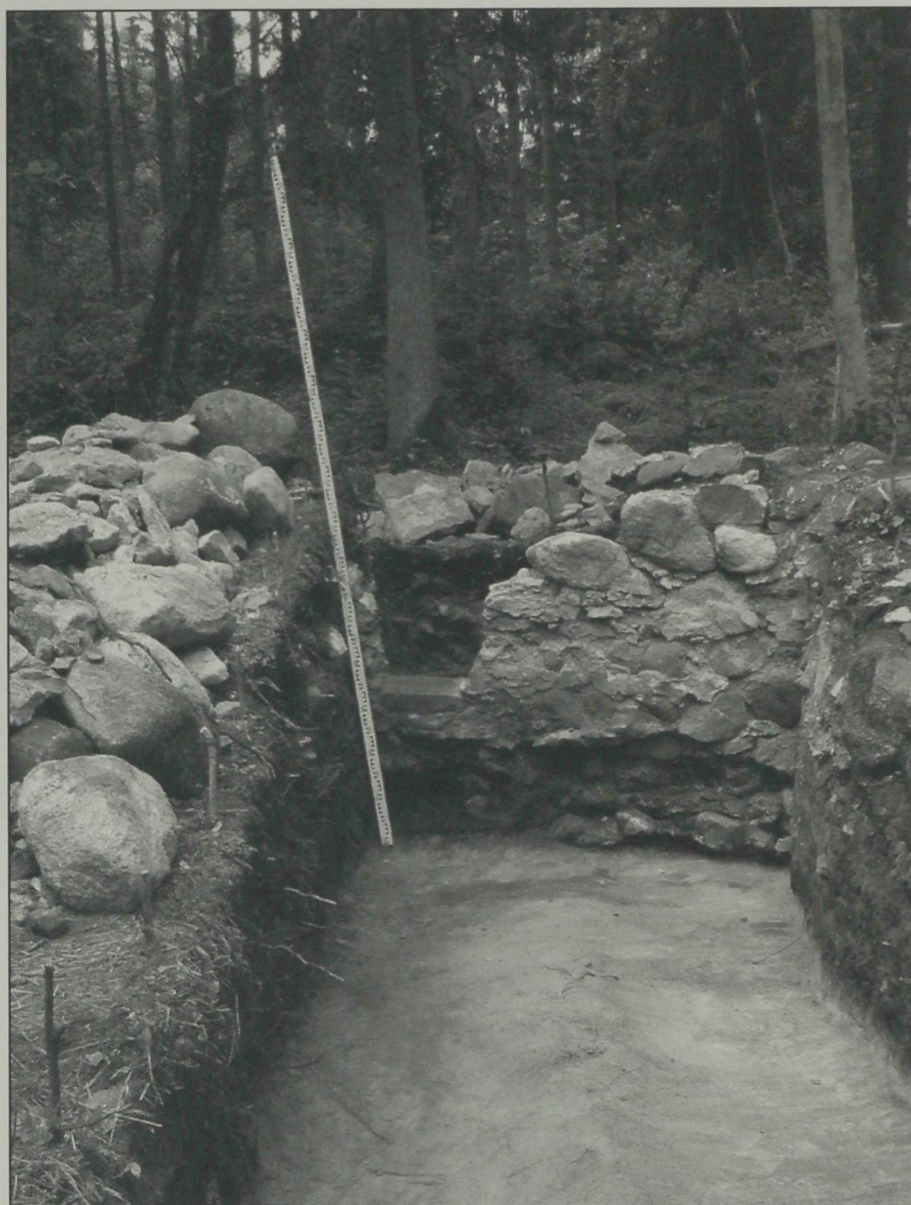
Fig. 5. The trench 2007-II. View from the East.
Jn 5. Kaevand 2007-II. Vaade idast.

Trench 2007-II measured 2 × 8 m, was across the central house ruins from their eastern side (Fig. 5). It was later extended towards north, tracing the north-eastern corner of the house. Trial pits 2007-V and 2007-VI (Fig. 2) were also made at two spots, one at the south-eastern and another at the south-western corners of the house. The north-western corner, however, could not be exposed due to a big stump of a tree, overlaying the exact spot, where the house corner once would have protruded.

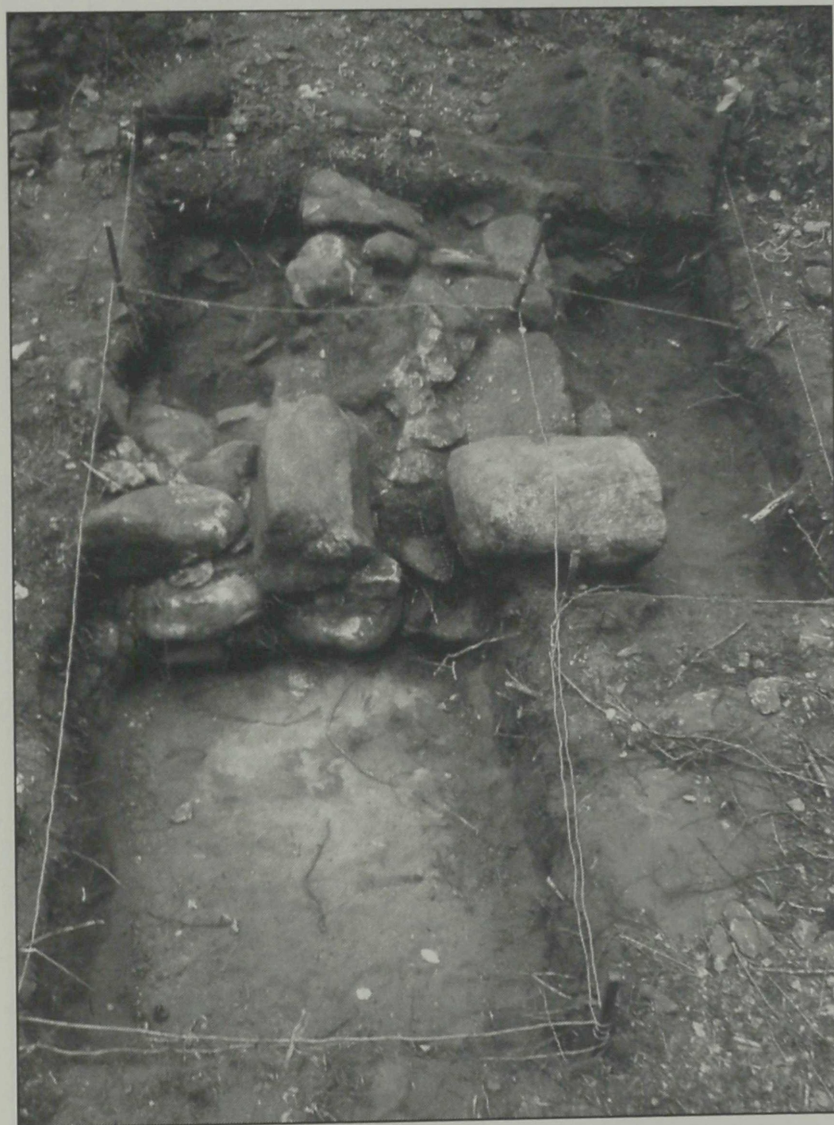
Fig. 8. Trench 2007-IV. View from the West.
Jn 8. Kaevand 2007-IV. Vaade läänest.

Trial trench 2007-IV (8.5 m²) uncovered the south-western corner of the western outbuilding in the complex (Fig. 8). The foundation found here was built of lime and granite stones with little traces of mortar. The foundation was 85–100 cm wide and survived to a height of 80–100 cm. The scantiness of collapsed stones, compared with the central house, suggests that this outbuilding was, like the northern one, built of wood on a stone foundation. The furthest end of this building towards north remained unsolved, but the stony elevation visible under the surface suggests that the building might have been some meters narrower than the central house.

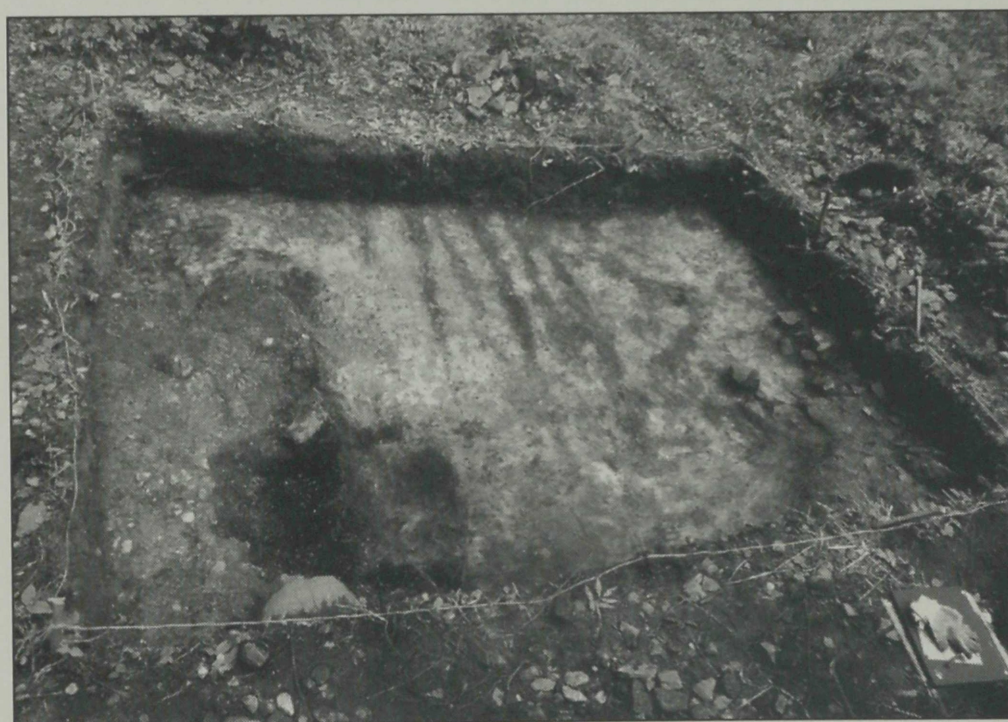
Fig. 10. Wood impressions in the trench 2007-I.
View from the South.

Underneath these building remains, but in the central part of the trench already in a depth of 10 cm, yellow river or sea sand with dark impressions of a once wooden construction emerged (Fig. 10). It was possible to distinguish the probable position of three posts, each with diameters ranging from 25–50 cm; next to them dark impressions of baulks or planks appeared. Six or seven baulk impressions, all about 10 cm broad and 6–10 cm thick, run parallel in N–S direction (that is, across the

river), set with distances of about 10 cm from each other. In the trench, such regularly placed impressions covered an area of about 1.6 × 1.6 m. Impressions of two more 10 cm wide baulks or planks run across or diagonally over the others. An oblique post which impression was drawn out in the riverside profile of the trench seemed to belong to the same construction.

The impressions in the sand can be interpreted as remains of a quay, when the wooden parts of it had started to decay and were partly broken. How far the quay had reached into the former river, remains unsolved – the impressions of baulks continued outside the excavated area. Resting right on top and in between the wood impressions Late Iron Age potsherds, animal bones and some fragments of iron were found; 16th–17th century finds were completely absent. The finds had

liiv. Selles joonistused tumedate laikude ja viirudena välja kunagise puitkonstruktsiooni jäänused (jn 10). Eristati 3–4 arvatavat postikohta. Kaevandi keskosas joonistused aga liivase pinnase taustal välja 6–7 puuprusside või -plankude jäänust, mis asetsesid jõega ristisuunas üksteise kõrval u 10 cm vahedega. Lisaks eristusid veel kahe plangu või prussi jäänused, mis asetsesid ülejäänute suhtes risti või diagonaalselt. Puidujäänuseid jõeliivas võib tõlgendada paadikaina, mis ilmselt toetus u 25 cm läbimõõduga puupostidele. Puidujäänuste pealt ja vahelt saadi üksnes 11.–12. sajandisse kuuluvat keeraamikat.
