ARCHAEOLOGICAL
FIELDWORK
IN ESTONIA

2007

INVESTIGATIONS IN TALLINN AND THE COUNTIES OF HARJUMAA, LÄÄNEMAA, IDA-VIRUMAA AND JÄRVAMAA

Villu KADAKAS, Ragnar NURK, Garel PÜÜA and Guido TOOS

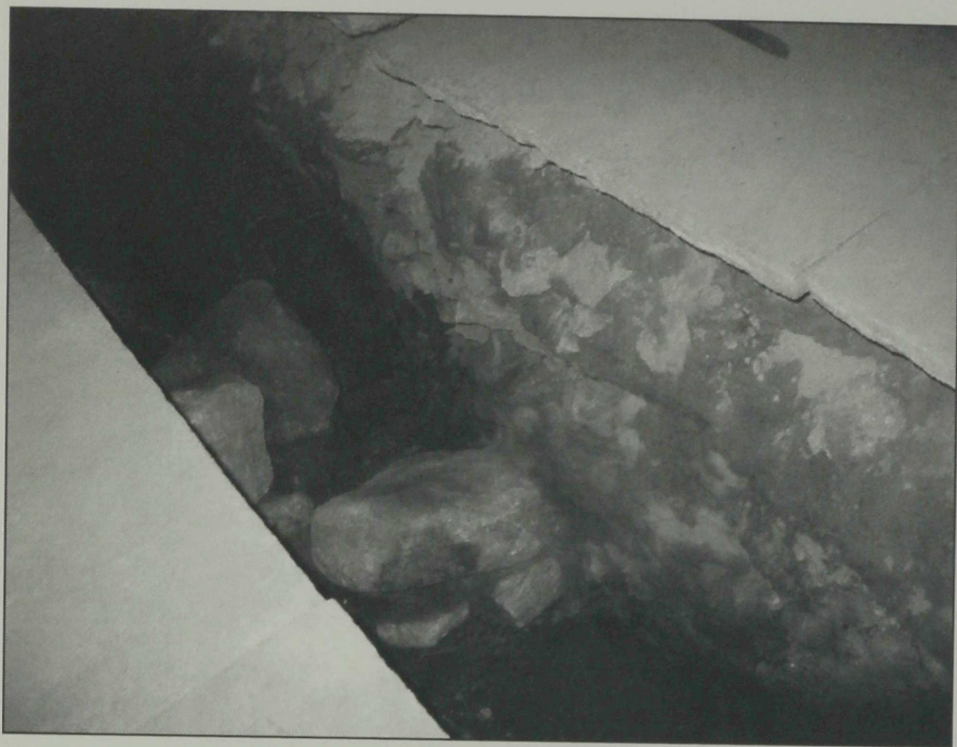
Fig. 2. The excavation with wall remains in Kaarli Church.

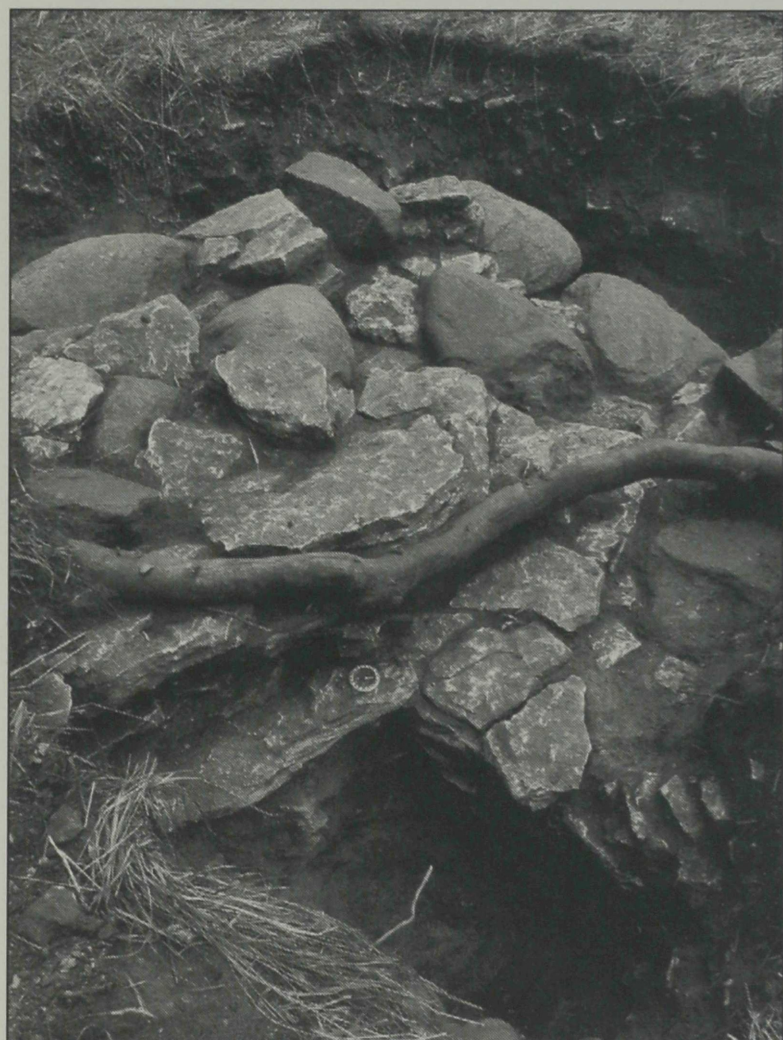
Fig. 4. Stove remains in the southern part of the island in the Keila River.
Jn 4. Ahjujäänused Keila jõesaare lõunaosas.

In the southern part of the island, on the only higher spot, a corner of a stove (Fig. 4) belonging to an unrecognizable building was discovered. The 1.1–1.3 m thick wall of the stove was built of limestone and granite and on the inner side was fitted with clay. “Monk-nun” type roof tiles were found, and since finds of later periods were missing the building may belong to the Middle Ages. Preliminary investigations also established the location of the wall that had surrounded a large rectangular area (about 130 × 100 m) at the rear of the main buildings of the manor. The average thickness of the limestone wall was 60–70 cm and the preserved bottom part of it revealed no traces of mortar. According to the *Inventarium*, a formal park belonged to the manor in the 17th century, when various local higher officials of the Swedish

Saare lõunaosas asuval kõrgemal künkal avati senitundmatule hoonele kuulunud ahju nurk (jn 3: 7; 4). Ahjumüür oli laotud pae- ja raudkividest ning siseküljelt savitatud. Väljapuhastamisel saadi munk-nunn tüüpi katusekivide katkeid, ja et hilisemad leiud puudusid, siis võib tegu olla keskaegse hoone jäänusega. Eeluuringute käigus tehti kindlaks mõisahoonete tagaküljel olnud riskülikukujulist ala (u 130 × 100 m) piiranud müüri kulg. Paekivimüür oli keskmiselt 60–70 cm paksune ja sellest säilinud alaosas polnud jälgi sideaine kasutamisest. Varaloendi järgi kuulus mõisa juurde 17. sajandil barokkpark. Tõenäoliselt paiknes park müüri ümbritsetud alal. Praeguse Harjumaa Muuseumi hoone ees satuti vähemalt kahe hoone jäänusele. Ühe juurest, millel on olnud ka kelder, saadi rohkelt 18. saj pärinevaid leide, sh ahjukahlite ja fajanssnõude katkeid. Mõisasüdame üldist skeemi silmas pidades on avastatud hoonete paiknemine loogiline, kuid jääb lahtiseks, kas ja milliste varaloendis nimetatud hoonetega võiks tegu olla.

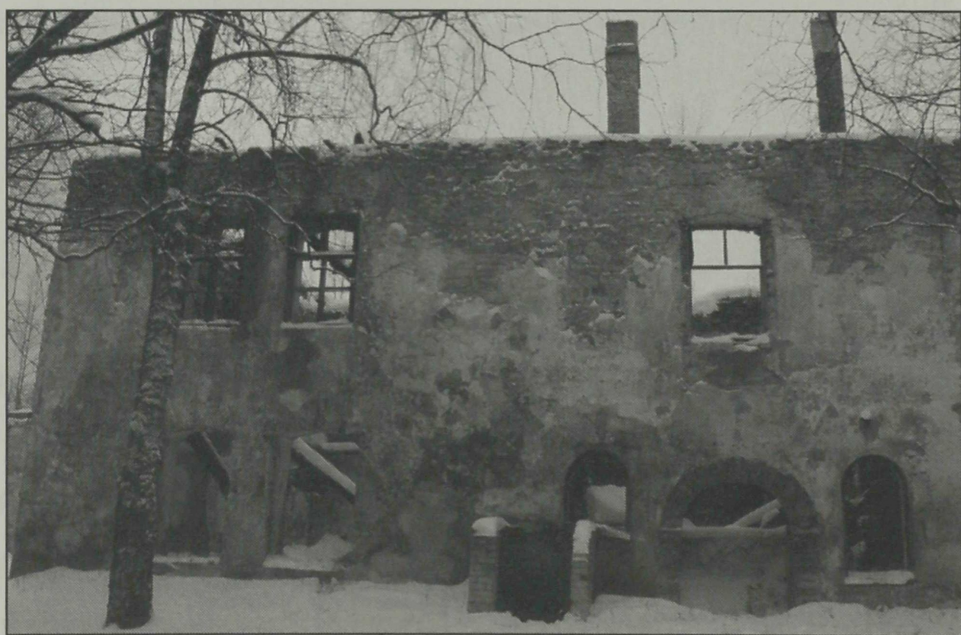
Fig. 5. The medieval part of the eastern façade of Kiltsi manor house.

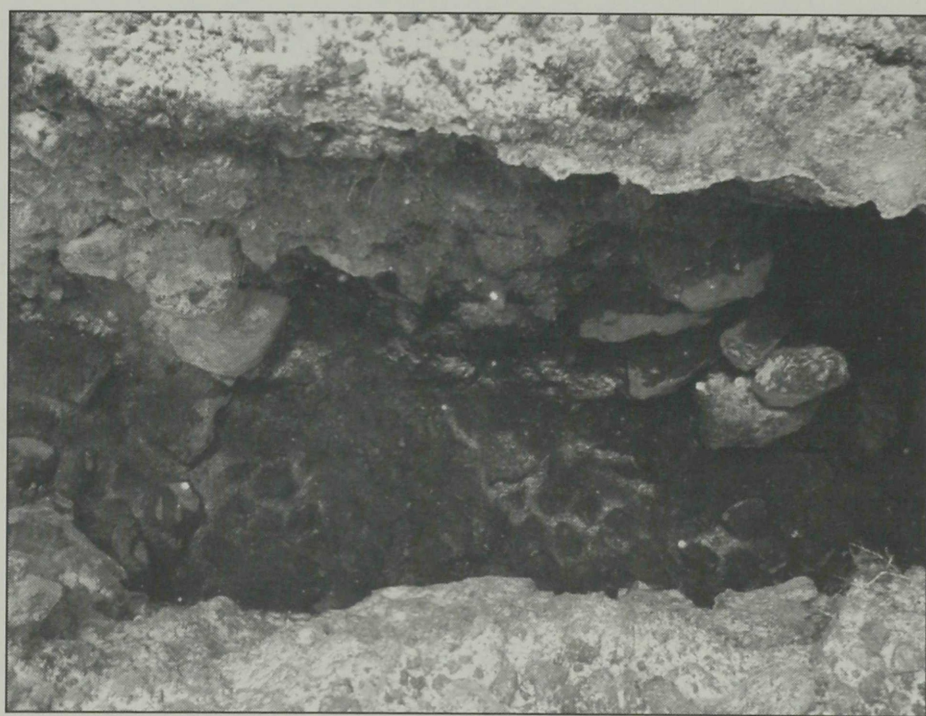
Fig. 8. *Trench in the Cistercian nunnery in Libula. Wall fragment (left), cobblestone pavement and partly exposed stone well (right).*
Jn 8. *Trass Libula tsistertslaste nunnakloostri alal. Müürifragment (vasakul), munakivisillutis ja osaliselt välja kaevatud kaev (paremal).*

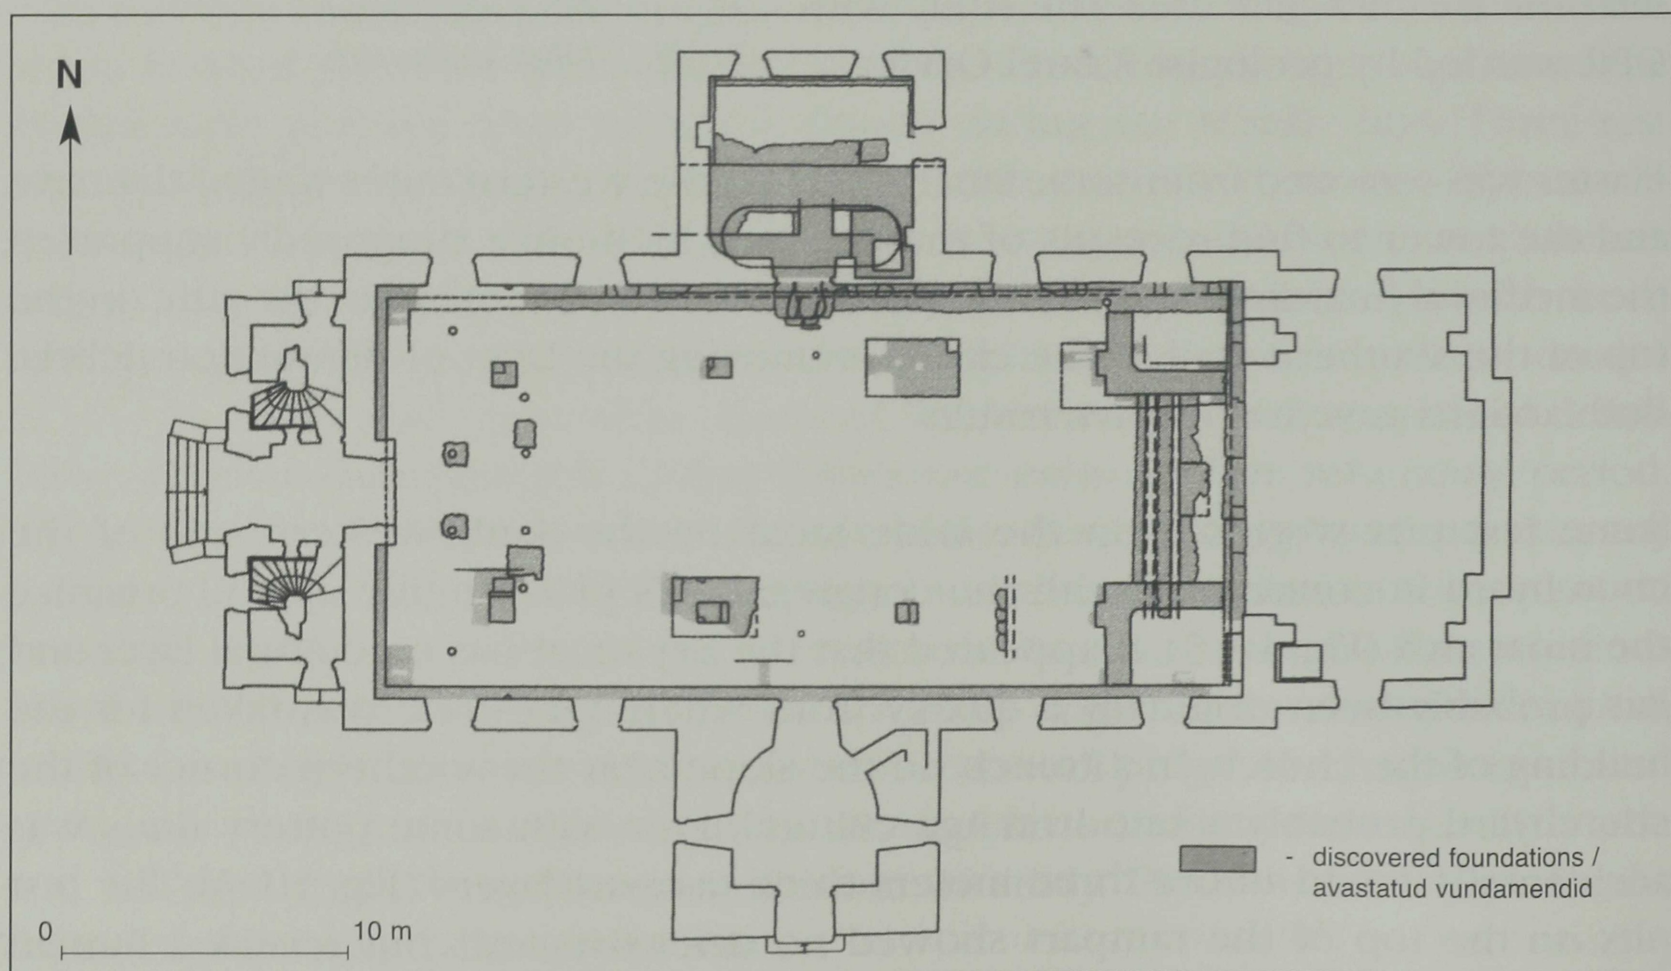
Fig. 11. Paide church. Plan of the present church.
Jn 11. Paide kirik. Praeguse kiriku plaan.

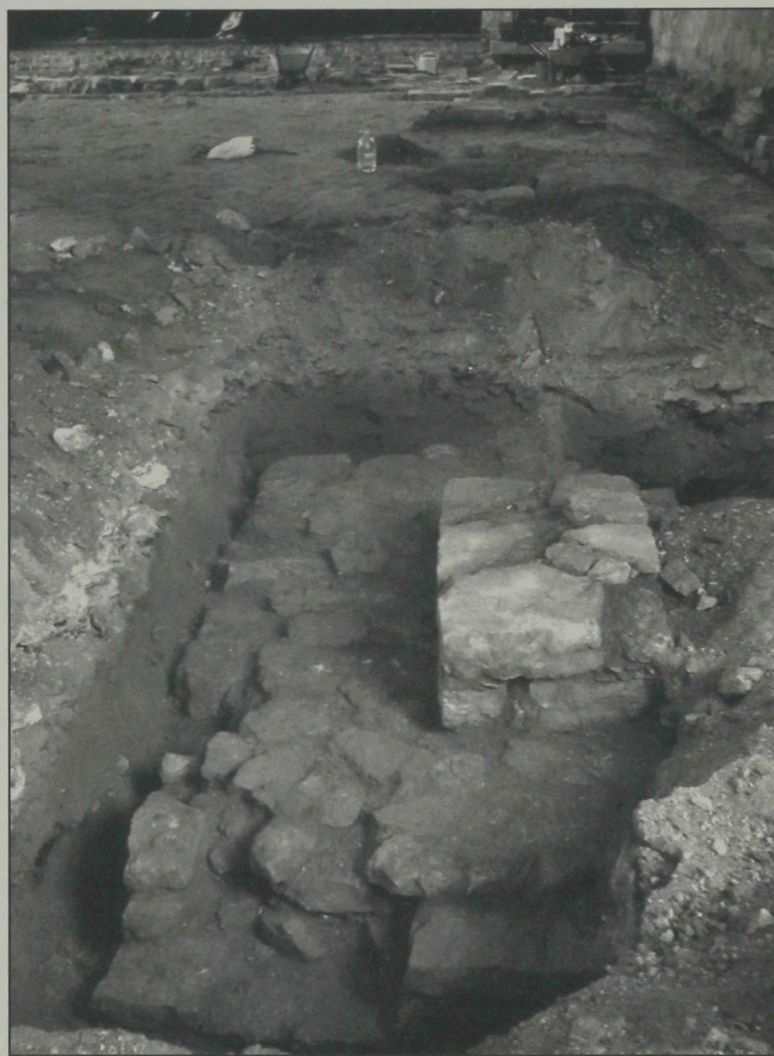
Fig. 12. Paide church. Two stages of stone pillar foundations in the nave.

Clearing some 50 cm thick demolition debris from after the fire of 1845 revealed quadrangular limestone pillar foundations from at least two periods (Fig. 12) and the outer wall foundations of the former church nave, which has been of the same size as the 18th century church, but with somewhat thicker walls. Unfortunately before building the 18th century church, the former church ruins were extensively removed, as stated by August Wilhelm Hupel (1774, 370) and confirmed during the monitoring. Even the floor level and a bit more soil (together with possible gravestone slabs) were probably removed, leaving only wall and pillar foundations (without mortar) of the former church in place. Even the level of the portal sills has been removed. In the eastern end of the nave a foundation of a possibly medieval quadrangular altar (180 × 100 cm) was found together with the foundation of a baroque altar, which was removed in the beginning of the 20th century to the new-built chancel. No dating evidence about the foundations in the nave was found. Some pillar foundations from the later building period might even come from the baroque church interior, which burnt in 1845 and about which almost nothing is known. Only the broken surface of the nave wall foundation suggests that it comes from a former church and is not originally built in the 18th century as a foundation for the
