ARHEOLOOGILISED  
VÄLITÖÖD  
EESTIS

2007

# ARCHAEOLOGICAL INVESTIGATIONS AT THE CASTLE OF THE TEUTONIC ORDER IN VILJANDI

**Riina JUURIK, Anti LILLAK and Heiki VALK**

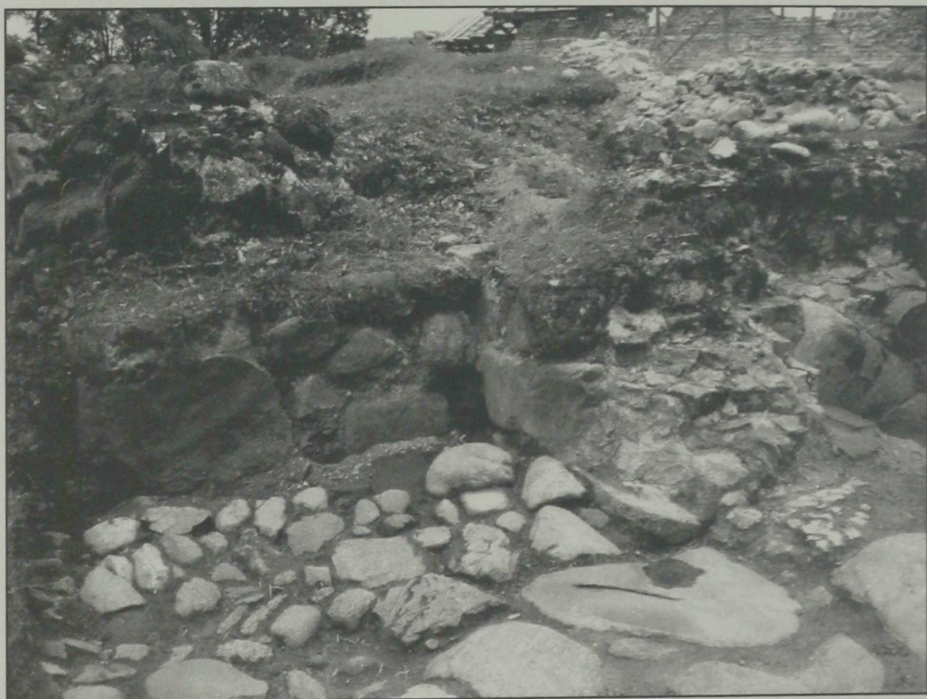
Archaeologists revealed a brick structure connected to the wall in the extent of 1.2 m; its length was 0.8 m (Fig. 2). Evidently the construction has been built later

than the main wall of the house of clerics, because there seemed to be a joint between the bricks and the stone wall. The brick construction can be interpreted as a footstall of a gate arch. This assumption could be affirmed by finding another similar brick construction at the other side of the pavement road, where presently there is a thick layer of earth.

Fig. 2. A brick construction next to the western wall of the "house of clerics".  
A view from the NW.

Jn 2. Telliskonstruktsioon vaimulikehoone lääne-seina küljes. Vaade loodest.

Esimese eeslinnuse põhjapoolse hoone (nn vaimulikehoone) lääneseina välisküljelt eemaldati müüri äärde kuhjunud pinnast. Kaevamiste käigus paljandus maakividest müüriga liituv telliskonstruktsioon, mida võib tõlgendada värava võlvkaare kanna jäänusena (jn 2). Samuti selgus, et hoone lääneseina põhjapoolsemad 2 meetrit olid ehitatud üldisest müürijoonest mõnevõrra tahapoole. Sellist astangulist müüriladu on raske mõista.

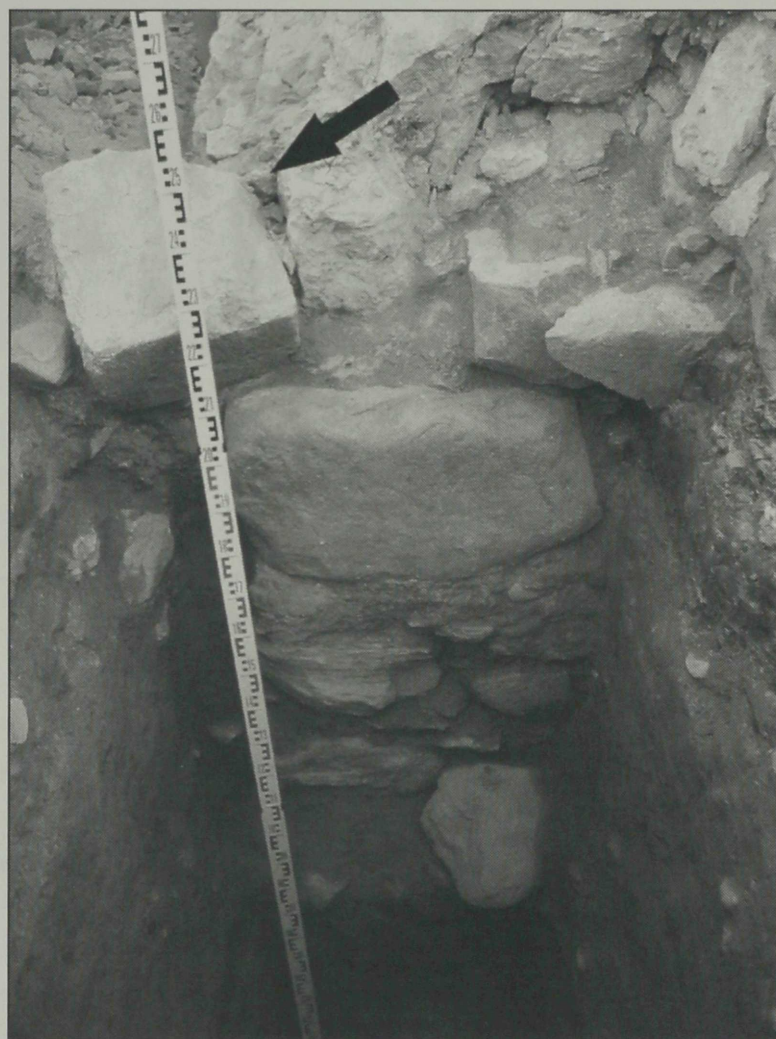
The lowermost hewed cornerstone lied actually almost on a ground level and has been shifted from its original position (Fig. 5). The outer wall of the Convent building was made of large granite stones and limestones. The lower edge of the footing was 2.5 m below the modern ground level.

Fig. 5. NE-corner of the castle chapel. An arrow points to a hewed cornerstone that is shifted from its original position. A view from the N.

Jn 5. Kabeli pikihoone kirdenurk. Nool näitab paigast nihkunud tabutud kvaadrikivi. Vaade põhjast.

Teine šurf (1,5 x 1,5 m) rajati konvendihoone kabeli pikihoone kirdepoolse välisnurga vastu (jn 1: 3). Nüüdisaegsest maapinnast õige vähe allpool paljandus munakivisillutis ning selle all mitmed tõenäoliselt keskajast pärit ladestused. Need sisaldasid arvukalt lubja-, mördi-, liiva- ja söelaike, loomaluid ning leide (jn 4), sh kivitööd, luuesemeid ja kaks ammunooletsa (neist üks pärineb 13. sajandi esimesest veerandist). Üks tahutud alumine kvaadrikivi paiknes praktiliselt praeguse maapinna tasemel, kuid oli oma esialgselt kohalt eemale nihkunud (jn 5).

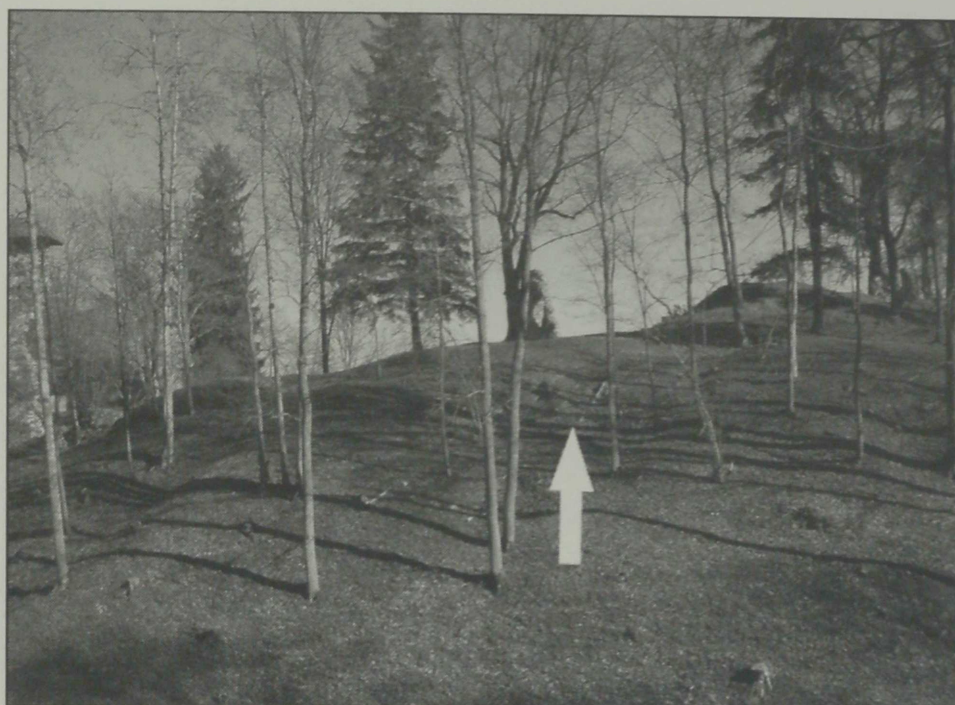
Fig. 6. The location of the trial pit on the NW-slope of the hill Kaevumägi. A view from the NWW.  
Jn 6. Kaevumäe loodenõlva proovikaevandi asukoht. Vaade lääneloodest.

hill, on the eastern slope of the deep moat (Fig. 6). It was situated roughly north-westerly - south-easterly and was 4 m long and 1 m wide. It became evident that layers on the slope consisted of numerous strata (Fig. 7). The upper layers contained a lot of debris, animal bones and some medieval and post-medieval finds, including iron nails, a fragment of a proto-stoneware jug (Fig. 8: 6; dated to the 1<sup>st</sup> half or the middle of the 13<sup>th</sup> century)<sup>5</sup> and two fragments of wheel-thrown pottery (Fig. 8: 2, 3). One of them can be dated to the Late Iron Age or to the 13<sup>th</sup> century, the other one probably to the 13<sup>th</sup> century.<sup>6</sup>
