**ARCHAEOLOGICAL
FIELDWORK
IN ESTONIA**

ARCHAEOLOGICAL FIELDWORK AT PÄRNU MEDIEVAL AND EARLY MODERN FORTIFICATIONS FROM 2007 TO 2009

From 2007 to 2009 substantial archaeological fieldwork took place in connection with new buildings and communication trenches in the north-eastern part of the former town of New-Pärnu in the Streets of Aida, Hommiku, Lai, Pikk and Põhja (Bernotas 2008; 2009a–b). More extensive work took place in the summer and autumn of 2007 in the plot of Aida St 5 (with the former address Aida St 7) where the foundation depression for a business and dwelling house was dug (Bernotas 2009b); in 2008 and at the beginning of 2009 in the plot of Lai St 7, where a parking house was built. Elsewhere archaeological monitoring in the area of the trenches for water pipes, sewage and electricity cables was carried out and in one section a part of a medieval corner tower was unearthed in order to specify the exact location of the construction (Bernotas 2009a). Sections of the medieval town wall as well as parts of the early modern rampart fortifications were excavated.

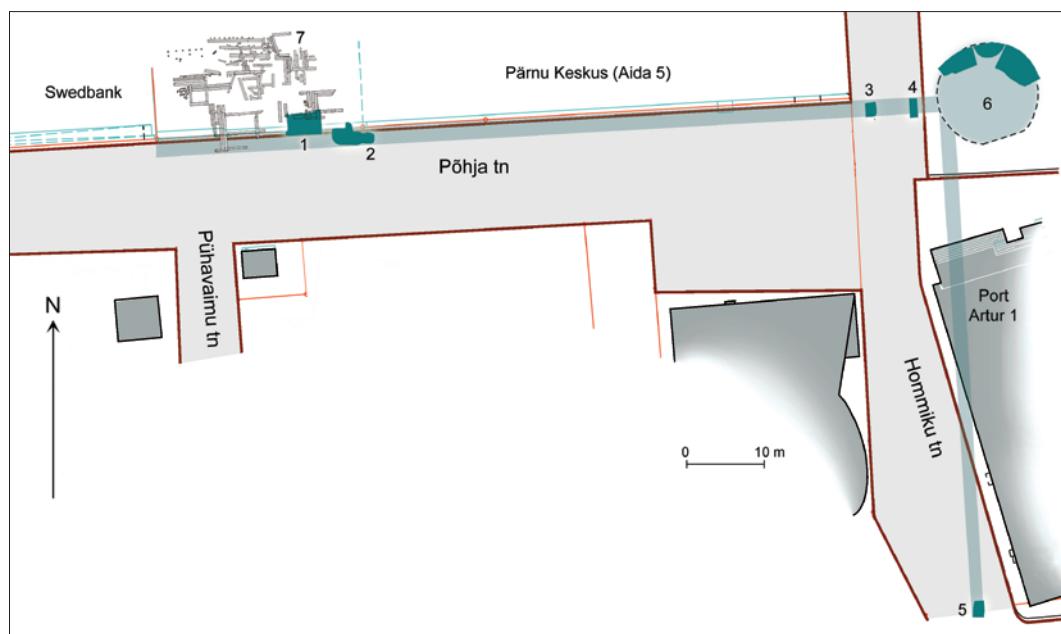
Fig. 1. Present Street network, medieval town wall and the positions of the opened sections (1–6) of the town wall and rampart fortifications.

So far the parts of the town wall have been unearthed in the course of several archaeological excavations, more extensively – by the length of 23 meters – it has been researched during the excavations of Munga St 2 in 1990–1991 (Tamla 1992, 291). To a lesser extent the wall fragments have been documented in the course of other work (e.g. Vunk 1998; Kadakas *et al.* 2003). During the excavations of 2007–2009 in the north-eastern part of the medieval town the town wall was opened in six sections, and the so-called White tower in the north-eastern part of the town was localized with a small test excavation (Fig. 1).

The area investigated in 2007–2009 remained between the bastions Mars and Saturnus (Fig. 7). A part of the rampart fortifications established alongside the town wall was opened in the plot of Aida St 5 (Fig. 1: 7) and single fragments of timber constructions that are probably connected with fortifications were documented in the plot of Lai St 7. An east to west oriented timber construction covering approximately 200 m² was unearthed in the plot of Aida St 5 (Fig. 8). The structure consisted of horizontally placed logs and stakes rammed into the ground. The logs used for construction work had the diameter of 15–35 cm and judging by the marks of hewing and the traces of dowels were at least partially in secondary use. The earthwork piled on the timber construction has been completely destroyed in this section during the town planning in the 19th century and the erection of later buildings, the structure cannot be dated more exactly, but it has probably been completed in the end of the 17th century together with the construction of the belt of the town bastions (Bernotas 2009b).

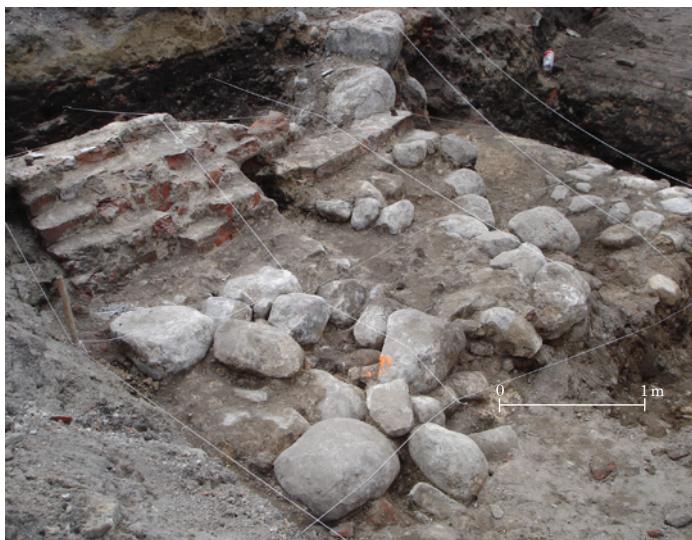
Fig. 2. Supposed section of town wall in the western side of the plot of Aida St 5. View from the north-east.

In the western side of the plot of Aida St 5 a supposed part of the town wall (Fig. 1: 1, 2), probably including a fragment of the gateway of the so-called Guild room, was excavated by a 4.5 m long (from east to west) and 2.7 m wide area. The stone construction exposed by 1.2 meters comprised of boulders⁴ with the diameter of 30 cm that had been irregularly piled together on top of each other. Unfortunately the described part of the town wall has been repeatedly damaged in the course of earlier construction work. The wall has probably been torn down already during

Välitöödel avati linnamüür kuues lõigus. Aida tn 5 krundi läänepüüljal kaevati 4,5 m pikku sel ja 2,7 m laiusel alal välja oletatav linnamüüri osa (jn 2), sh arvatavasti ka fragment nn Gilditoa värvavakäigust. 1,2 m körguselt väljapuhastatud kivikonstruktsioon koosnes korrapäratult üksteise peal paiknevatest kuni 30 cm läbimõõduga maakividest. Paraku on kirjeldatav linnamüüri osa saanud korduvalt kan-natada tänavakatte ja hoonete rajamisel 19.–20. sajandil. Väljakaevatud kivikonstruktsiooni võiks pidada linnamüüri fragmendiks, sest see asub seni väljakaevatud linnamüüri osadega samal joonel. Värvavakäiku võib seal oletada 17. sajandi linna-plaanide järgi.

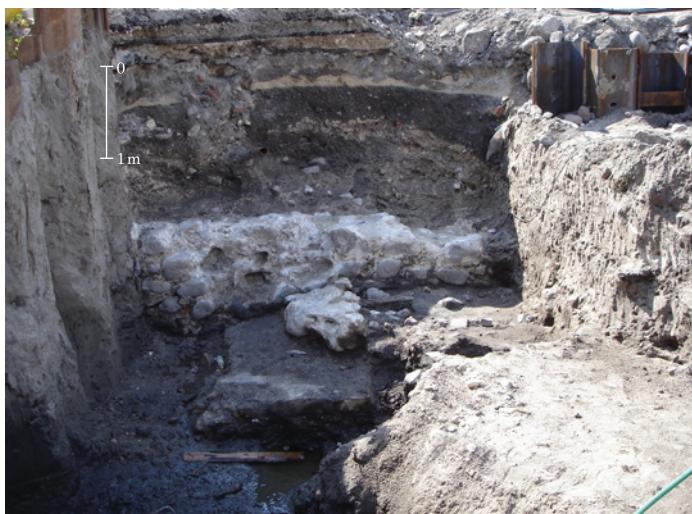
Fig. 3. Section of town wall on the plot of Aida St 5. View from the north.

Another, an up to 1.6 m wide piece of the town wall, was opened in Aida St 5 in the vicinity of the supposed wall fragment described above (Fig. 1: 2, 3). The wall has been built of boulders with the diameter of 25–30 cm joined together with lime mortar. A raft of logs orientated in the same direction as the stone formation was detected under the wall. The raft had only been preserved in the southern side of the wall fragment. Two parallel logs with the diameter of 30 cm (the southernmost being 2.5 m and the northernmost 2.9 m long) were unearthed directly under the stone layer. It is possible that this piece of the wall has also been a part of the gateway of the Guild room.

Eelkirjeldatud oletatava müüririkatke lähedal Aida tn 5 avati veel üks kuni 1,6 m laiune linnamüüri osa (jn 3). Müür on ehitatud lubjamõrdiga seotud 25–30 cm läbimõõduga maakividest ning toetub 30 cm läbimõõduga palkidest parvele. Võimalik, et see müürilõik on samuti osa Gilditoa värvavakäigust.

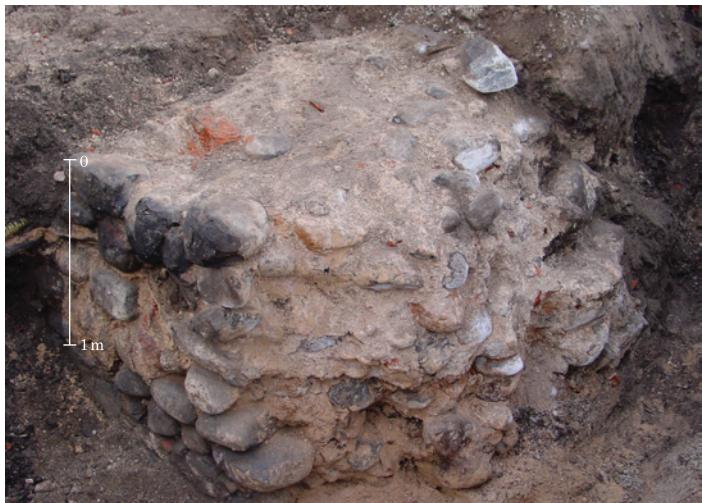
Fig. 4. Section of town wall in Põhja St by the south-eastern corner of the plot of Aida St 5.
View from south-east.

Directly by the south-eastern corner of the plot of Aida St 5 another fragment of the town wall was unearthed. It was situated at the depth of 0.5 m from the present ground level and was 1.4 m long from east to west and 1.84 m wide from north to south (Fig. 1: 3; 4). Excavations did not reach the footing, thus leaving 1.55 m for the height of the opened part of the wall. The wall comprised of boulders with the diameter of up to 30 cm joined together with brittle lime mortar that contained pieces of brick. The wall was preserved and covered with sand; St covering was put on top of it.

Vahetult Aida tn 5 krundi kagunurga juures Põhja tänavalt kaevati välja tänapäevastest maapinnast 0,5 m sügavuselt ida-läänesuunaline 1,4 m pikkune ja 1,84 m laiune linnamüüri fragment (jn 4). Müür koosnes kuni 30 cm läbimõõduga maakividest, mis olid omavahel seotud tellisetükke sisaldava pudeda lubimõrdiga.

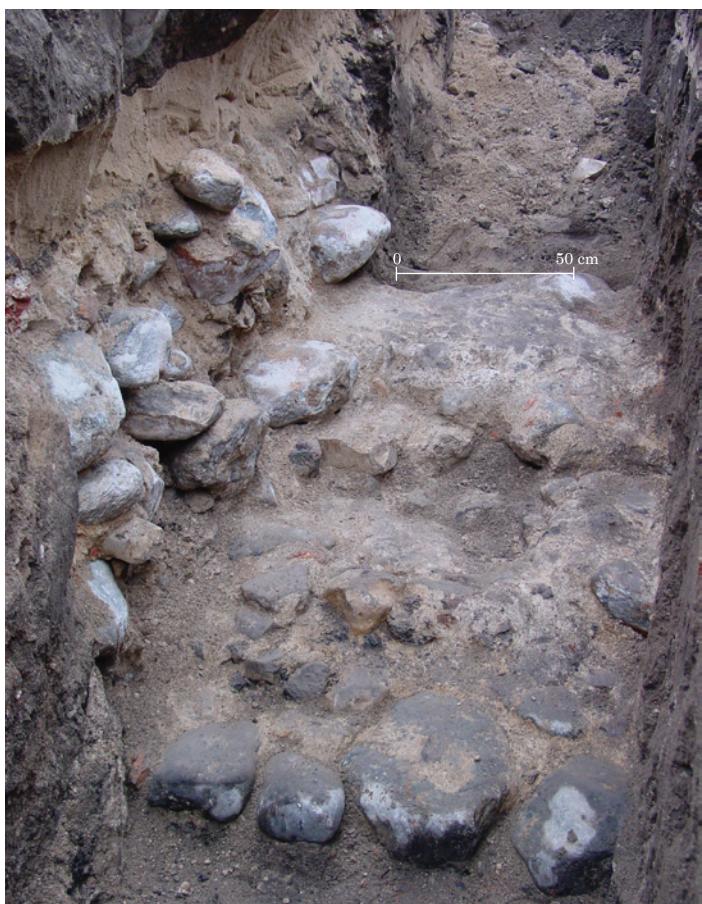
Fig. 5. Section of town wall in Hommiku St.
View from the south.

In Hommiku St a town wall fragment (Fig. 1: 4) partly destroyed during previous excavations was unearthed approximately 1 m deep from the present ground. The wall fragment was opened by 1.2 m in length and 1 m in height (Fig. 5). The 2.3 m thick wall had been laid of boulders with the diameter of 30 cm joined together with lime mortar containing pieces of brick and limestone. The wall was preserved and covered with sand; a heating trench was established on top of it.

kõrguselt varasematel kaevetöödel osaliselt lõhutud linnamüüri osa (jn 5). 2,3 m paksune müür oli laotud 30 cm läbimõõduga maakividest, mis olid oma-vahel seotud tellise- ja paekivide tükke sisaldava lubimõrdiga.

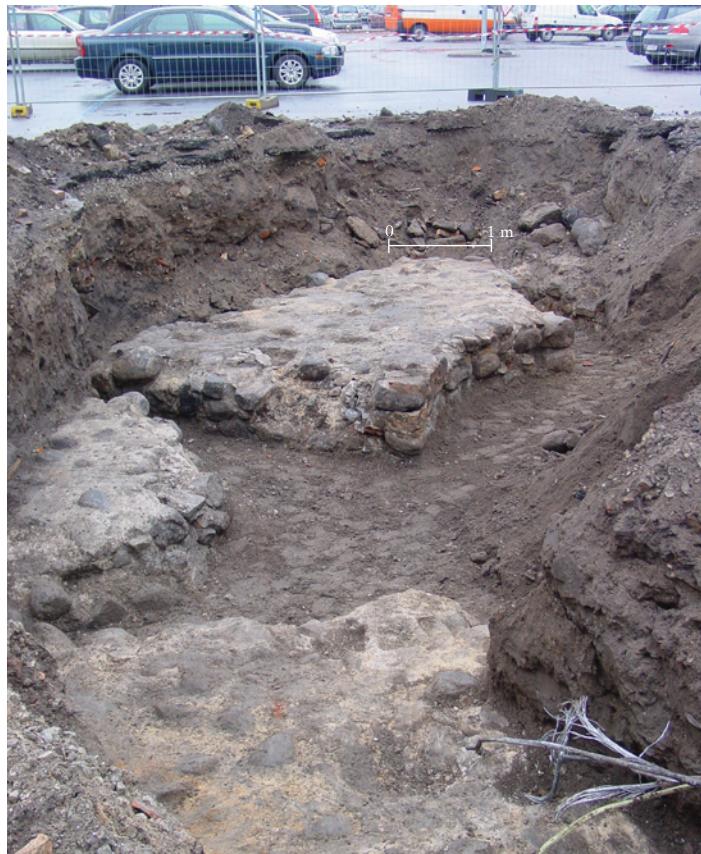
Fig. 6. Preserved part of White tower. View from the west.

By Hommiku St near the Port Artur-1 trade centre a part of the so-called White tower located in the north-eastern corner of the town wall was reopened (Fig. 1: 6). The tower has been built between 1533 (after the predecessor of White tower was exploded) and 1543 (the new tower has been mentioned in historical records) (Laakmann 1956). The preserved part of the tower was excavated in 1976 (Vali *et al.* 1978, 5) but was thereafter covered with soil again. Its re-excavation in December 2008 was brought about by the need to specify the location of the remains of the tower in order to compile special conditions required for the establishment of a fountain in the historic area. The excavations opened a 62.5 m² large area (Fig. 6). The northern part of the tower with double-embrasures was unearthed. After documenting the results the foundation of the tower was re-covered with sand.

Hommiku tänavu äärest Port Arturi kauban-duskeskuse lähedalt taasavati osa linnamüüri kir-denurgas paiknenud 16. saj esimesel poolel rajatud nn Valgest tornist. Torni säilinud osa kaevati välja 1976. a, kuid seejärel kaeti uesti pinnasega. Selle osalise väljakaevamise 2008. a tingis vajadus täpsustada tornisäilmete asukohta eritingimuste koos-tamiseks purskkaevu rajamiseks. Välitööde käigus avati 62,5 m² suurune ala (jn 6). Välja puastati torni paarislaskeavadega põhjaosa.

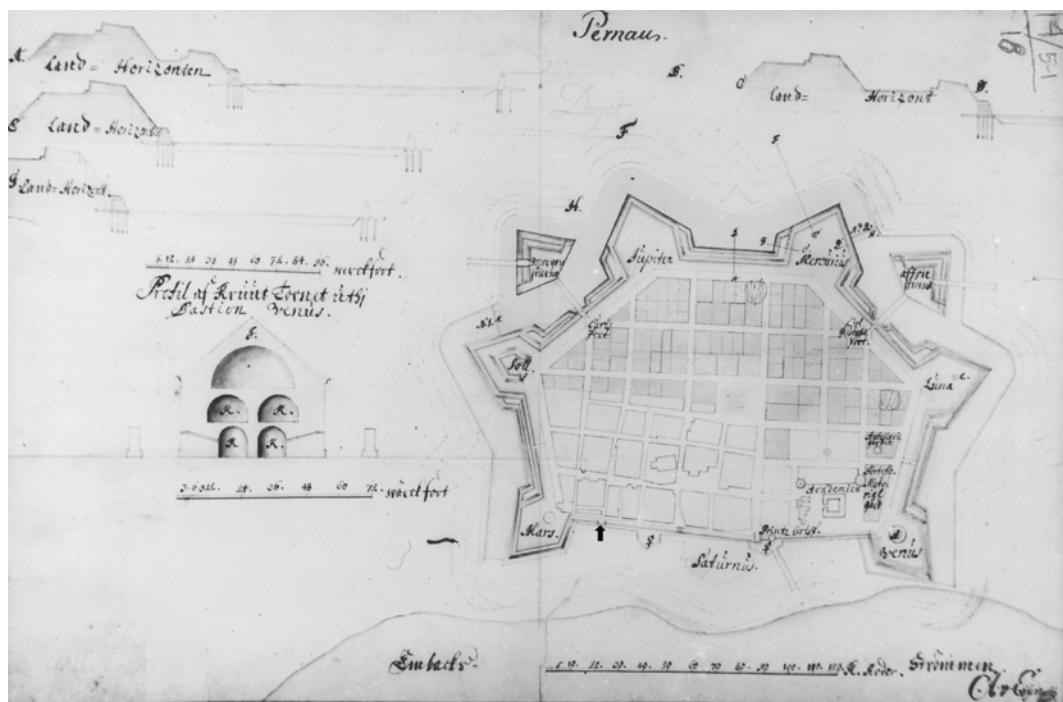
Fig. 7. Town plan of Pärnu (1699). The arrow marks the area where parts of rampart fortifications were opened in 2007–2009.

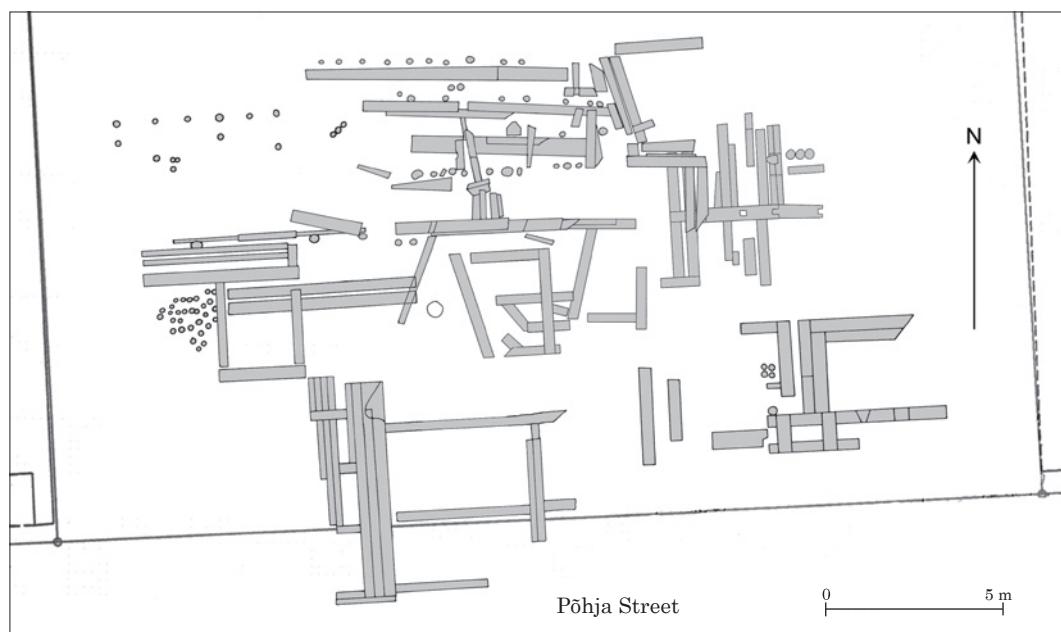
Fig. 8. Timber constructions of rampart fortifications.

In order to strengthen the horizontal defence system of the Early Period constructions of vertical and horizontal logs have been established before the piling of the soil. The hewing and dowel marks refer that some logs have been secondarily used; it is possible that these originate from smaller earth fortifications that lay in the same location before the extensive rebuilding of 1670.

Välitööd teostati ka muldkindlustustel 17. saj lõ-pul rajatud bastionide Mars ja Saturnus vahelisel alal (jn 7). Osa linnamüüri vastu rajatud muldkind-lustustest avati Aida tn 5 krundil ja üksikuid arvata-vaid kindlustuste fragmente dokumenteeriti ka Lai tn 7 alal. Aida tn 5 krundil kaevati välja u 200 m² ida-lääne-suunaline puitkonstruktsioon (jn 1, 8). Rajatis koosnes horisontaalselt asetatud palkidest ja maasse rammitud vaiadest.
