**ARCHAEOLOGICAL  
FIELDWORK  
IN ESTONIA**

**2009**

## ARCHAEOLOGICAL EXCAVATIONS IN NARVA IN 2008–2009

ALEKSANDR NIKITJUK

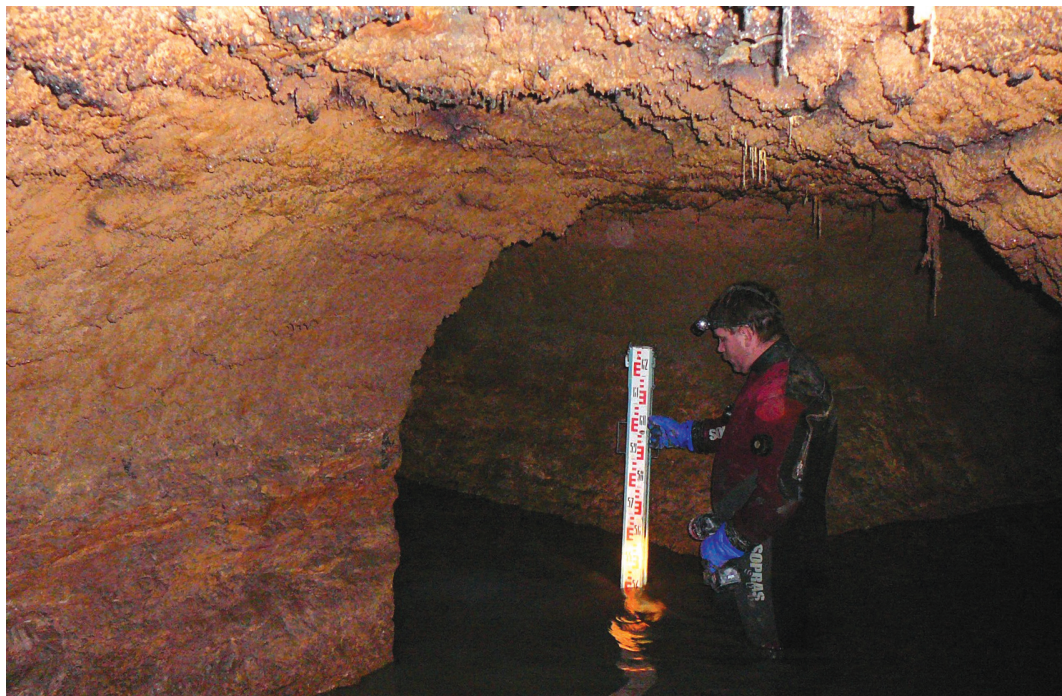
*Fig. 2. Investigations of flooded Victoria bastion dungeons.*

During the works a full engineering survey of all preserved parts and elements of the monuments was made. The floors of dungeons, staircases and ceilings were surveyed. In addition, exploration, engineering and geodesic surveys of remote (flooded) dungeons were initiated (Figs. 2–3). The total length of the dungeons' corridors under investigation was 750 m. 92 loopholes, 20 wall niches, 14 flights of steps were found and recorded during the research. Also damages caused by the siege and assault of Narva by the Russian troops in 1704 as well as the evidence of follow-up repair work on the bastions were found.

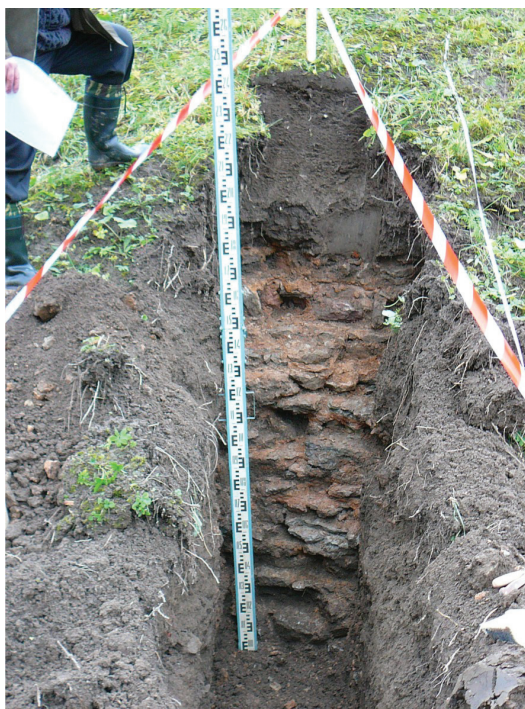
Fig. 5. Breast-wall foundation in the test pit of the 5th ravelin.

solid layer of bluish-grey clay where the ditches were made; that is why the historical location of the ditches can be seen on the cross-section of trenches and test pits, which makes the restoration of the monuments easier. In the rampart of the 5th ravelin a stone (scarp) wall (quarry stone in calcareous base) was found which most probably served as a support wall for the rampart mount (Fig. 5). Besides, in the stratigraphic cross-section of one of the test pits traces of glacis filling were spotted. Finally, not far from the Honor bastion a pit for lime production ( $7 \times 3.5$  m) was found, which may be connected with the period of construction and repair works on the bastion.

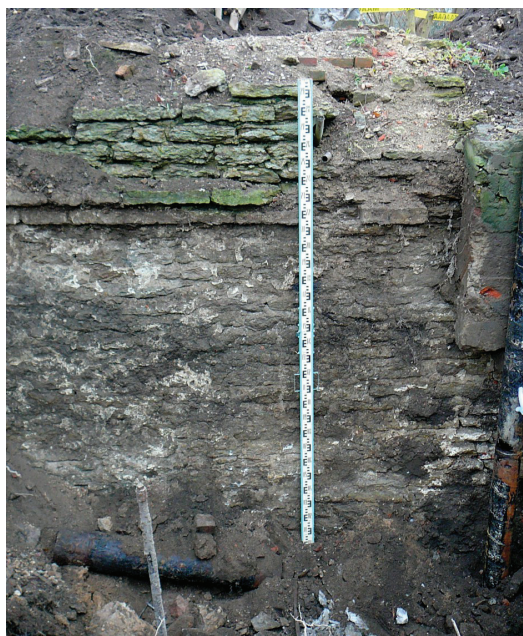
Fig. 7. Medieval town wall.

town wall of the 14th century (Figs. 6–7). The wall was still there on the territory of the old town in the 1930s (Karling 1936, 78). The wall was demolished during the post-war construction work on the territory of the old town and till the present day it was not known whether its foundation has been preserved. With this new evidence it can be considered as a proved fact. A part of the medieval town wall was traced for more than 30 m, with the upper part of the quarry stones being almost at the level of modern day surface (under the layer of the top soil). The stone wall can be seen at the depth of more than 3 m.

2008. a gaasitrassi järelevalve käigus leiti Vestervalli tänava piirkonnas 30 m ulatuses keskaegse linnamüüri jäänused (jn 6–7). Paekivimüüri ülemine osa asub praktiliselt maapinnaga ühel tasandil, mättakihi all ning on jälgitav üle 3 m sügavusena. 2009. a uuriti seoses plaanitava puhkeala rajamisega ka Joaoru piirkonna ajaloolist territooriumi (jn 8). Välitööde käigus tuvastati lisaks kultuurikihi- le ka 17.–19. sajandi tööstusehitiste vundamendid. Ajalooliste andmete põhjal asusid 17.–18. sajandil antud territooriumil paekivikarjäär ja lubjaahjud.
