**ARCHAEOLOGICAL
FIELDWORK
IN ESTONIA**

ARCHAEOLOGICAL EXCAVATIONS AT LOSSI 21, VILJANDI

ANDRES TVAURI

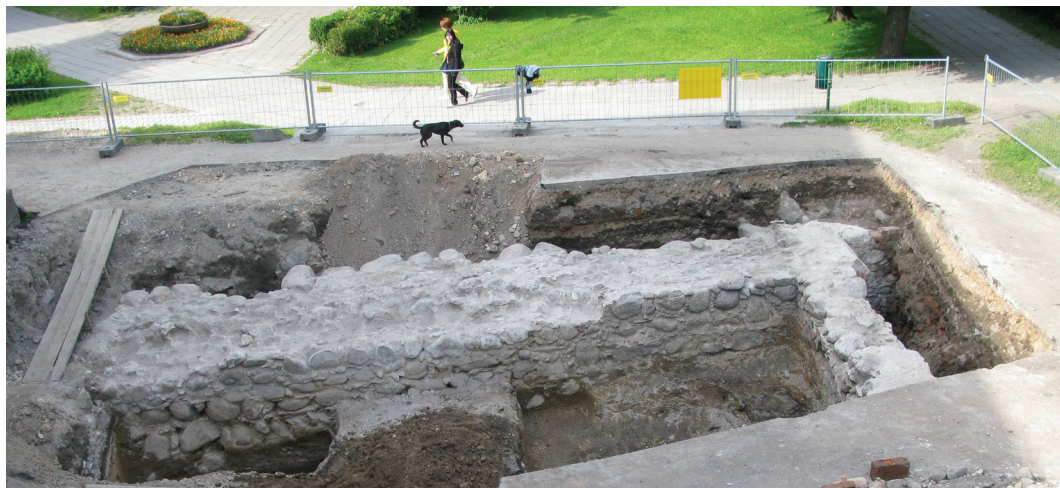
Fig. 3. Town wall. View from the south.

The most remarkable construction remains were the lower part and foundation of the medieval town wall of Viljandi exposed in the northern area of the excavation (Fig. 2). The wall was in general east–west directed and preserved as a 8.7 m long section (Fig. 3). In its western part it had been destroyed in the course of the construction of the cinema. In the eastern part a cellar had been built through the wall in the 19th or the first half of the 20th century. The thickness of the town wall was 2.25 m measured from the upper rim of the preserved part. The biggest height of the preserved part with the foundation was 1.8 m.

In erecting the wall three layers of big boulders have been laid on the initial ground. The gaps between the boulders had been filled with silt and

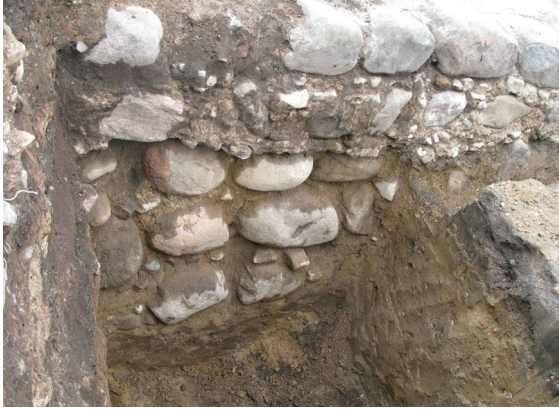
Fig. 4. Part of town wall. View from the north.
 Jn 4. Linnamüüri detail. Vaade põhjast.
 Photo / Foto: Andres Tvauri

smaller stones (Fig. 4). At the same time on both sides of the foundation a layer of silt was amassed the thickness of which was up to 90 cm measured directly by the wall. The town wall bound with lime mortar was laid on top of the foundation of boulders fixed with silt. The wall had been laid of big boulders in horizontal rows. Smaller boulders and pieces of limestone had been wedged between the big stones. The wall laid with mortar has preserved in the excavation site up to the height of three stone rows.

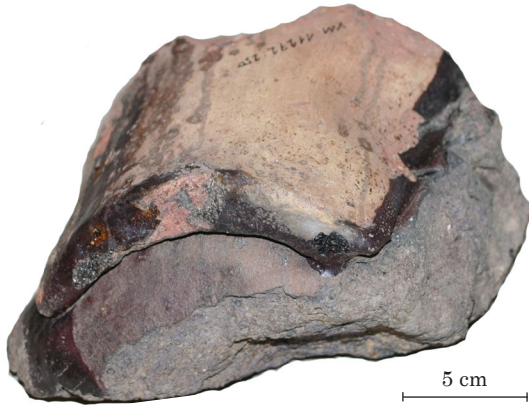
Fig. 5. Waster of the medieval roof tile.
 Jn 5. Keskaegse katusetellise praak.
 (VM 11272: 250.)
 Photo / Foto: Andres Tvauri

Väärib märkimist, et kraave täitnud tellistel ja munk-nunn-tüüpi katusekividel ei olnud mördijälgi ja osa neist oli kuumuses kasutuselbmatuks väärdunud või üle põletatud (jn 5). Tegemist on telliste ja katusekivide valmistuspraagiga, mis viitab lähikonnas asuvalle keskaegsele tellisepõletuskohale.

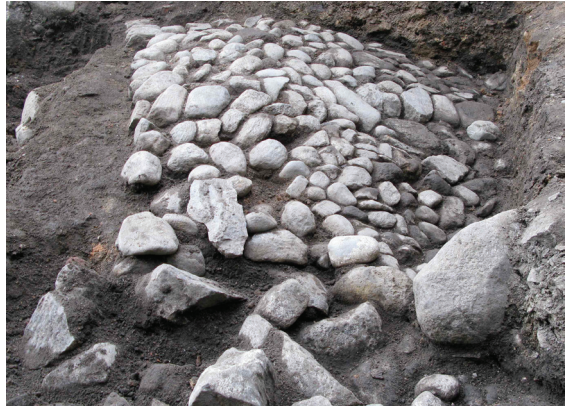
Fig. 6. The earlier medieval cobble stone pavement. View from the west.

Directly under the higher pavement, 10–20 cm below the previous, an older pavement with similar measurements was discovered. This had been laid on the up to 10 cm thick red sand (Fig. 6). A similar pavement laid on the red Devon sand has been exposed in several places of former streets during the archaeological excavations and monitoring in the area surrounded by the town wall in Viljandi (Haak 2003).
