## INVESTIGATIONS OF THE NORTHERN PART OF THE RAMPART FORTIFICATIONS OF TALLINN

RAGNAR NURK, VILLU KADAKAS and GUIDO TOOS

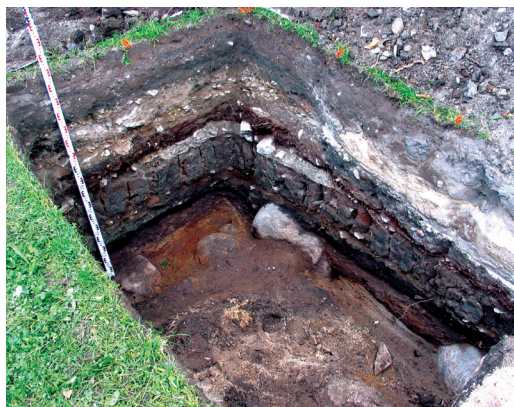
Fig. 5. Test pit in front of the Skåne bastion on the outer side of the moat, in the north-eastern corner of the investigated plot. Former seashore with granite stones, in profile upon it a thin black cultural layer and the layer of clayish 'bricks' which formed the surface of the covered way.

Jn 5. Šurf Skoone bastioni esisel alal vallikraavi väliskaldal, uuritud kinnistu kirdenurgas. Endine suurte raudkividega mererand, selle peal profiilis õhuke must kultuurikiht ja varjatud tee pinna moodustanud "savipätside" kiht.

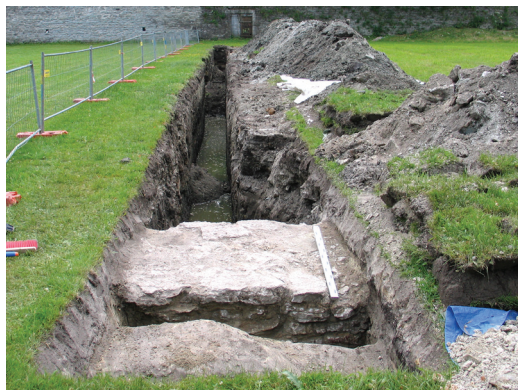
Fig. 6. Present-day football field north of the Skåne bastion, with counterscarp wall in front and scarp wall in the rear.

Jn 6. Skoone bastioni põhjakülje esine jalgpalliväljak, kontreskarp müüri ees ja eskarp müüri taga.

it runs straight in the east – west direction through the investigated area (Fig. 1). Under most of the football field the wall was preserved only to the height of 2 m immediately beneath the sod layer (Fig. 6). In the higher western edge of the football field the counterscarp wall was preserved even in its full height (see Fig. 3), as probably also in front of the western side of the bastion. The wall had been built upon the sandstone plateau, the surface of which is at about the same level at both ends of the investigated site. On the 0.5 m high foundation built on hard sandstone stood a 3.5 m high and 1.3–2 m thick wall. The top surface of the cornice stone, which moat-side edge was unfortunately broken, was covered with a thin layer of clay, used as isolation. Behind the wall the earlier bank of the moat was also recognizable as a level of loose limestone slabs together with the relatively humus-rich layer on it. Inside the moat, on the sandstone there was a mixed clayish layer and on it a humus-rich layer, which had accumulated while the moat was still open. Test pits proved also that the supporting wall of the inner side of the glacis has been quite surely demolished in front of the northern side of the bastion.

Nothing visible has survived of the historic Small Coast Gate bastion, but while building the big complex of warerooms and workshops at the beginning of the 1980s it was given an appearance imitating a bastion. The outer wall of the building was erected almost exactly on the place of the scarp wall (Fig. 6), but considerably higher than the original one had stood. The test pits of 2010 were dug in the area in front of the northern and north-eastern side of the building, which is divided between a parking lot and a public garden. Even before, in April 2010, in connection with installing a gas line, we also came across foundation fragments, presumably belonging to the rampart gate of the Small Coast Gate, at the corner of the Uus street and the Väike Rannavärava street (Fig. 1: 5; Nurk *et al.* 2011a).

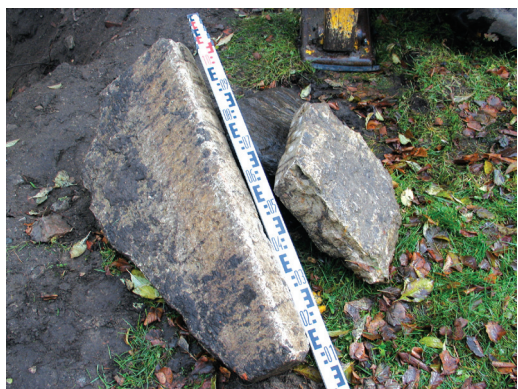
Fig. 7. The cornice stones of the counterscarp wall from the test pit dug in front of the Great Coast Gate bastion.

Jn 7. Kontreskarp müüri karniisikivid Suure Rannavärava bastioni eest.

the second half of the 18th century. On the wall the cornice stones were missing, but several of these were found loose in the fill soil (Fig. 7). The edge of these cornice stones was with a rectangular cross-section, with rounded corners.

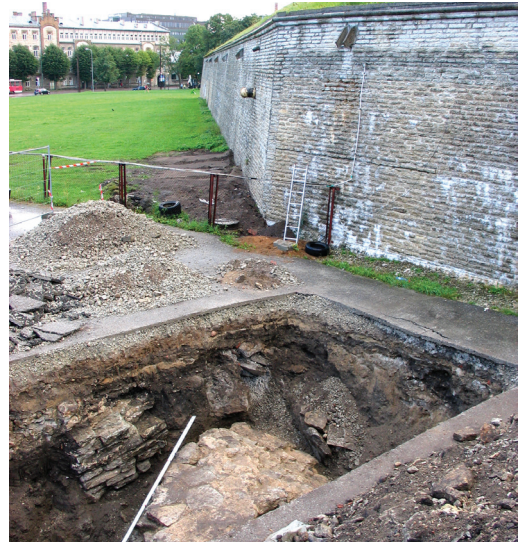
Fig. 8. Excavation with the southern corner of the tenaille scarp wall in front of the Small Coast Gate rampart gate. The building beside the excavation is a reconstruction of the Small Coast Gate bastion from 1980s.

Jn 8. Kaevand Väikese Rannavärava esise tenaile eskarpmüüri lõunanurgaga. Kõrvalolev, 1980. aastate alguses ehitatud hoone imiteerib ajaloolist Väikese Rannavärava bastioni.

In one of the excavations the southern corner of the tenaille which was situated in front of the rampart gate of the Small Coast Gate was documented (Figs 1: 6; 8). It appeared that the slightly salient foundation, 70 cm high, of the tenaille's scarp wall had been built on a timber raft. The wall itself, preserved to the height of 3.3 m had an inclined outer side, so that its thickness remained between 1.45–2 m. The foundation had been built on a nearly 2 m higher level and the wall itself was at least 1 m higher than Zobel (1977, 20–21) had presumed on the basis of the results of the analysis of historical drawings of Russian military engineers.

Uuringutega saadi uusi andmeid muldkindlustuste esisest vallikraavist ja eelkindlustustest. Avati Väikese Rannavärava vallivärava esise tenaili eskarpmüüri lõunanurk (jn 8). 1750. aastate alguse tenaili müür oli rajatud puitprussidest alusparvele ja oli säilinud 3,3 m kõrgusena, mida on u kolmandik enam kui Rein Zobel oli seda varem ajalooliste jooniste põhjal eeldanud. Kontreskarp müür dokumenteeriti kokku viies punktis (jn 1: 3, 6 ja 7). Müüri arhitektuur ja heatasemeline teostus sarnanevad linna lõunaküljelt leitud samast ehitusetapist pärineva, 18. saj teise poole kontreskarp müüri. Suure Rannavärava bastioni ees, kus algne kontreskarp müür oli ehitatud juba u 17. saj keskpaiku, piirduti samal ajal vaid varasemale müürile vallikraavi poolsesse külge paksenduse ladumisega. Skoone bastioni juures selgus, et vallikraavi väliskaldaks oli enne müüri ehitamist pikka aega pinnasest nõlv, mida näitas huumusrikas kiht koos selles leiduvate lahtiste kaldus pae kividega. Nii Skoone kui ka Suure Rannavärava bastioni ees moodustas vallikraavi väliskaldal kulgenud varjatud tee tasandi omapärasest poorsest savist massi või samast materjalist lõigatud “pät-side” kihi pealispind (jn 1: 4; 5). Bastionaalvööndi kõige välimise osa moodustanud glasiivalli varjatud tee poolsest küljest toetanud väike müür on tõenäoliselt hävinud Skoone bastioni põhjaküljel, kuid mujal uuritud bastionide ees ilmselt rohkem või vähem säilinud, nagu ka varjatud teel paiknenud kaponiiride müürid.
