## **INVESTIGATION OF THE MEDIEVAL AND EARLY POST-MEDIEVAL KARJA GATE AND THE SUBURB IN FRONT OF IT IN TALLINN**

The present article gives a brief overview of the results of the archaeological investigation that took place in 2009–2010 in the south-eastern part of Old Tallinn, in the area of the Karja gate and the suburb in front of it. Digging a cable trench across the southern part of the Karjavärava square from a fountain in front of the cinema ‘Sõprus’ was archaeologically supervised by archaeologist Peeter Talvar and the foundations of the medieval main gate tower of the Karja gate were recorded (Fig. 2: 1; Talvar 2009). In July and August 2009 Ragnar Nurk supervised the archaeological monitoring at an extensive digging for cable trenches in Suur-Karja and G. Otsa streets (Figs 1: 3; 2: 3–12; Nurk *et al.* 2010).<sup>1</sup> The last recordings connected with the same trenches took place in April 2010 (Fig. 2: 2; Nurk & Toos 2011). In May and June 2009 preliminary archaeological investigation was carried out in the vacant part of the plot of the Tallinn Secondary Science School, where 5 test pits were made (Fig. 1: 1, 2, 5; Nurk *et al.* 2009). The work was necessitated becau

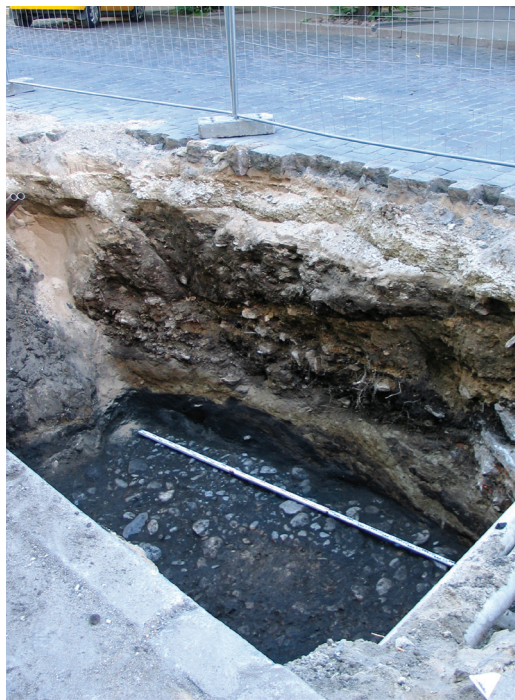
Fig. 4. The 13th century rubble pavement of a road to the Karja gate, under the present-day Suur-Karja street.

(Fig. 4) had been laid on a special sand pad, beneath which there was a thick fill layer of dung. Consequently, there must have been a natural or artificial depression in this place. Maybe the shore of the peat-bottomed small lake, presumed by Zobel to have been located between the Harju and Karja gates, extended as far as here (Zobel 2011, fig. 5: L; 79, note 4). The early date of the pavement is indicated by the 13th-century finds discovered upon it. Also a later road pavement made from larger limestone slabs, was documented. Generally the later medieval cultural layer was not very well preserved in the area of Karja gate itself, probably due to the extensive construction work carried out there throughout many centuries. The cultural layer containing lots of medieval imported pottery, mainly from the 14th–15th centuries (Fig. 5), was best preserved in the south-western part of the plot of the Tallinn Secondary Science School, where it was up to 50 cm thick. There we also came across a bottom of a cask, with a diameter of 220 cm, which rested upon natural sand. It is possible that the cask had been originally used to store something, and later as a waste container. Approximately in the 16th century a building with a limestone foundation and a wooden floor (Fig. 1: 2) had been erected on a little bit higher level, above the cask bottom.

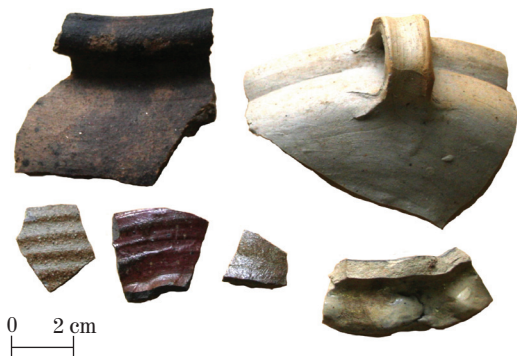
Fig. 5. Medieval pottery from the cultural layer of the plot of the Tallinn Secondary Science School.

Jn 5. Keskaegseid savinõukilde Reaalkooli kinnistu kultuurkihist.

(AI 6918: 2–4, 10, 15, 18.)

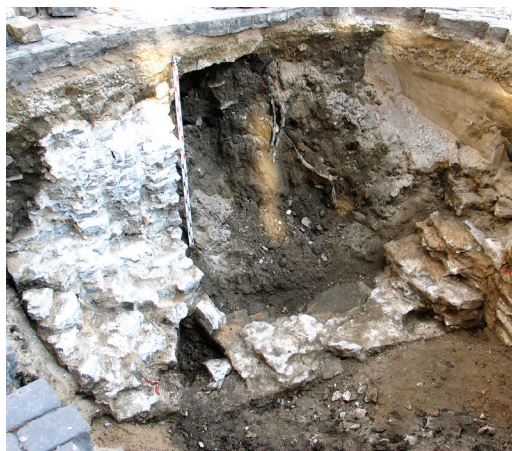
Fig. 7. Southern corner of the Karja watermill, formed by the north-eastern wall of the barbican (right) and the south-eastern wall of the watermill (left), together with a wall added later (left, profile). View from the north.

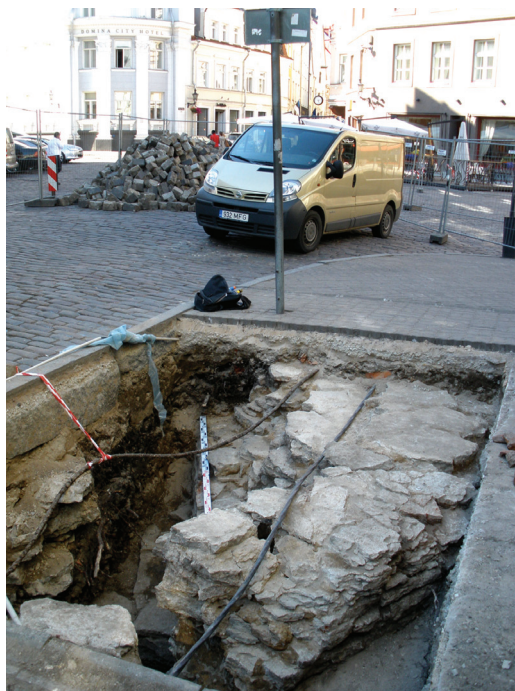
Fig. 8. Southern corner of the Karja barbican behind the secondary wall in front of it. The rectangular main gate tower was located near the present-day street corner visible in the background.

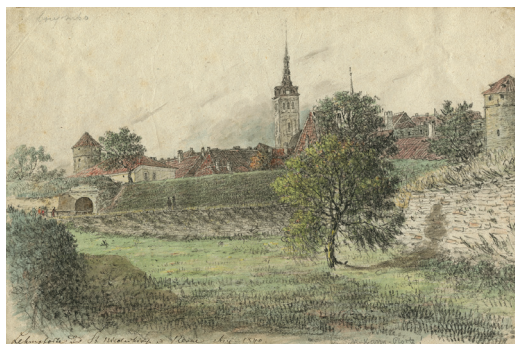
Fig. 9. C. Buddeus. View of Karja gate and St Nicholas church (1840). Italian pencil, aqua.

Jn 9. C. Buddeus. Vaade Karjaväravale ja Niguliste kirikule (1840). Itaalia pliiats, akvarell. (AM 13802.)

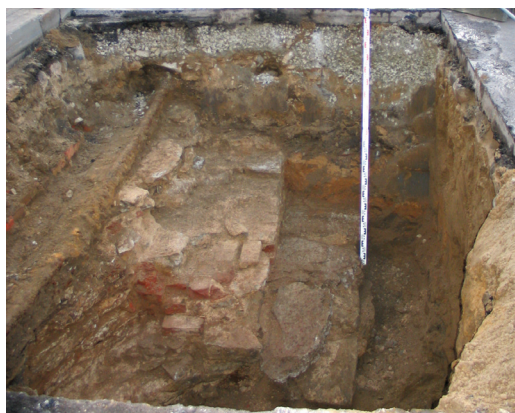
Fig. 10. South-western corner of the façade of New Karja rampart gate (18th c).

18. saj teisel poolel rajasid Vene võimud Karjaväravastkummalegi poole poolbastionid. Uuringutel oli võimalik näha nende poolbastionide vahelises sirges kurtiinivallis paiknenud uue Karja vallivärava (jn 9) välimist edelapoolset fassaadinurka (jn 1: 3; 10). Puitprussidest parvele rajatud müür oli laotud valdavalt paekivist, kuid väravakäigu sisekülj viimistletud punaste tellistega. Reaalkooli kinnistul toimunud eeluuringutega selgitati edelapoolse poolbastioni esise vallikraavi väliskallast toetanud kontreskarp-müüri paiknemine (jn 1: 5).
