# **ARCHAEOLOGICAL INVESTIGATIONS AT THE PROPERTY OF THE GREAT GUILD IN TALLINN**

KRISTA SARV

Archaeological investigations took place at the Great Guild Hall, Pikk Street 17 in Tallinn – the former property of the Great Guild of the merchants of Tallinn – during the renovation of the Estonian History Museum in 2009 and 2010. The investigations included the cellars, the courtyard and the passage known as Börsi Passage between properties 15 and 17 at Pikk Street.

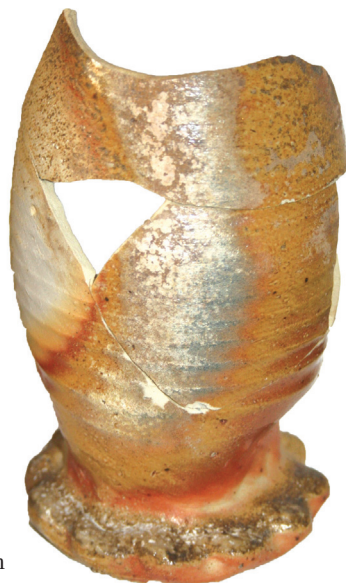
Fig. 2. Siegburg stoneware.  
Jn 2. Siegburgi kivikeraamiline kann.  
(AM 1111: 5.)  
Photo / Foto: Krista Sarv

A thin layer (approximately a square metre in size) containing a stave vessels with one or two hoops and shards of Siegburg stoneware<sup>4</sup> (Fig. 2), had been preserved in the centre of the building along the wooden drain which had run under the arch (Figs 3; 5) of the third cellar's western wall. The main layer of the cellar was 15–30 cm high made up mostly of pieces of bottle, fine glass dust and animal bones, and in places pieces of roof tiles and bricks and a layer of soil containing mortar that was all stratified on sandstone. Russian and Swedish copper and silver coins from the 17th and 18th century<sup>5</sup> were found in the foundations of the western part of the cellar on the Pikk street side – the Schotelmund building. On top of the aforementioned layer, the floors were tiled or concreted. Limestone tiles, which had covered the whole room, were extant in only three cellars on the Lai street side.

Keldri keskosas, lääneseina läbiva võlvkäigu alt jooksva puitkanali (jn 3) ääres oli ainsana säilinud u 1 m<sup>2</sup> laiguna õhuke keskaegne kultuurkiht. Kihist leiti Sieburgi kivikeraamiliste veinikannude katkeid (jn 2) ning vitsiknõusid. Keldri peamise kihistuse moodustas liivakivile ladestunud 15–30 cm paksune enamasti pudelikatkeid, peent klaasipuru, loomaluid ning kohati katusekivide ja telliste tükke ning mörti sisaldav täitekiht.

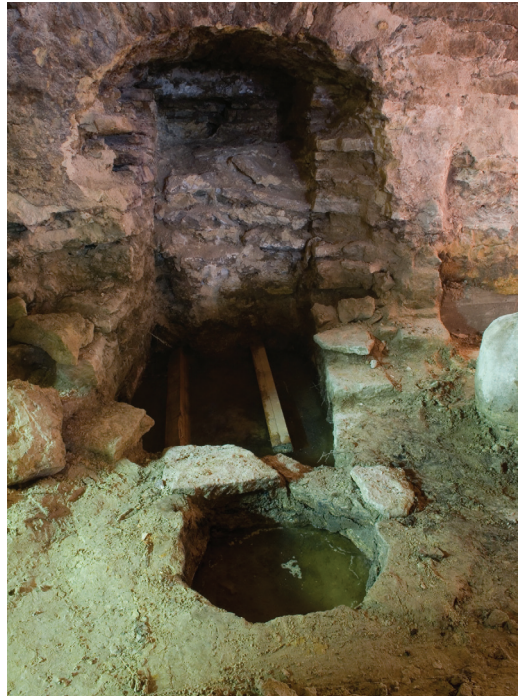
*Fig. 3. The cellar of the Great Guild Hall. A medieval cultural layer had only survived under this arch.*

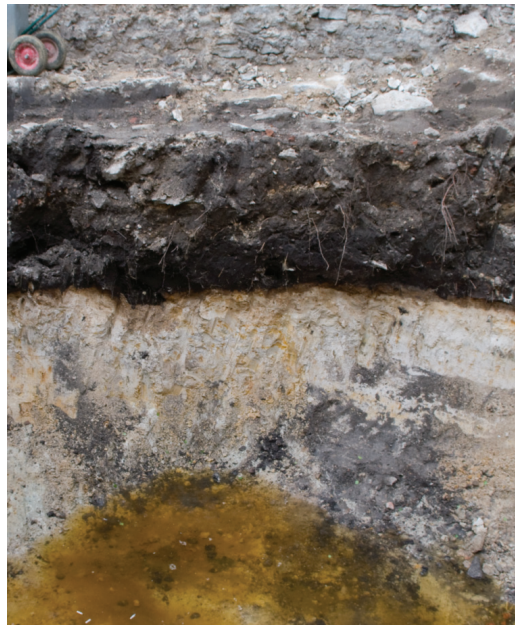
Fig. 6. Cultural layer in the courtyard.

The whole area of the courtyard was covered by an even layer of soil approximately 1.3–1.5 m deep (Fig. 6), which included pieces of bricks and roof tiles, animal bones and ceramics. Most of the finds were from the Early Modern and the Modern period – pieces of a trivet with greenish brown and reddish brown glaze, and pieces of clay pipes

as well as shards of 19th century porcelain.<sup>8</sup> There were solitary 5 cm wide strips of sand, and on the Great Guild Hall side, also strips of mortar that had fallen off the wall. Between the sandstone, which made up the bottom layer, and the layer described above, there was a layer of humus approximately 20 cm wide with no finds. It must be stressed that the layers on top of the sandstone were against the back wall of the Great Guild Hall.
