## ARCHAEOLOGICAL STUDIES IN RISTI CHURCH AND CHURCHYARD

**VILLU KADAKAS, KAIRE TOOMING and MAURI KIUDSOO**

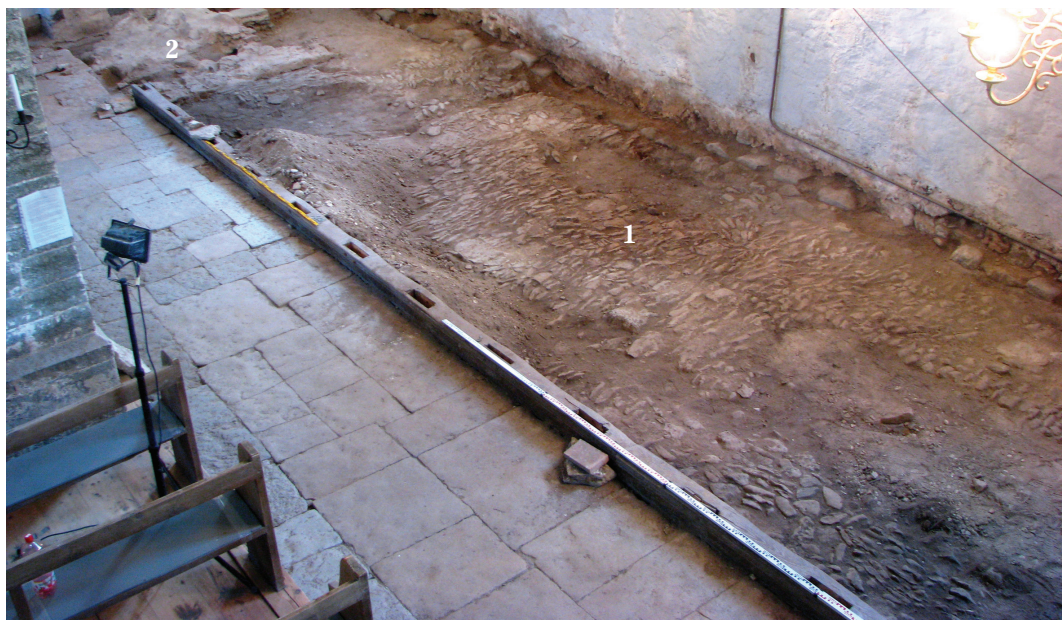
Fig. 4. Southern aisle. Remains of a medieval floor (1) and the side altar (2).

very similar situation – the floor of upright limestones and remains of a side altar in the eastern part of the nave – were discovered and cleaned. The limestone floor in the southern aisle appeared to be much better preserved than in the north. Some small-scale test pits were dug deeper with the aim to get some idea about the underlying deposits, but the floor was not damaged.

Mõlemas löövis avastatud põrandajäänused (jn 4, 7) on laotud sideaineta mitmesuguse, enamasti 10–20 cm läbimõõduga rohmakalt töödeldud paekividest. Kivid on laotud püsti erinevates suundades. Korratu põrand on selges kontrastis kirikuhoone regulaarse planeeringu ja üldiselt väga kvaliteetse raidkivitööga. Võib-olla on põranda ehitanud kohalikud talupojad, millele osutavad mõned selgete piirjoontega põrandalad. Osa selgete piiridega alasid võivad olla matuste järel laotud lapid. Mitmed põrandas olevad kirstukujulised tühemikud osutavad, et hilisemal ajal ei peetud matustejärgset põranda taastamist enam ilmselt vajalikuks.

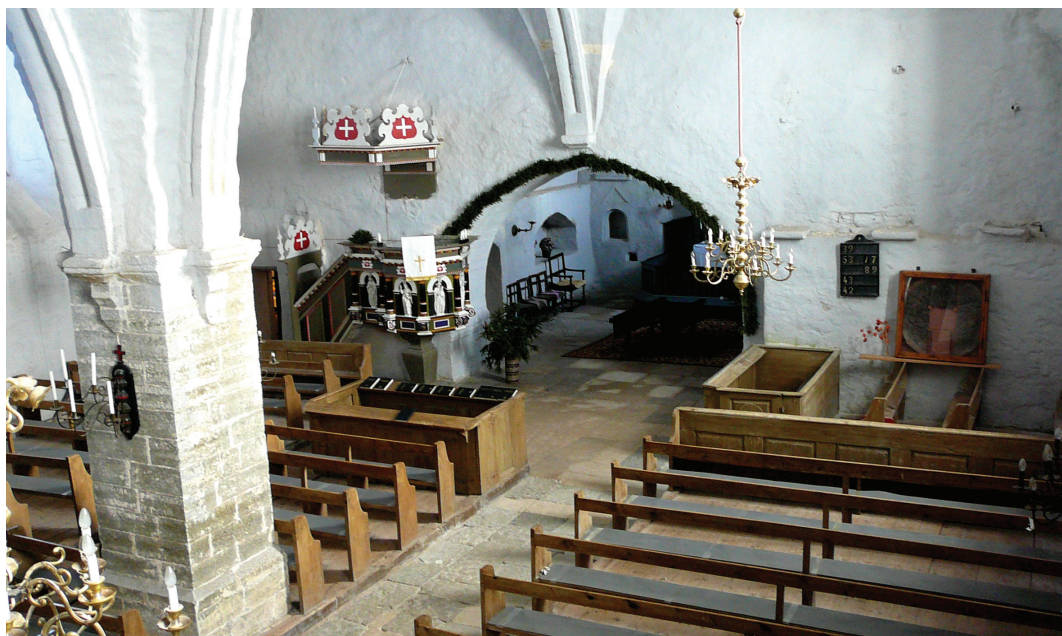
Fig. 5. Interior of the nave. View towards the chancel arch.

The pews of the nave (Fig. 5) have been fixed on three similar wooden platforms, leaving two uneven limestone slab covered pathways running from the western portal to the chancel arch. The oldest parts of the pew systems are the underlay beams of the platforms.<sup>4</sup> The present pews originate from the 19th century together with the rotten floor boards, which existed until the present conservation works. There are mortises on top of the underlay beams, now mostly futile and filled, to which the ends of previous pews have once been attached. Thus obviously the underlay beams are carrying a secondary set of pews already. The underlay beams have a baroque edge profile on the pathway sides. The accurate interface between the pew platforms and the floor of limestone slabs under the pathways allows assuming that these were planned and built at the same time. In the eastern end of the northern aisle there was a larger area without pews covered with a limestone floor around the pulpit. In the corresponding area in the eastern end of the southern nave there was a separate pew-box isolated from the rest of the pews.

Pikihoone pingistiku (jn 5) vanimaks osaks osutusid nende aluste puitplatvormide alustalad. Praeguste põrandalauade aluste talade peal avastati varasema pingistiku põsklaudade valdavalt täis plommitud tapipesad. Ühe, ilmselt 17. saj pingistiku põsklaua ülemine ots (jn 6) leiti põhjapoolse platvormi alt.

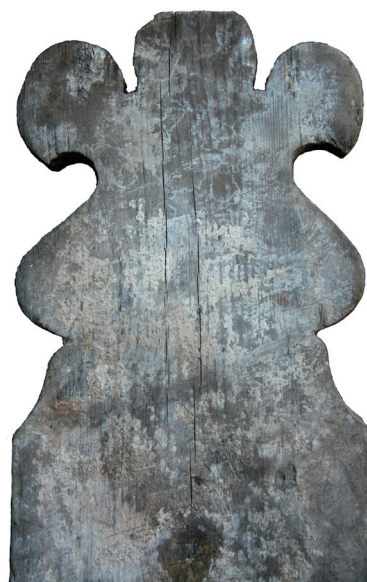
Fig. 6. The end of an old pew discovered from under the floor platform.

An end of an old pew, namely, its upper part, was discovered from lying under the northern platform (Fig. 6). Its top form, both technology and design, refer to the 17th century. Pew ends with somewhat similar decoration have been preserved in the Ruhnu older church with pews from the mid-17th century. Most probably the underlay beams of the pew platforms and the discovered pew end of Risti come from the church restoration activities of the period after 1622, when the areas of the former Padise monastery were bestowed to Thomas Ramm (Johansen 1933, 540).

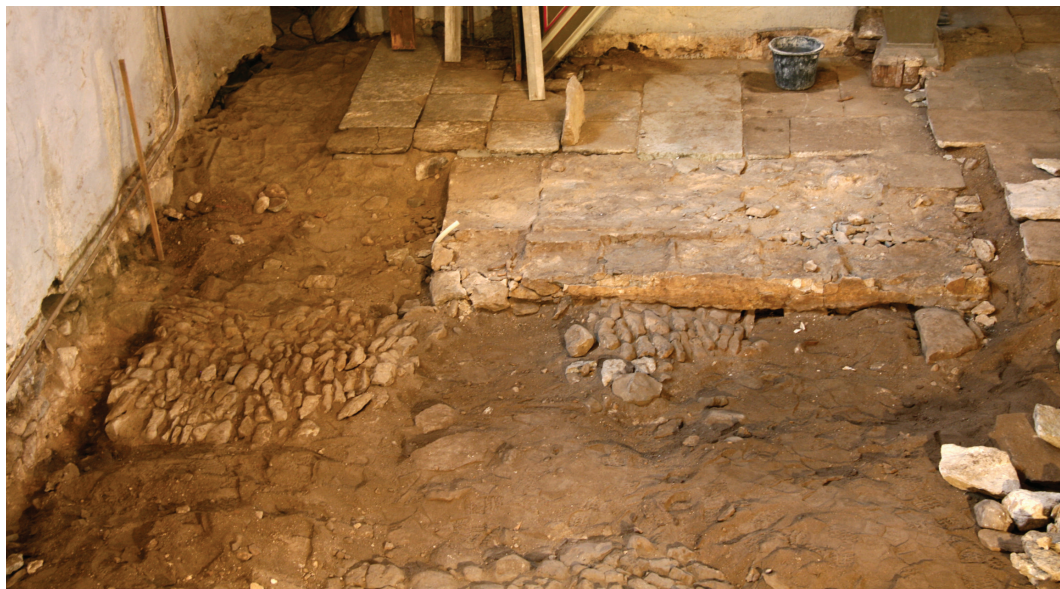
Fig. 7. Northern aisle. Remains of the medieval floor and the side altar.

The northern side altar (Figs 3, 7) has been a freestanding structure (distance from the eastern wall is *ca.* 100 cm and from the northern wall *ca.* 155 cm) with the main body of approximately 109 × 182 cm. Around it runs a step (39–46 cm wide) with a plastered outer surface and it is paved with rectangular limestone slabs. There are

only few slabs preserved, but by the imprints of the slabs in the mortar it can be said that the size of the slabs has varied. This step has been added later to the main body of the altar as it has been built on the floor of upright limestone and there is a layer of plaster between those two parts of the construction.

Pikihoone põranda restaureerimistöödel leiti pikihoone idaosast kõrvalaltarite jäänused. Põhjapoolne kõrvalaltar (kehand 109 × 182 cm) on rajatud seintest eemale (jn 7). Kehandi ümber kulgeb 39–46 cm laiune nelinurksete paeplaatidega kaetud aste, mille välispiind on krohvitud. Aste on altari põhiosale lisatud hiljem. Lõunapoolne kõrvalaltar (jn 9) on rajatud vastu pikihoone idaseina. Selle altari põhikehandi mõõtmed ulatuvad ligikaudu 147 × 182 cm ning algset kehandit on hiljem laiendatud. Esmalt ehitati altari põhikehandi läänepoolsele küljele 89 cm laiune lisandus. Tõenäoliselt samal ajal kui põhjalöövi altarile, lisati 50 cm laiune sillutatud aste ka lõunapoolsele kõrvalaltarile.

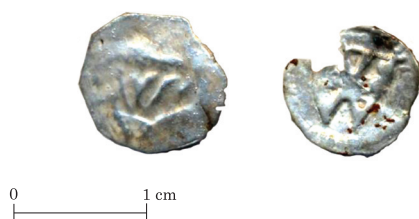
Fig. 8. The earliest coins from the debris between stone and timber floors.

The earliest coin found in Risti church was minted in Visby, Gotland, before 1260/70 (1288?), the latest belong to the 20th century. From the aspect of the studies of coin circula-

tion in Livonia the most interesting specimen is undoubtedly a W-bracteate (Fig. 8) from Gotland (1270/80–1361), which was most likely minted approximately in the middle of the 14th century (Lagerqvist 1970, Grupp XXXIV: A: 1c). Although Gotland coins, the influx of which to Livonia ceased after the renewal of local minting in 1260 (Leimus 2004a, 64; Kiudsoo & Tamla 2006, 278–279), reappear *en masse* in the composition of Estonian hoards of the third quarter of the 14th century (Kiudsoo 1999, table; Kiudsoo 2001, 69), these are already invariably gotes, the first nominals larger than a penny in the Nordic countries. No Gotland pennies of the 14th century had been previously found in Estonia.

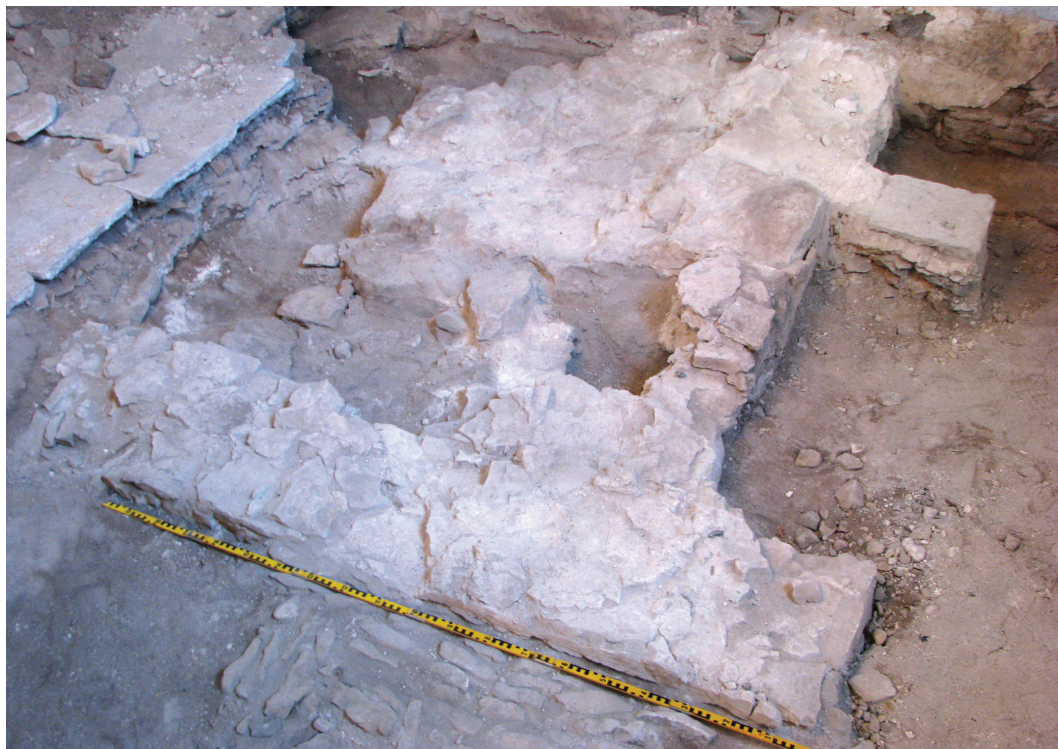
*Fig. 9. Southern aisle. Remains of the medieval side altar. View from the south-west.*

The southern side altar (Figs 3, 9) differs considerably from its northern counterpart. It has been built next to the eastern wall (distance from the southern wall is *ca.* 164 cm). It is significantly bigger than the northern side altar with the main body of approximately  $147 \times 182$  cm. The southern side altar has two additions to its original structure. At first a construction (*ca.* 89 cm wide) was added to the main body of the altar. The function of this addition is not clear. It could have been a rebuilding of an existing altar or adding a platform to the front of the altar. Probably at the same time as to the northern altar the paved step around the whole construction was added to the southern altar as well. Similarly the step has been built on the floor of upright limestone and the limestone slabs used to pave the step have the same character as the ones found in the northern side. The step has been about 50 cm wide. This addition enlarged the side altar to the extent that it protruded to the opening of the chancel arch.

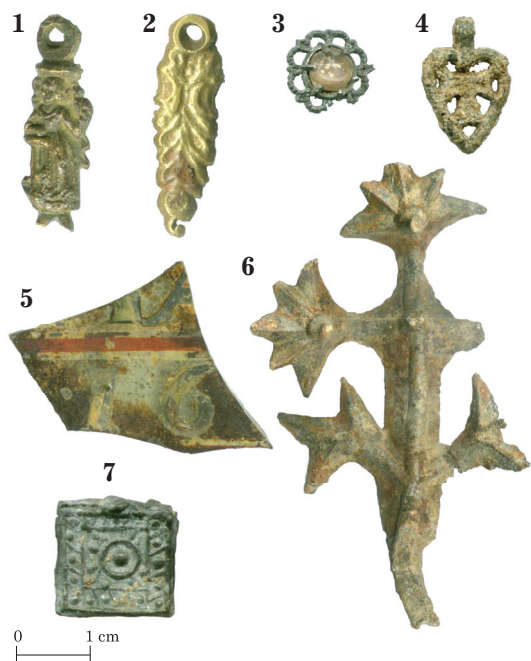
Fig. 10. Samples of artefacts from the debris between stone and timber floors.

The fieldwork brought to light dozens of small metal artefacts and their fragments, some bone artefacts, as well as pieces of window glass (Fig. 10: 5), glass beads, fragments of limestone masonry etc. The find material needs further research, but at first glance it was possible to say that it contains finds of all last six centuries. Among metal artefacts, probably things attached to clothing and jewellery dominate: lead and bronze belt buckles, belt mounts and ends (Fig. 10: 7), various decorative pins, small pins, a small bell, chain pieces, a bronze spiral, various buttons, hooks, heel irons, simple rings and various pendants. A lead jug, a possible pilgrimage badge of lead with St Anthony's cross (Fig. 10: 4), decorated bronze book clasps (Fig. 10: 1, 2), decorative copper nails and innumerable coffin nails should be mentioned among other things.
