## **RECENT STUDIES IN KURESSAARE BISHOP'S CASTLE**

**GAREL PÜÜA**

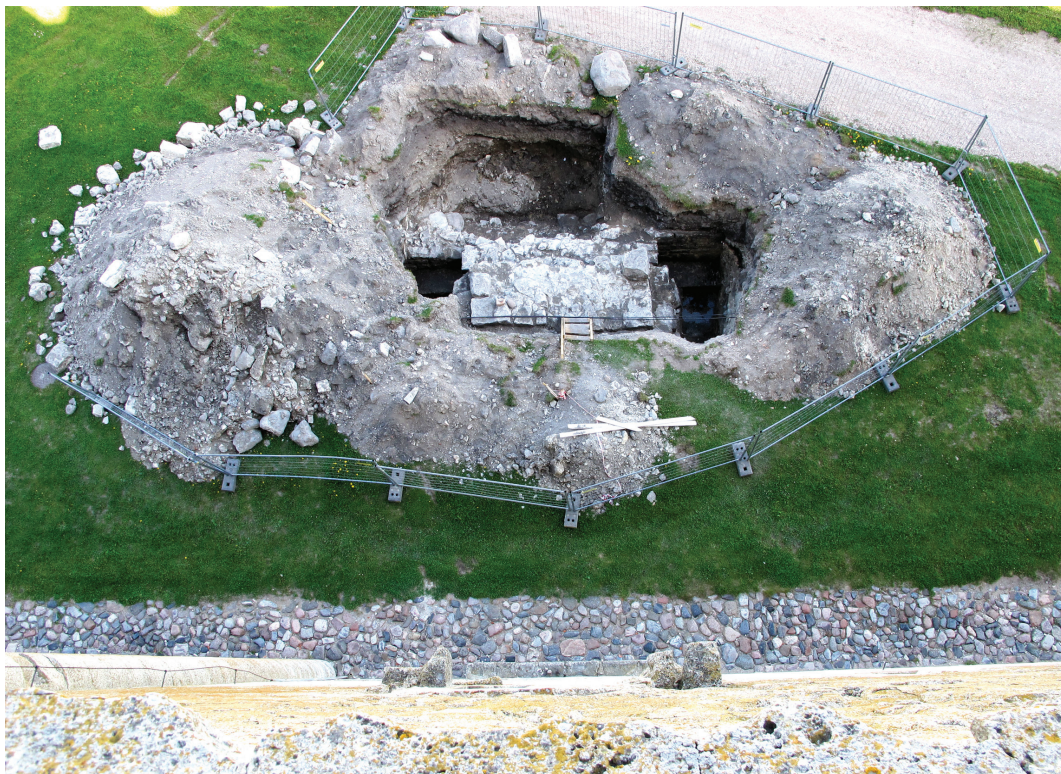
Fig. 4. Support for drawbridge built in the first surrounding wall on the south-eastern side of the convent house (excavation III). Below left the tower of Tall Herman can be seen. Below in the middle the other support of the bridge, built together with the convent house, salient from its wall.

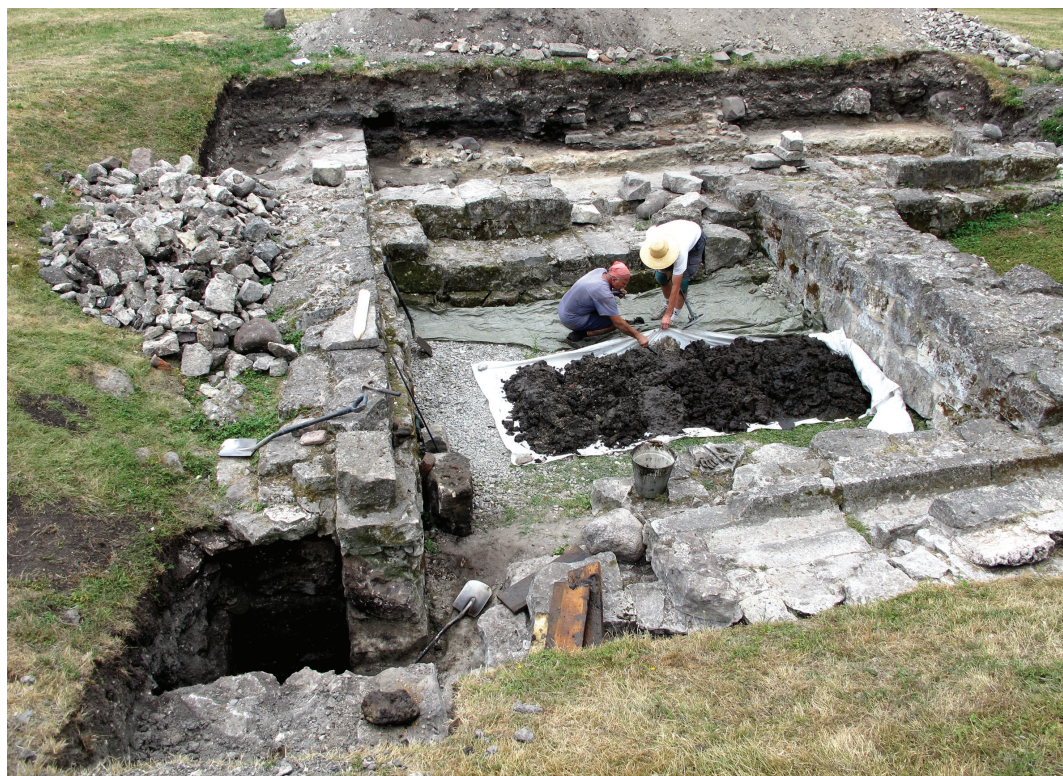
Fig. 5. Clearing of the medieval latrine chute (left) built inside the first surrounding wall (excavation XIV). On the right foundations of rooms of the first bailey and the dolomite gutter, which took sewage from the outer bailey through the latrine into the moat, can be seen.

against the south-eastern side of the surrounding wall. The gutter probably took rainwater from the first outer bailey courtyard into the rectangular chute (80 × 145 cm) discovered in 2011 and built within the first curtain wall (Fig. 5). The bottom part of the chute was connected with the first moat by a short vaulted channel. Since the gutter had been built within the house, it is quite probable, that also a multi-seat lavatory had been positioned above it. The oldest finds recovered from the bottom of chute date from the second half of the 14th century and the beginning of the 15th century. While clearing the chute a supporting beam from the time of construction of the first curtain wall was discovered. The dendrochronological investigation performed at Tartu University established that the pine had been felled in 1352.<sup>2</sup> Therefore most likely the construction of the first curtain wall began simultaneously with the convent house, only after the St George's Night Uprising (1343), when the Livonian Order started to build the Maasilinn castle on eastern Saaremaa for the centre of the bailiwick.

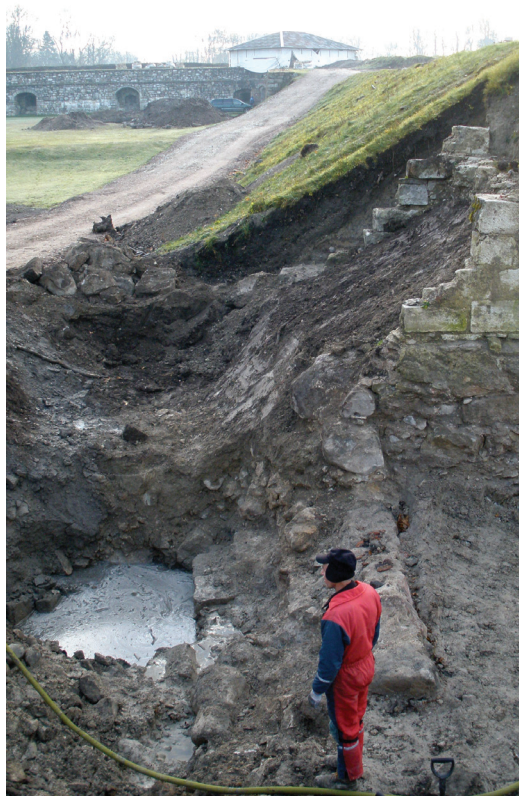
Fig. 7. Second surrounding wall, built on top of the counterscarp, together with the south-western tower annexed to it (excavation I). Left of the wall lies the I moat. In the background the Gunpowder Tower can be seen. View from north-west.

On the seaward side of the second defence wall a small south-western tower was discovered (Fig. 1, excavation I). The existence of this tower was hitherto unknown. The measurements of the south-western tower discovered in the south-western early modern curtain rampart are approximately 2.7 (salience from the curtain wall) × 6 m. The thickness of the wall of the tower, built from dolomite blocks on the outside, is 99–107 cm and it rests upon the presumable foundation step of the curtain wall located on the south-western outer side of the first moat (Fig. 7). The tower is secondary to the curtain wall and there are no traces of loopholes in its preserved part. The overground part of the tower (with smoothly built walls), preserved to the height of 2.6 m in the south-eastern curtain, has a 160–180 cm high foundation beneath it (Fig. 8). The foundation built on two crossed beams and mainly on the soil, projects 12–22 cm from the walls of the tower on all sides. The dating of the south-western tower should be adjusted by the results of the analysis of the charcoal sample collected from the foundation. The potsherds found in the soil layer upon the mortar streak from the time of construction, observed at the step of the foundation of the tower, were dated to the 15th–16th centuries.

The curtain wall II discovered in the excavation I has served first as a counterscarp and later as a defence wall reaching above the bank, which is a unique solution among Estonian defence constructions. Against its outer side even a defence tower has been built, which definitely belongs to the period before raising the 17th century curtain rampart, i.e. to the Middle Ages. It is incomprehensible how it was possible to tend and supply such curtain wall and tower when the moat filled with water expanded to the wall from inside. Anyway, such solution could not endure the pressure of the soil of the early modern curtain rampart mounted against the outer side of the II curtain wall in the post-medieval period and a long section of it on the south-western side has fallen into the first moat, apparently in the mid-17th century. Its remains have been later buried in the early modern curtain rampart.

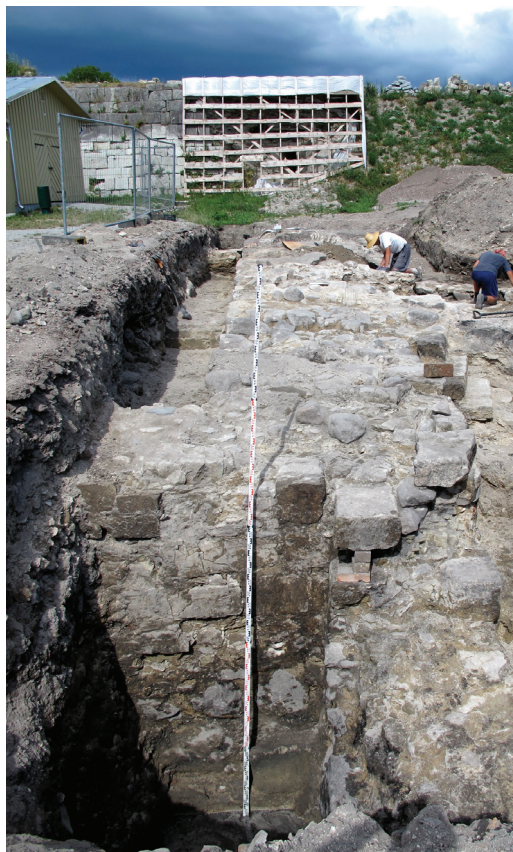
Fig. 8. The construction stage expanding the outer bailey towards north-east (town), starting from the eastern corner of the first moat (excavation XIII). In the 2nd half of the 15th c the surrounding wall was probably extended straight from the outer corner of the moat and the small eastern tower was built (under awning).

In excavation XIII dug in 2011 in the eastern outer corner of the first moat (Fig. 1: 9, excavation XIII) it appeared that simultaneously with building the counterscarp higher and elevating the yard ground the outer bailey has been expanded towards north-east, i.e. towards the present town of Kuressaare along the line of the south-

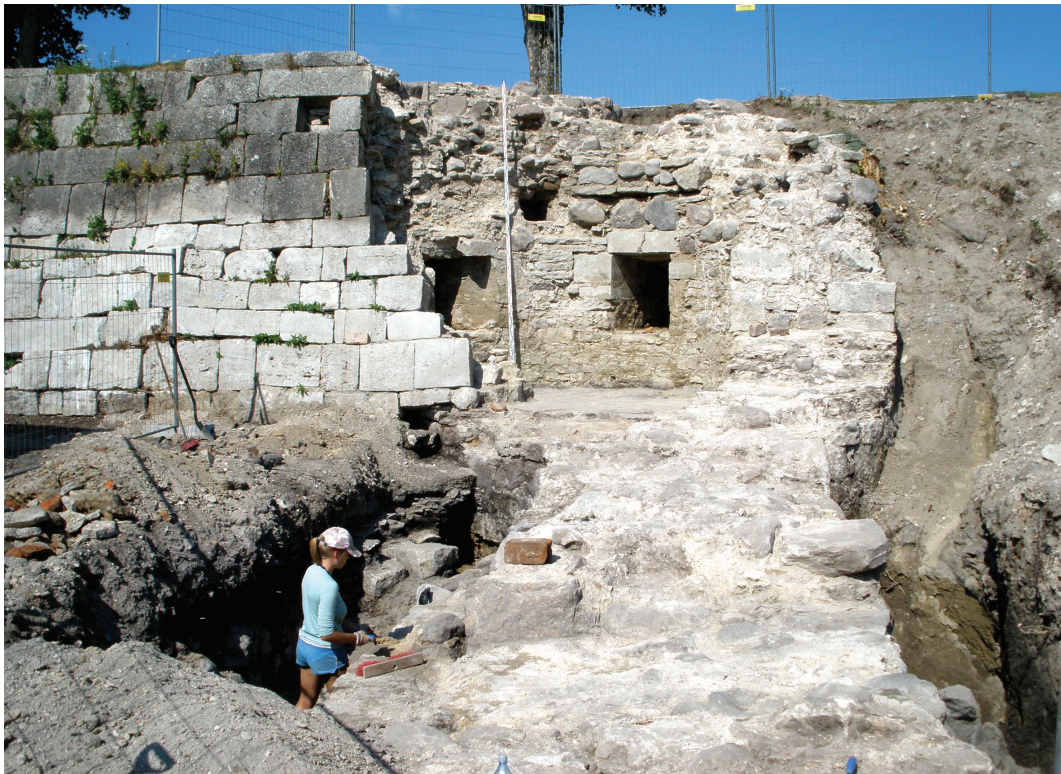
Fig. 9. View of the eastern tower cleared from the north-eastern curtain of the Kuressaare castle, and the surrounding wall demolished to the level of the courtyard ground (excavation II). On both sides of the perch loopholes can be seen, and above them a socket of a beam of an intermediate ceiling. View from south-west.

The ground plan of the corner tower, disclosed from the embankment of the north-eastern early modern curtain rampart resembles a three-fourth of a circle the outer perimeter of which has been formed by a circle with a diameter of 6.8 m (Figs 1, 9). The inner perimeter of the tower has been determined by a circle with a diameter of 3.7 m, shifted inwards from the centre of the outer perimeter by 25 cm. The thickness of the wall of the eastern tower is 168–181 cm and most likely it has been a two-storied (both defence floors) flanking tower, open on the castle side. Lime mortar has been used at the building, and rows of granite stones of irregular shape alternate with levelling layers of limestone. The tower has been built integral with the II curtain wall.

The eastern tower has been founded upon limestone rubble at an absolute altitude of about 0.5 m and it is preserved to the height of about 9 m. In the north-western side of the tower a narrow vertical loophole is preserved of the mostly collapsed upper floor. Its mouth, with the original width of about 17 cm, has been widened later by chopping

off the sides of the aperture (width 45 cm). Apparently the tower has had three loopholes on the upper floor, likewise on the lower, well preserved defence floor. On the lower floor two similar loopholes were cleared. These were roughly plastered on the inside, like the whole tower inside and outside. The loopholes have been finished with a lintel and flanks of dolomite. The ends of each loophole (20 × 80 cm) have been walled up later. Of the third, south-eastern loophole of the lower floor only one side was preserved. Since a beam, meant to support a gun had been walled into a side of one of the loopholes already during the construction of the tower, it seems that the tower was built during the period of transition to firearms.

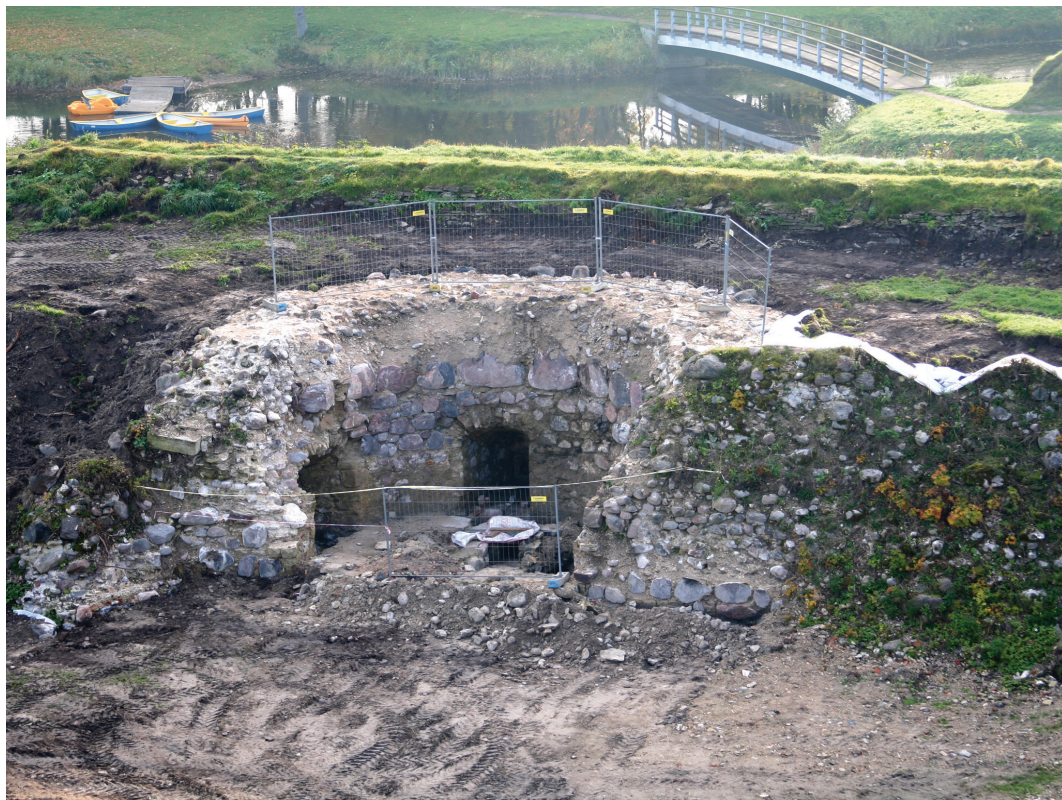
Fig. 10. View of the south-east tower with 3.4 m thick walls, preserved in the south-eastern curtain (excavation III) from the wall-walk of the convent house of Kuressaare. In the background the second moat and south-east ravelin.

The Cannon Tower at the northern corner and the Gunpowder Tower at the southern corner of the third curtain wall have been restored now, but the south-eastern tower was only briefly investigated in 1972 (Fig. 2). This tower, disclosed from the south-eastern early modern curtain rampart in the course of current investigations and conservation, has also a ground plan of nearly three-quarters of a circle, with the outer side shaped by a circle with a diameter of 13 m (Figs 1, 10). The inner perimeter of the tower has been determined by a circle with a diameter of 6.3 m, shifted inwards from the centre of the outer perimeter by 10 cm. The south-eastern tower was evidently a flanking tower with two defence storeys, open on the castle side. The thickness of its wall was 337–350 cm and it was built mainly from granite stones of varying size. In levelling layers smaller granite stones as well as limestone pieces have been used.

The outer surface of the tower had survived in the south-eastern early modern curtain rampart immediately beneath the sod layer (absolute altitude 8.6 m), but the upper 110–130 cm high part of the inner surface (above the line of large granite stones) have been evidently repaired later with abundant lime mortar and stone rubble (Fig. 10). The interior of the tower has been sooted and stones damaged by fire. In the upper part of the south-eastern tower no traces of loopholes, intermediate ceiling or its supporting constructions could be discovered.

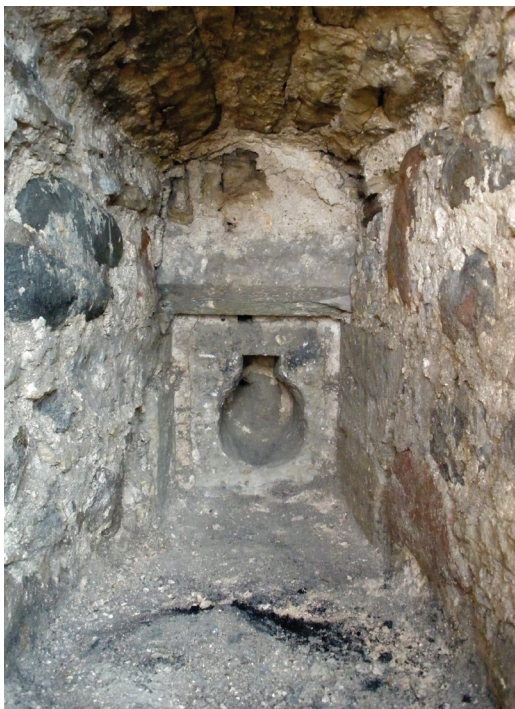
Fig. 11. The three preserved gun ports of the ground floor of the south-east tower were of the key-hole shape, with diameters of 26–31 cm.

On the ground floor of the south-eastern tower three vertical narrow loopholes can be observed, with varying width (115–196 cm). All loopholes (height 180–207 cm) are topped with an arch and plastered on the inside, like the whole tower. The mouths of the loopholes have been finished with hewn limestone slabs in the shape of keyholes (diameter 26–31 cm, Fig. 11). In the lower part of each loophole a horizontal beam has been walled as a support for a harquebuse, and the sides have been finished with large and quite neatly hewn dolomite blocks.
