ADDITIONS TO THE EARLY CONSTRUCTION HISTORY OF THE KURESSAARE BISHOP'S CASTLE

GAREL PÜÜA and GUIDO TOOS

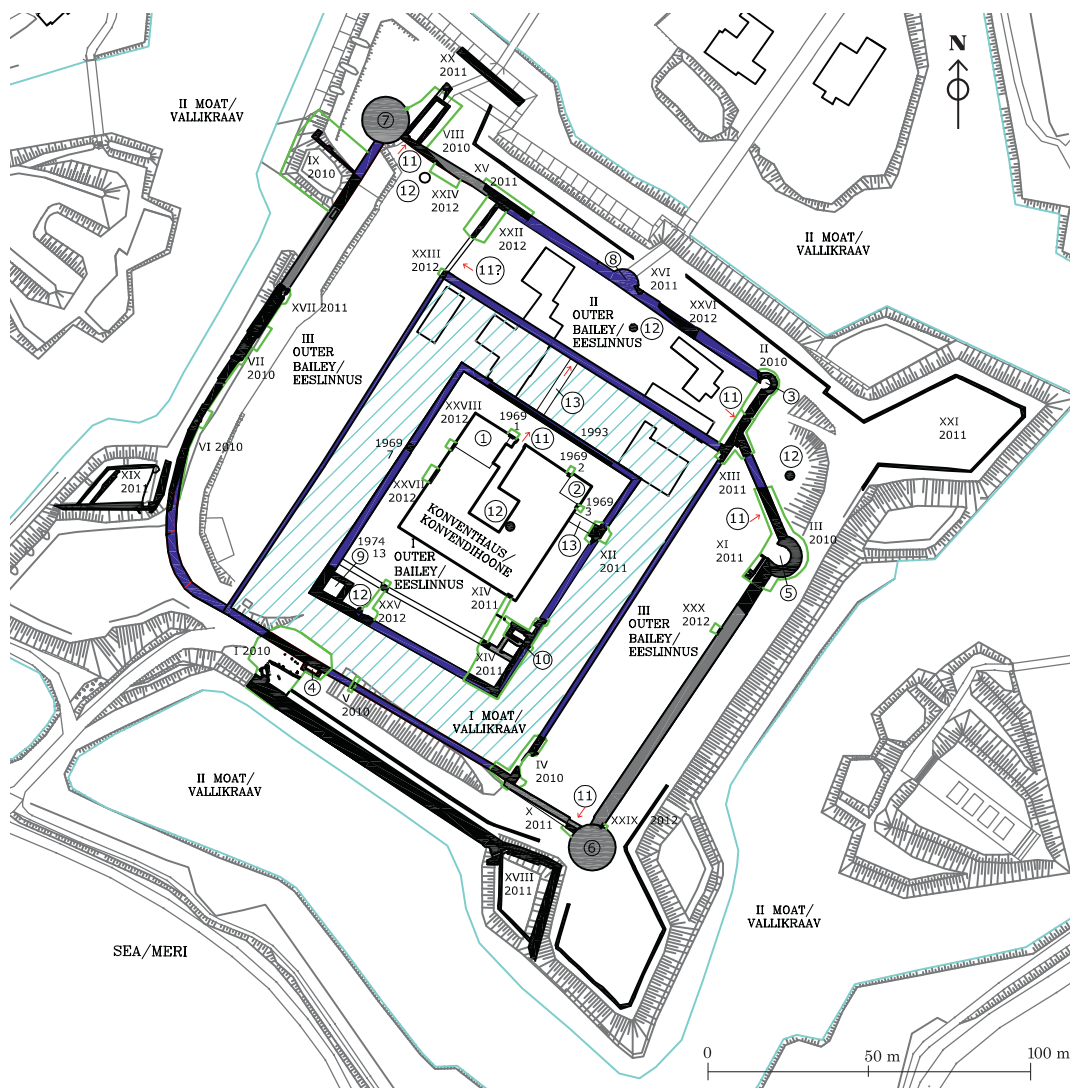
Fig. 1. Towers and walls. Excavations of 2010–2012 (I–XXX). 1 – tower Sturvolt (14A), 2 – tower Tall Hermann (14B), 3 – eastern tower (15b), 4 – south-western tower (15b), 5 – south-eastern tower (Piper tower; 15B), 6 – Gunpowder (Kuther) tower (15d), 7 – Cannon (Fortenau, Forsnau) tower (15d), 8 – tower Kakelborch (Kakelburg; 15b), 9 – Wolff's (Wulff's) tower (14B), 10 – latrine chute built inside the I curtain wall (14B), 11 – gates, 12 – wells, 13 – bridges.

Excavation XXVIII in 2012 disclosed the junction of the western corner of Sturvolt and the side wall of the *Konventhaus* (Fig. 1). It revised and enlarged pit 5 dug by K. Aluve in 1969 (see Püüa *et al.* 2012, fig. 2, excavation 1970, 5) and therefore the soil layers were mostly mixed. In the excavation it appeared that the point chosen for the defence tower was most appropriate regarding natural conditions: Sturvolt has been founded on solid limestone bedrock rising 1.7 m above sea level, i.e. even higher than the coastal ridge discovered in other excavations. The placement of stones beneath the western corner of the tower suggests that Sturvolt has not been designed as a separate tower and the foundation continues towards south-west.³

In 2012 the presumable vertical joint between the room south-west of Sturvolt and the wall of the later *Konventhaus* was disclosed in an excavation measuring 3 × 6 m (Fig. 1, excavation XXVII). In the bottom zone different construction stages could not be observed and the foundation continues towards the sea as a homogenous stonework (see Fig. 3). This leads us to the conclusion that the original plan of the castle included,

important role. It disclosed the foundation of the *Konventhaus*, and in a long trench (up to the first surrounding wall of the I outer bailey) revealed a complete cross-section of soil layers at the seaward side of the I outer bailey, and the partly preserved buildings there (Fig. 1, excavation XIV).

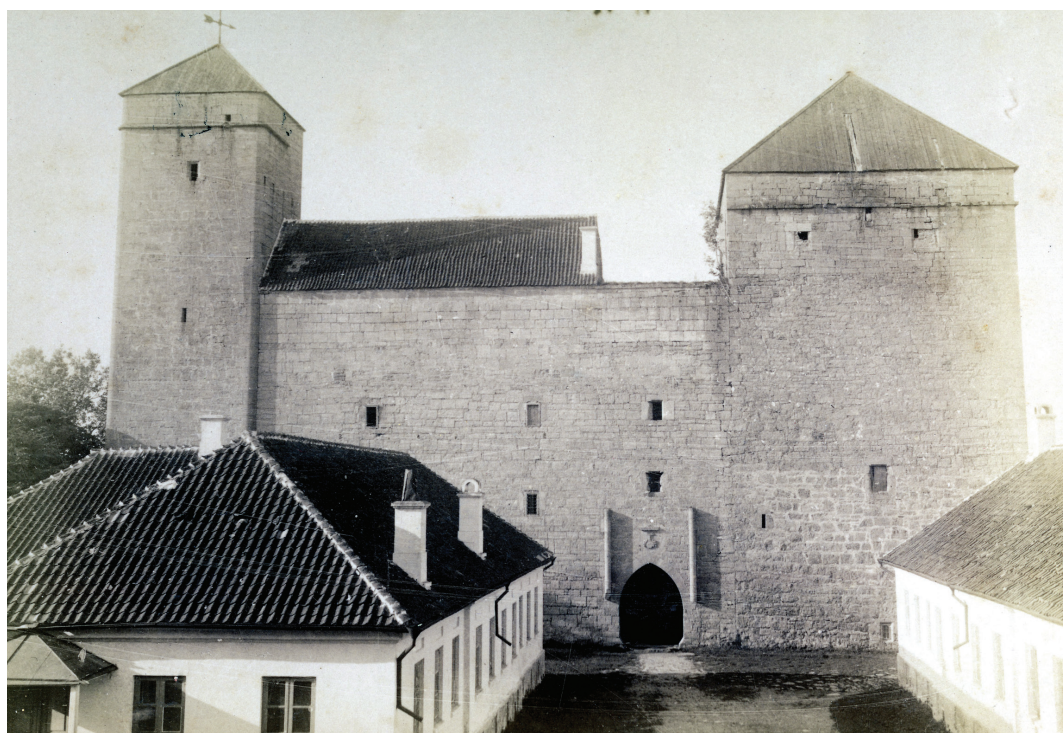
Fig. 2. The Kuressaare Konventhaus in the last quarter of the 19th century, view from the north-east. On the left, the tower of Tall Hermann, on the right, the massive Sturvolt. Binding stones, left during the building of Sturvolt, can be observed quite clearly. On the left in front of the Konventhaus is the officers' building, which was demolished in 1910. On the right the officers' dwelling house, preserved to the present day, can be seen. Today it houses the office rooms of the Saaremaa Museum.

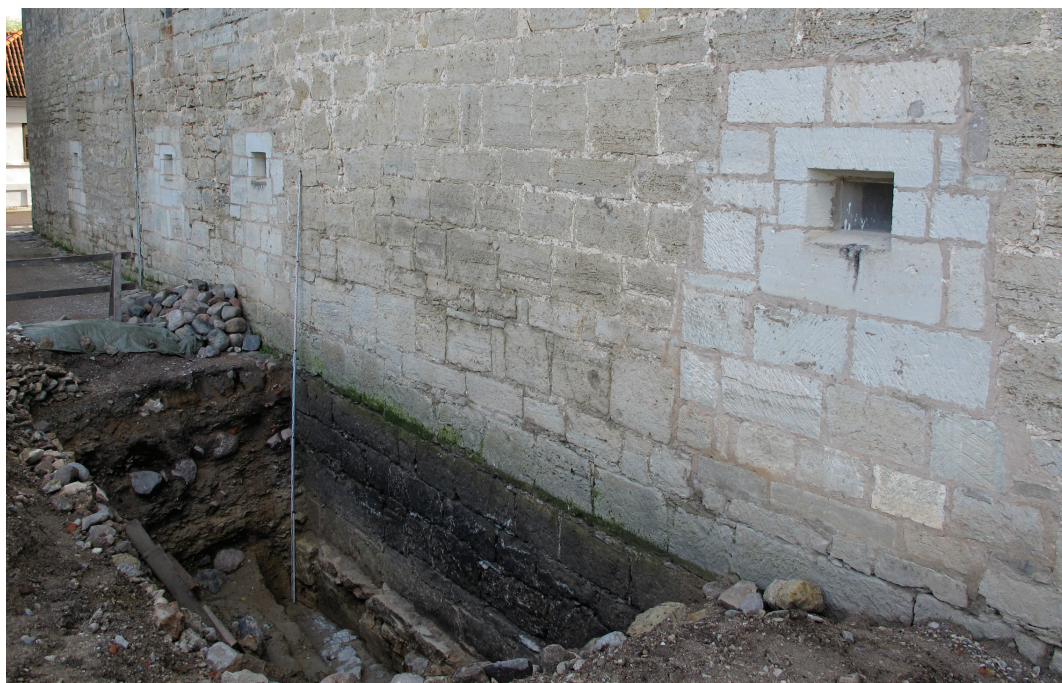
Fig. 3. Excavation XXVII at the junction between the room south-west of Sturvolt and the later north-western wall of the *Konventhaus*. In the foundation zone uniform stonework without visible building stages can be seen. View from the west.

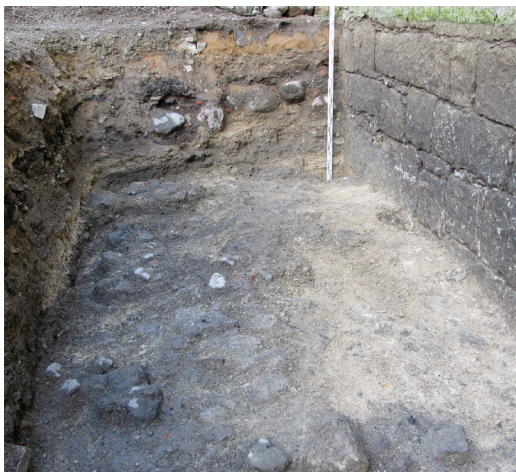
Fig. 4. The medieval road, partly preserved in excavation XXVII at the north-western side of the main castle, straight upon the mortar layer from the period of the construction of the *Konventhaus*.

The medieval cultural layer in excavation XXVII was 1.15–1.3 m below the present-day ground level, and had emerged immediately upon the mortar layer from the times of the construction of the *Konventhaus*. Although clear remains of pavement laid upon sand or clay base could not be detected in the excavation, the north-western stonier part of the layer apparently once formed a road pavement (see Fig. 4). Deciding by the finds the ground remained at the same altitude from the beginning of the 15th up to the 17th century, and only later it has been elevated to the present level by mixed rubble and demolition debris fillers. The earliest well identified artefacts from the occupation layer upon the mortar from the construction of the *Konventhaus* are two coins, *lībische*, of the Livonian Order minted in Tallinn, which date from the period 1395–1420.⁴ Relying upon the finds we may assume that by that time construction had been completed at least on the outer perimeter of the *Konventhaus*. It is also unlikely that the coins fell into the ground much later, since in connection with the monetary

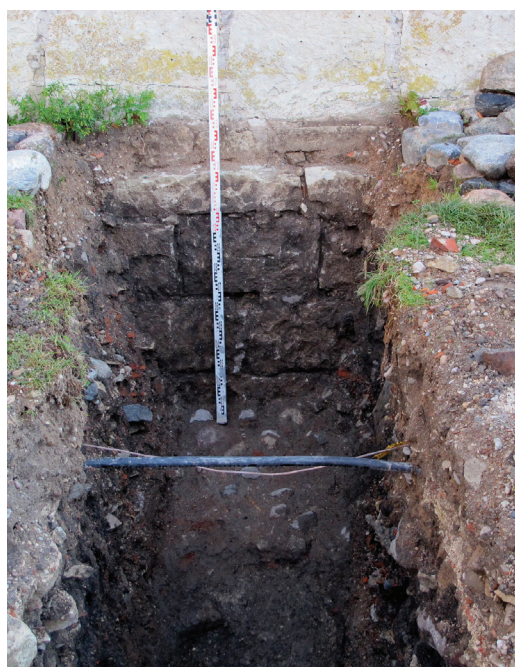
Fig. 5. Two different wall textures discovered at the south-western side of the main castle (excavation XIV). On the right, the transition on the southern corner of the *Konventhaus* from the quadrate corner of the lower part to the rounded one in the upper part can be seen. The ground under the measuring rod remained on the same level still in the 17th century. Jn 5. *Pealinnuse edelaküljel (kaevandis XIV) paljastunud kaks erinevat müüri faktuuri. Paremäl on näha konvendihoone lõunanurga üleminekut kvadraatselt alaehitiselt ümardatud nurgaga seinäosaale. Mõõtelati alla jääv maapind püsis samal kõrgusel veel 17. sajandil.*

In excavation XIV two different wall textures of the *Konventhaus* were clearly discernible. In the lower part, virtually up to the present-day ground level (1.25–4.08 m above sea level) the stonework is regular, but only roughly worked stones have been used. Above that level (at the same height the quadrate corners of the *Konventhaus* at the foot of the wall change into rounded ones) hewn blocks are used. Finds from the pavement-like rubble (at the altitude of 2.6–2.87 m) indicate that the medieval yard surface has remained on approximately the same level until the 17th century (Fig. 5). Hence the lower part of the wall from unhewn limestone was not originally a foundation hidden in soil, but rather a kind of a footing, visible to the height of about 140 cm. Transition from one material to the other is immediate (no base ledge or moulding). Therefore it does not seem likely that the contrasting of the textures was deliberate in erecting the *Konventhaus*. It is more likely that the lower part of the wall dates from an earlier period, it may have been part of the surrounding wall of the *castellum*. And so the outer wall of the *Konventhaus* seems to be following the *castellum* wall also on the south-western side.

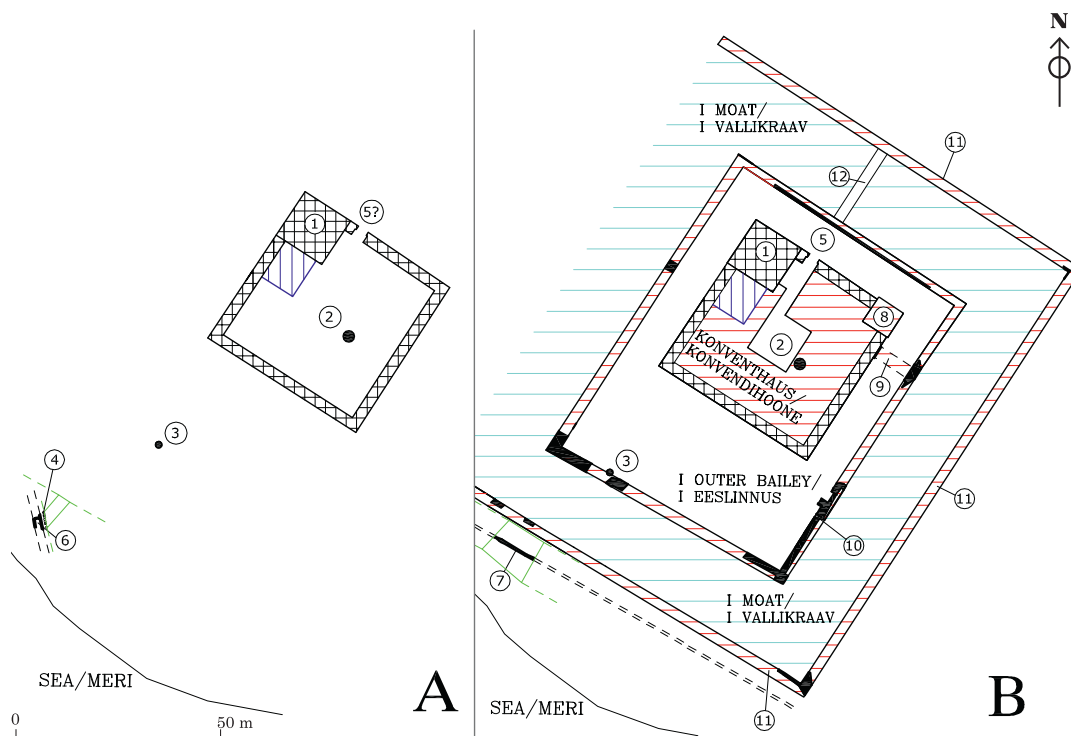
A. Curtain wall of the castellum, Sturvolt tower (1) and small building next to it, before 1343 AD.

B. Four ranges of the Konventhouse with tower Tall Hermann (8) and first curtain wall with bridge (ca. 1346–1400 AD). Moat and counterscarp (11) on three sides of it (work started probably at the end of the 14th century).

Fig. 6. Kuressaare bishop's castle. Development concept A and B. 2, 3 – wells, 4 – row of stakes (ca. 1276–1321 AD), 5 – gates, 6 – timber road on the beach (ca. 1264–1301 AD), 7 – log palisade, 9, 12 – bridges, 10 – latrine chute inside the I curtain wall (ca. 1353 AD).

Summarizing the obtained information we may assert that in Kuressaare a *Ringmauerkastell* (Fig. 6, A), the outer dimensions of which coincided with the later *Konventhaus* (Fig. 6, B), was built first. At the same time it strikes the eye that the transitions of the stonework of the *castellum* and the *Konventhaus* are, in some places, quite random. This leads us to the conclusion that the *castellum* was never completed and at some moment its building was suddenly interrupted.

The oldest construction discovered on the territory of the Kuressaare castle in the course of the recent fieldwork appears to be the plank road (Fig. 6 A: 6) discovered in 2010 while digging a new car tunnel through the south-western early modern rampart curtain (Fig. 1, excavation 1). The road,⁸ preserved only in fragments and repeatedly damaged by the stormy sea (the planks had been replaced at least five times) ran along the shore towards the harbour. The ¹⁴C dating of the better preserved bottom beam of the plank road gave the result 705±25 BP (Table 1: 1). The age of the latest preserved road plank was dated to 610±30 BP (Table 1: 2), i.e. to the 14th century.

At the castle side of the road a row of poles rammed in the ground was discovered (Fig. 6 A, 4), the analysis of a sample taken gave the result 665±30 BP (Table 1: 3). The pole row, evidently intended to serve as a fence, precisely followed the direction of the road, and so did the sloping clay embankment, up to a metre high, starting at the same line (see Fig. 6 A). It is likely that with strong southerly winds the sea rose quite high and it was necessary to shelter the construction site from overflow.⁹ The plank fragment found from the clay embankment was dated by ¹⁴C method to 560±30 BP (Table 1: 4). The plank road and the pole row, as well as the original clay embankment have existed together during some period. Here, secondary use may be possible at the bottom beam, but at plank fragments and poles it does not seem likely. Equally, the analyses also allow us to date most of the mentioned constructions, with quite a high probability, to the end of the 14th century or even to the beginning of the 15th century, but the following construction activities seem to exclude the possibility. That is to say, after the end of the exploitation of the plank road a new higher embankment has been piled upon it (and also upon the earlier embankment), and on that a log palisade has been built (see Püüa *et al.* 2012, 104). The ¹⁴C analysis of a sample taken from a preserved timber construction of the palisade gave the result 620±50 BP (Table 1: 5). The reconditioned palisade on the embankment, meanwhile piled still higher, persisted until the construction of the seaward side of the great surrounding wall and the south-western tower (see Fig. 1).

Returning to the construction phase of the main castle before the *Konventhaus*, the two known wells may also be connected with this period. The first well (Fig. 6, 2) is in the well room at the south-eastern side of the inner court of the present *Konventhaus*; the choice of the site seems quite inconvenient for use. Therefore it is possible that the well was related already with the *castellum*, since it frequently happened that earlier effective resolutions were exploited. The other well (Fig. 6, 3) is located in the western corner of the I outer bailey, and partly inside the surrounding wall. The well was discovered by Kalvi Aluve in his south-west – north-east oriented trench dug in 1969 (see Püüa *et al.* 2012, fig. 2, excavation 1970, 6), but it is not marked on the earliest known historical plans dating from the mid-17th century.
