ARCHAEOLOGICAL INVESTIGATIONS IN THE INNER COURTYARD OF THE PUPPET THEATRE ‘NUKU’

EERO HEINLOO

In the summer and autumn of 2013 archaeological studies were conducted in the inner courtyard of a puppet theatre ‘NUKU’ with the aim to specify the existence and nature of possible construction remains and the character of cultural layers. The study concluded that more than half of the excavated area (total area *ca.* 350 m²) consisted of construction remains of various periods (walls, vaulted cellars, limestone floors) that the National Heritage Board and the Advisory Panel of Archaeological Monuments suggested to preserve. This decision made it possible to study the virgin cultural layer below the floors of the Early Modern and Modern Times constructions in the main pit with the area of 120 m² and two smaller pits with areas of 15 m² and 5 m², covering the total area of *ca.* 140 m² (Fig. 1). The archaeological studies in the inner courtyard of the NUKU Theatre were directed by archaeologists Peeter Piirits and Eero Heinloo from MTÜ AEG (Heinloo & Piirits 2014).

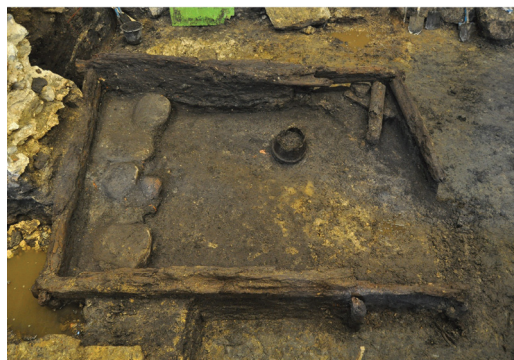
Fig. 4. Timber building deepened into the ground and a cask with no bottom side under the floor.

into the ground, was erected in the area (Fig. 3: III). This timber building had a dirt floor, with a wicker cask with no bottom side below it (Fig. 4), in order to reduce excess damp under the building. Above the floor a layer of dung and rotten wood contemporary to the use of the building had formed. A level surface made of field stones was in the north-western side of the building – a threshold to the building. The timber building, which according to the find material was used until the fourth quarter or end of the 14th century, was probably an auxiliary building, since no hearth that is necessary for a dwelling was discovered. No traces of a main building that would have belonged to the auxiliary building were found in the trenches; therefore it is possible that the main building is under the preserved stone constructions.

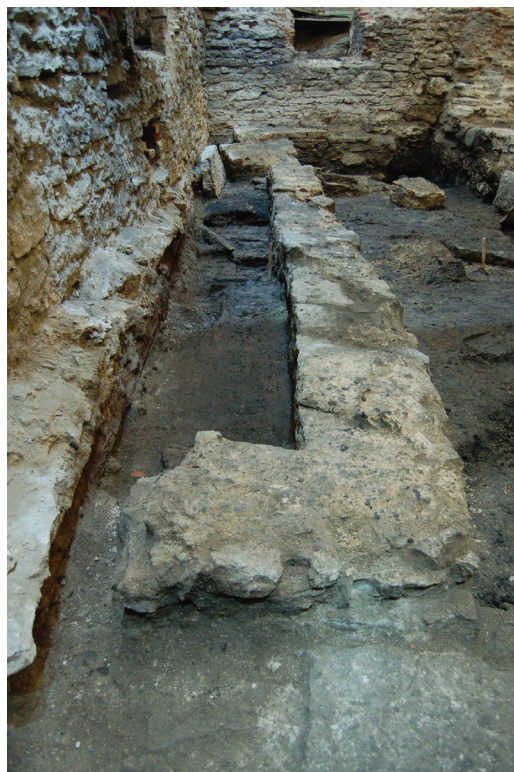
Fig. 5. Medieval stone building in the area of the main trench.

Puithoonestus on 14. saj IV veerandil / lõpus asendatud kivihoonestusega. Suure kaevandi alal avastati tagasihoidliku kivihoone müürid (jn 5). Hoonet on korduvalt ümber ehitatud. Hoone loodeossa jäi osaliselt maapinda süvendatud juurdeehitus, mille rajamise käigus lõhuti osaliselt põhihoone kirdemüür. Juurdeehitusele oli iseloomulik tellisest tasapind, mis oli pealt kaetud tahmajälgedega. Tellised olid laotud ristkülikukujulise paekiviplaadi peale, mille all omakorda asetses pealt paekivitükkidega kaetud renn (jn 6). Kuigi põlemisjälgedega tellisetasapind viitab ennekõike ahjule, ei seleta see renni olemasolu telliste ja paekiviplaadi all, mistõttu jääb konstruktsiooni olemus lahtiseks. Juurdeehitus oli omakorda lõhutatud L-kujulise massiivse paekivikonstruktsiooniga. Korduvalt ümber ehitatud kivihoone on lõplikult hävinud hiljemalt 17. saj alguses. Teise eeldatava keskaegse kivihoonega seostub paekividest šaht, mida kasutati käimlana. Leidudest saadi käimlast terviklikke puitsemeid, aga ka naha- ja tekstiilikatkeid. Šahti sisse jäi sisse vajunud ümarpalkidest ja laudadest põrand, mis tähistab käimla kasutusaja lõppu. Edasi täideti šahti segajäätmatega. Käimla kasutusaja algus jääb 14. saj lõppu / 15. saj algusesse ning šahti sekundaarne kasutus 15. saj keskpaika. Kahe kivihoone vahelisele alale jäid kümnekond püstposti, mis tähistavad omaaegset põimtara. Tara oli kasutusel keskaegsete kivihoonetega üheaegselt, paiknedes kruntide vahelisel piiril. Suure kaevandi keskossa jäi omakorda lõhandikest palkraketega kaev (jn 7), eeldatavasti joogiveekaev, mida võis võis veega varustada Nunne tänaval olev (oletatav) veetorustik. Veekaev oli kasutusel 15. sajandil. 15. sajandil kasutusel olnud veekaev täideti seejärel jäätmatega, mille hulgas oli ka mitmeid puitsemeid (sh nii meistri- kui omanikumärgiga kibu).

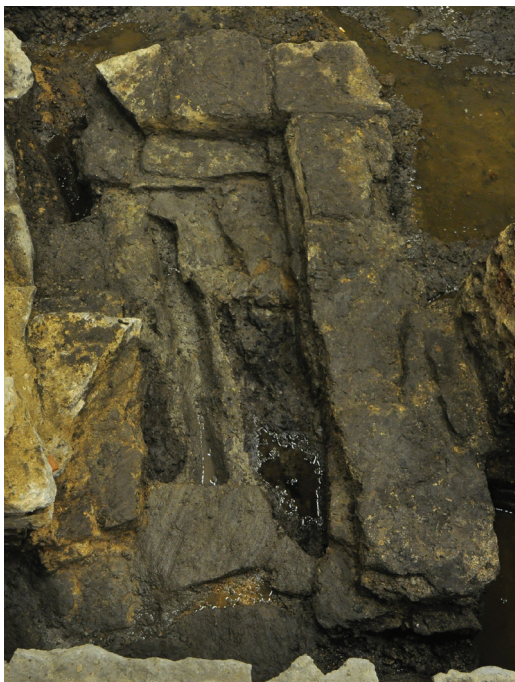
Fig. 6. Annex of the medieval stone building, with a V-shaped chute in the lower part, made of pieces of limestone and covered from above.

plain the gutter below the bricks and the limestone slab, which leaves the purpose of this construction uncertain. The annex itself had been destroyed by a massive L-shaped limestone construction, which had also taken into account the basic constructions of the medieval stone building. The repeatedly rebuilt stone house has been conclusively destroyed in the beginning of the 17th century at the latest.

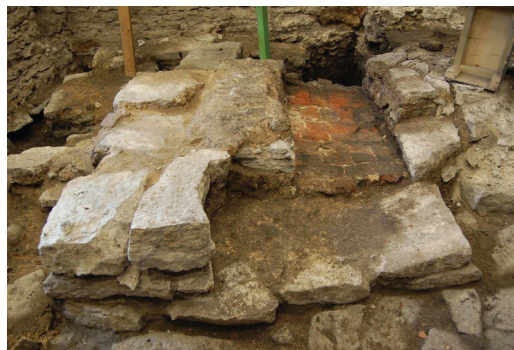
Fig. 10. Structure of the keris type stove in the Early Modern Times stone building.

Keskaegse hoone kohale rajati 17. saj alguses uus kivihoone. Kivihoonel eristus kaks eriaegset hooneosa (jn 8). Varasemal hooneosal eristati vähemalt kaks ruumi, mida teineteisest eraldas kitsas paekividest laotud vahesein. Vaheseina loodeküljel paiknes kerisahi (jn 10), millel eristus kokku kolm tellistest laotud

ahjupõhja. Ahjusuu jäi loodepoolsesse ruumi, selle ees tuvastati vähemalt neli üksteise peal asetsevat munakividest või tellistest laotud leosa. Kivihoone kaguküljel paiknes hilisem hooneosa, mille rajamine jäi 17. saj keskpaika / II poolde. Varauusaegsest kivihoonest mõnevõrra hilisemad on sisehoovi alal olevad (silinder)võlvidega keldriruumid, mis jäid uuritava ala põhja- ja edelaossa (vt jn 10). Varauusaegse eluhoonega seostus kaevandi kirdeervas avastatud ühe kivirea laiune kivivundament. Vundamenti olemust arvestades oli tegu maapinda süvendatud tagasihoidliku (puit)hoonega, mis oli kasutusel abi- või kõrvalhoonena. Kivivundamendiga võis seostuda ka temast vahetult kagu poole jäänud puidust kast. Puitkonstruktsioon jäi suuresti kaevandialast kirde poole ning mõnevõrra enam õnnestus seda uurida 2009. a arheoloogilise järelevalve ajal. Siis tuvastati, et kasti (mõõtmetega 280 × 290 cm) täitis sõnnikune kiht, mis ennekoike viitaks jäätmekastile. Varauusaegsest kivihoonest vahetult hoovi poole jäi korrapärase kujuga (u 2 × 2 m suurune) vooderdamata auk, mille puhul oli tegu välikäimla maapealsete (puit)konstruktsioonide alla jääva jäätmeauguga. Arvestades august saadud keraamikaleide, jäi jäätmeaugu kasutusaeg 17. saj I poolde.

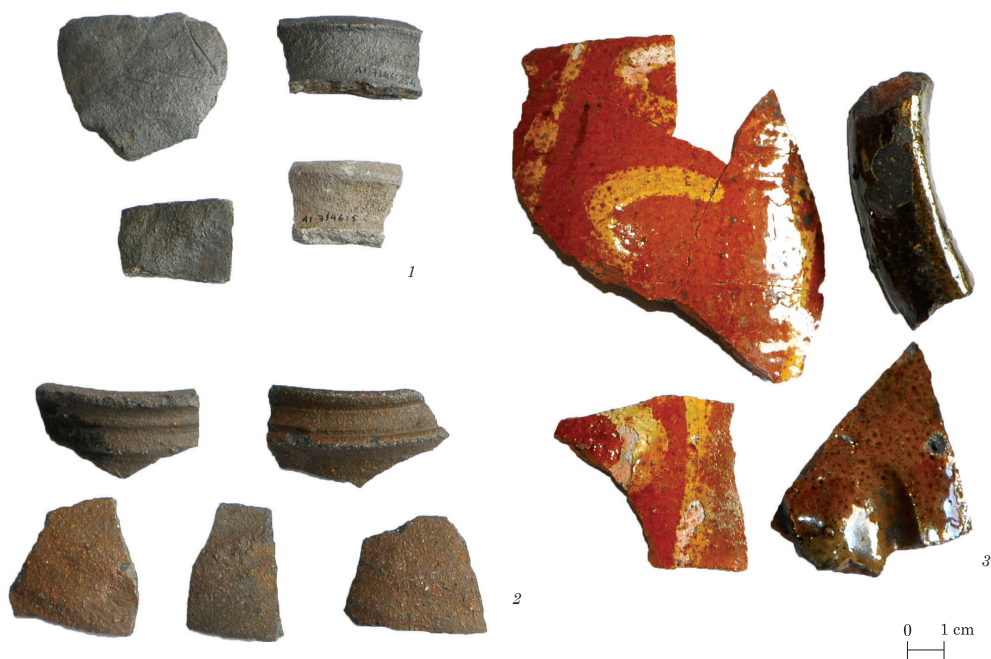
Fig. 12. Early imported ceramics. 1 – Paffrath-type ware, 2 – Siegburg proto-stoneware, 3 – early (ornamented) glazed redware.

Lower Saxony, Langerwehe early stoneware, early glazed redware), but also a significant amount of imported ceramics associated with the earliest medieval settlement (Paffrath-type ware, early stage of the Siegburg proto-stoneware, early (ornamented) glazed redware), which may most likely be dated to the second quarter of the 13th century (Fig. 12) (see Russow 2006). Ceramics included also a large number of fragments of stove tiles, which were unearthed from under the floor level of the Modern Times stone building at Nunne street. The tiles, covered with brown or dark glaze, wore baroque motifs (Fig. 13) and most probably date from the beginning of the 17th century.

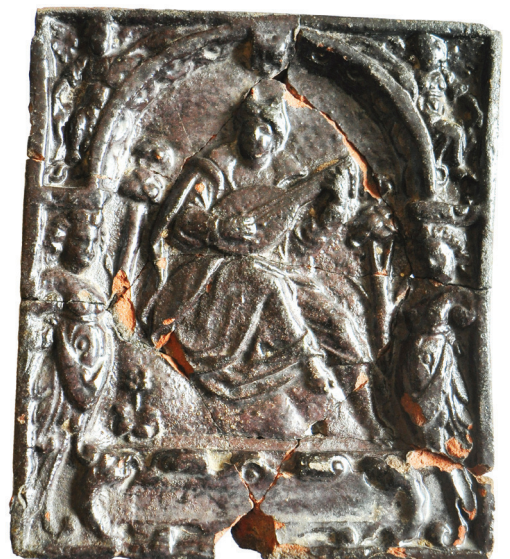
Fig. 13. Stove tile with baroque motifs.
 Jn 13. Baroksete motiividega ahjukahhel.
 (AI 7146: 1482.)
 Photo / Foto: Eero Heinloo

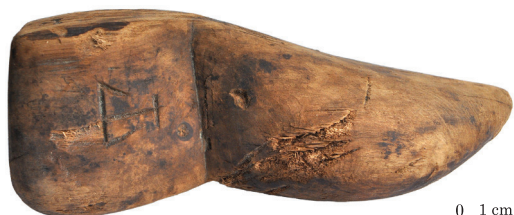
Fig. 14. Shoe last that bore the marks of both the craftsman and the owner.
 Jn 14. Meistri- ja omanikumärgiga jalatsiliist.
 (AI 7146: 1439.)
 Photo / Foto: Eero Heinloo

Other types of finds featured for example wooden items, since both the shaft that was used as a toilet and the timber well for drinking water contained whole finds, including e.g. dozens of small wooden stave dishes, a piggin, a shoe last (Fig. 14) and a bucket. An interesting find was a two-place toilet seat and an exceptional spinning top (Fig. 15) that is unique in the context of Estonian urban archaeology. Apart from wooden items also textile and leather objects were present, including several whole leather shoes and knife sheaths. The majority of leather finds was, however, residue material, which may refer to leather working in the area. Metal finds (mostly nails, a horseshoe, a spur, a knife, two crossbow arrowheads) and bone items (e.g. four bone combs) were more modest.
