ARCHAEOLOGICAL MONITORING AT MUNGA AND SEPA STREETS IN THE OLD TOWN OF VILJANDI

ANDRES TVAURI and KÄRT METSOJA

INTRODUCTION

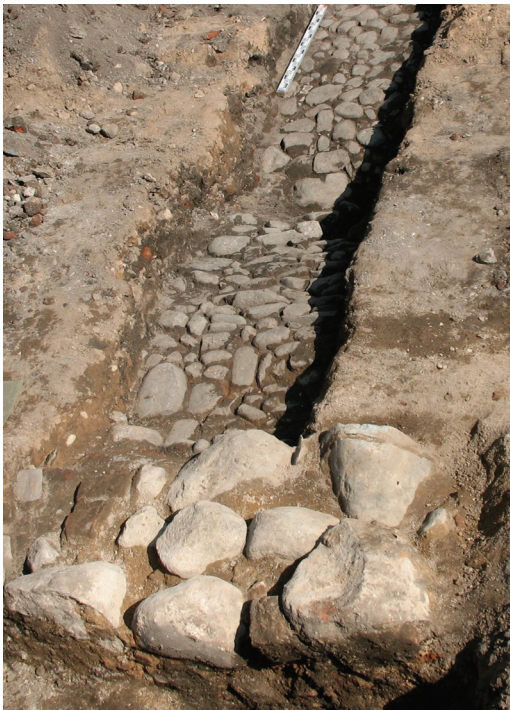
Fig. 3. Trench 2 at Sepa street. View from the west.
Jn 3. Vaade kaevandile 2 Sepa tänaval lääne poolt.
Photo / Foto: Andres Tvauri

Cobblestone pavement was also visible in the southern and middle part of Sepa street (Fig. 2). In trench 2 there were up to five layers of Devonian sand bedding of earlier pavements under the layer of preserved pavement stones. Thus, the cobbles of Sepa street have been removed, the surface refilled and flattened and the pavement restored at least four times. Trench 2 revealed that at least during the use of the last pavement layer there had been a drain running along the central axis of the street (Fig. 3).

Kogu Munga tänaval alal oli jälgitav punase liiva kihistus, mille peal oli enamasti säilinud muna-kivisillutus, mis on katnud Munga tänavat selle praeguses laiuses. Kihistus oli 10–50 cm paksune, koosnedes ühest kuni kolmest mullaga eraldatud liivakihist. Varasemate uuringute põhjal on teada, et see, linnamüüri piiratud Viljandi alal paljudes kohtades jälgitav sillutus pärineb keskajast. Sillutus oli alles ka Sepa tänaval lõuna- ja keskosas. Sepa tänaval kaevandis on sillutise all jälgitavad neli varasema sillutise liivapadjandit. Vähemalt kõige viimases sillutises on piki Sepa tänaval keskosas kulgenud sadeveerenn (jn 3).

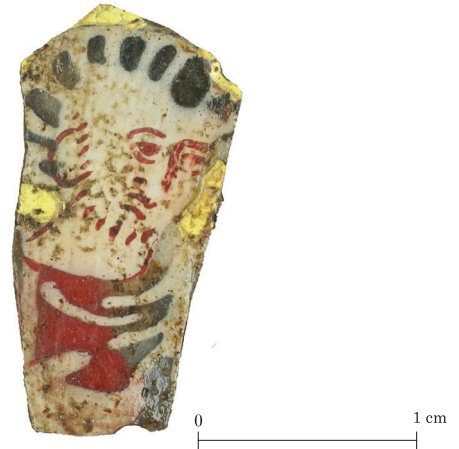
(VM 11458 A 561: 281.)

Fig. 4. Fragment of a medieval decorated glass beaker from trench 2 at Sepa street.

The red sand bedding layers below the pavement were empty of finds. In the filling layers between sand beddings a few sherds of stoneware and, from the fill layer underneath the sand bedding of the youngest pavement layer as a most remarkable artefact, a fragment of glass beaker decorated with polychrome paintings (Fig. 4) were found. In Estonia, the largest number of fragments of such beakers, manufactured probably in Venice in the 13th – 14th centuries, has been found in Tartu. A few fragments have also been found in the medieval town of Haapsalu, the suburban area of medieval Tallinn and in the castles of Viljandi and Otepää and the hill fort of Vooremäe at Pikasilla (Kull 2010). The fragment found at Sepa street was the first from the territory of the medieval town of Viljandi.

Sillutise alused liivakihid olid leiutühjad. Vaid sillutiseliiva vahelistest tätekihtidest leiti mõned kivikeraamiliste kannude killud. Tähelepanuväärseimaks leiuks on värvilise maalinguga klaaspeekri kild (jn 4), mis oletatavasti pärineb Veneetsias valmistatud nõust ning on esimene seda tüüpi leid Viljandi linnast. Sillutise pealne kiht sisaldas rohkesti leide 16. saj teisest poolest. Seega on sillutus mattunud kas Vene-Liivi sõja ajal pärast Viljandi vallutamist Moskoviitide poolt 1560. aastal või 17. saj alguses Rootsi-Poola sõdade käigus.

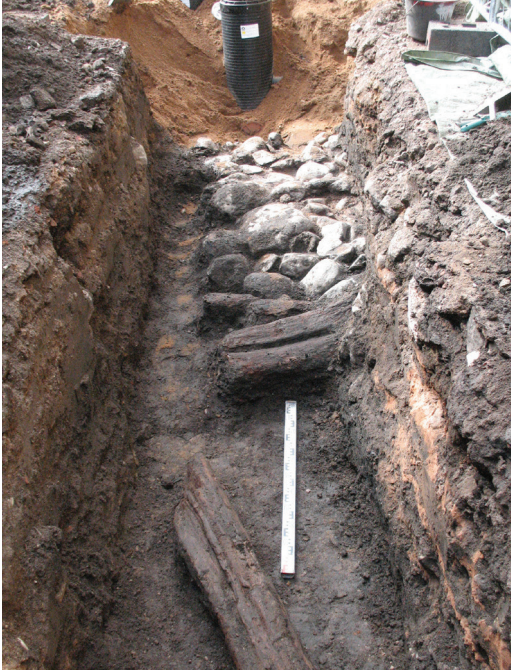
Fig. 5. Trench 1 at the western part of Munga street. View from the east.

The only stone construction unearthed at Munga street was a granite stone base of a stove and a row of stones (possibly a base for a wooden wall) connected to it, found in trench 1 (Fig. 5). Below the stove-base and construction attached to it, the aforementioned medieval occupation layer continued. The composition of the layer deposited on the natural ground and the stove-base and remains of logs within this layer demonstrate that at least before the middle of the 14th century there was no street or road on that area, but a courtyard and some building instead.

Munga tänaval paljastus tänavasillutise aluses keskaegses kihis palke ja maasse rammitud vaiu. Leitud palgid polnud omavahel tapiga seotud ega moodustanud konstruktsioone. Ainus kivikonstruktsioon oli Munga 4 hoone ees kaevandis avastatud maakividest ahjualus ja sellega seostatav kivirida (jn 5), mis võis olla osa puithoone vundamendist. Looduslikule aluspinnasele ladestunud kihi koostis ja selles leidud ahjualus ja palgijäänused näitavad, et enne 14. saj keskpaika ei olnud sellel kohal tänav või tee, vaid hooviala ja hooned.
