## ARCHAEOLOGICAL STUDIES IN THE CHURCH AND CHURCHYARD OF KOSE

### INTRODUCTION

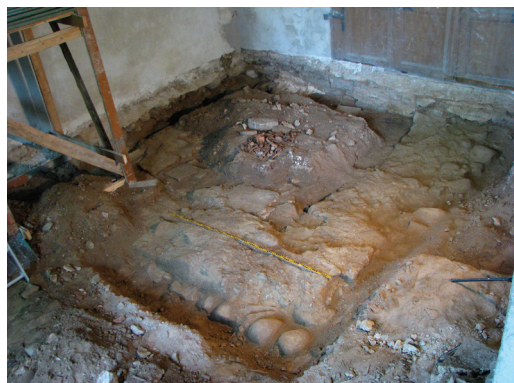
Fig. 2. The foundations of the old sacristy of Kose church from north-west.

In 2011 during the replacement of the floor of the 'New Church', filling layers of demolition debris together with some structures coming from the 'New Church' period were removed. In the south-eastern part of the 'New Church' the foundations of the western and northern walls of the medieval sacristy were discovered (Figs 1: 5; 2). The outer edge of the old walls of the old sacristy had preserved only in the height of an underground foundation of unworked irregularly laid fieldstones. The inner edge of the walls of the old sacristy had preserved only in the height of one row of stones above the original floor level. Therefore it was difficult to estimate the thickness of the walls of the old sacristy: only in one place the thickness of the northern wall could be measured ca. 100 cm. The eastern wall has obviously been located on the same line as the eastern wall of the 'New Church' and has been completely removed. Probably the outer measures of the sacristy were ca. 5.35 m in the east-west and ca. 4.15 m in the north-south direction, inside ca. 3.05 m and 3.15 m respectively.

As there was no vertical joint between the western foundation of the sacristy and the nave, it could be concluded that both were built during the same stage. In the original floor there were both limestone slabs of natural shape and slabs worked into a regular rectangle, also pieces of slabs, probably in secondary use. From the sand and organic soil under the floor some coins and sherds of vessel tiles of a stove were gathered. Among these the more precisely datable coins belong to the period of Wolter von Plettenberg, Master of the Teutonic Order in Livonia (1494–1535), indicating that one of the reconstructions of the floor might have taken place during the first half of the 16th century.

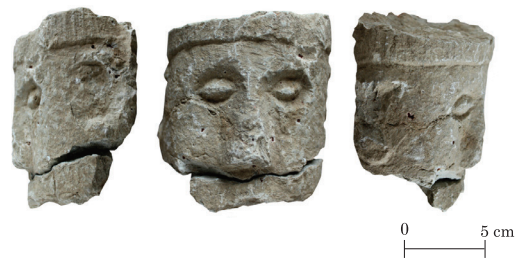
Fig. 3. Fragment of a limestone masonry detail

worked into the shape of a human head.

The most significant among the few finds gathered from the debris covering the foundations of the sacristy was a fragment of limestone masonry detail worked into a shape of a human head (Fig. 3). It could be a fragment of a corbel of the vaults of the nave or a piece from the western portal, which have not been preserved. Little can be said about the sculpture. The human has worn a cap or a helmet, indicated by a welt above the eyes. A piece of a special brick of a double rib of a vault, found from the debris might come from the still preserved vault of the chancel or be an unused extra piece made for it. Although it cannot be excluded, there is no reason to suggest that the sacristy itself had a brick vault, as it appeared that the sacristy had been built together with the nave, in an earlier building stage than the chancel. An ample quantity of pieces of roof-tiles with S-profile was discovered covering the foundations of the sacristy. These came from the last roof of the old sacristy, built probably in the 17th or 18th century.

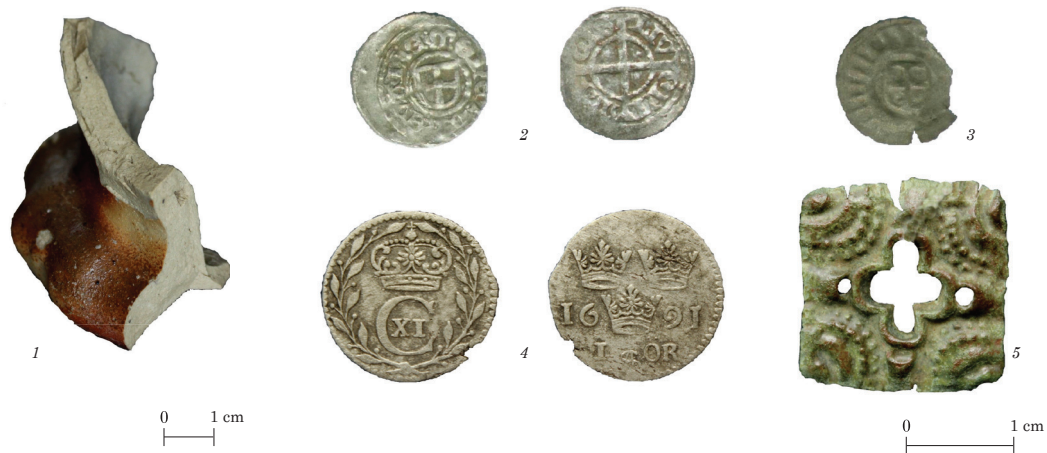
Fig. 4. Finds from the old sacristy: 1 – sherd of a Siegburg stoneware beaker or a jug (ca. 1400–1550), 2 – pfennig of the Teutonic Order in Livonia, Tallinn (ca. 1515–1555), 3 – scherf of the Teutonic Order in Livonia, Tallinn (ca. 1515–1520), 4 – Swedish 1 öre (1691), 5 – lock's decorative plate.

Surprisingly a sherd of a bottom part of a stoneware jug or a beaker, made between ca. 1400–1550 in Siegburg, Germany was discovered from 20th century debris (Fig. 4: 1). Siegburg stoneware is a common find in Estonian towns (see Russow 2006, 49), e.g. Tallinn, less in villages close to Tallinn, but not at all in medieval churches of Estonia. As Communion chalices were normally of metal, the jug or beaker of Kose church might have been a simple drinking vessel or used as a vase for flowers.

From the soil under the floor of the old sacristy several Late Medieval coins of the Teutonic Order in Livonia were gathered. Three coins of five – one *pfennig* and two *schers* (Fig. 4: 3) – belong to the time of Master Wolter von Plettenberg (1494–1535), additionally one more vaguely datable *pfennig* (1515–1555; Fig. 4: 2) could originate from the same time period. A *pfennig* of Henning Scharpenberg (1424–1448), Archbishop of Riga, represents an earlier period. The only *pfennig* from the time of W. von Plettenberg was minted in Riga, while the three other coins of the Order were minted in Tallinn. This is the first assemblage of coins gathered during an archaeological excavation in a sacristy of a medieval church in Estonia.

The finds from debris covering the foundations of the sacristy included Swedish copper and silver coins, a copper alloy lock plate with stamped ornament and a cross-shaped keyhole (Fig. 4: 5). The item has been fixed with four small nails belonging supposedly to a small chest. Also abundant mixed human bones were gathered and reburied.

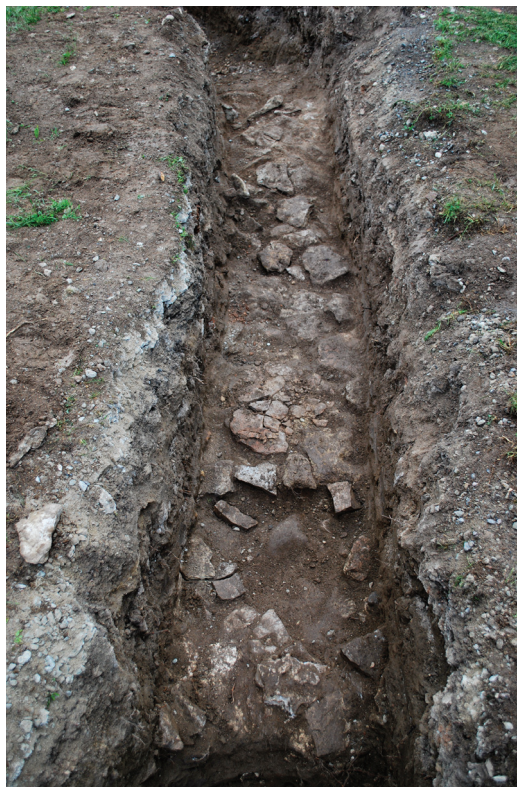
Fig. 6. An unearthed limestone paving near the north-western corner of the tower of Kose church.

Surprisingly a limestone paving (Fig. 6) was unearthed near the north-western corner of the church 60 cm below the present-day ground level. The preserved length of the pavement was three metres, the width could not be determined as it extended to the northern and southern profile. It was probably buried during the construction work of the church, e.g. in 1856 when the foundation for the new sacristy was built. Under the western part of the paving was a dark area with pieces of charcoal where burnt human bones were collected (cremation no. 1) – mostly fragments of cranium and tubular bones. Some burnt bones were collected as stray finds from the other parts of the trench; these originate from disturbed cremations.

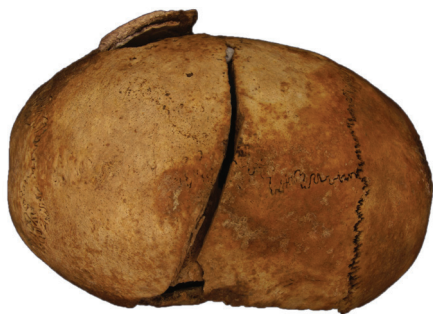
Fig. 7. Male skull (burial no. 84) with fatal cut wound on the neurocranium.

The most interesting osteological find was a cranium of a man<sup>4</sup> (burial no. 84), which had a 7.6 cm long *peri mortem* cut mark on the vault (Fig. 7). It is of the same colour with the rest of the cranial bones and has sharp edges. Since the cut is narrow and clean, it can be concluded that the blow was made with a narrow-bladed object, e.g. a sword. The man was aged 25–35 years<sup>5</sup> when he died. The blade had cut deep into the skull injuring soft tissues

and therefore was fatal to the individual. Additionally the lower third of his sternum had a penetrating diamond-shaped (1 × 0.4 cm) injury that could have been caused by an arrow or a piercing weapon.

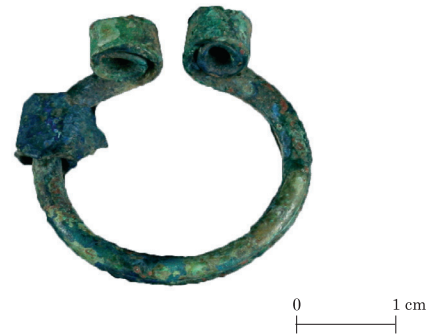
Fig. 8. Penannular brooch (13th – 14th century).

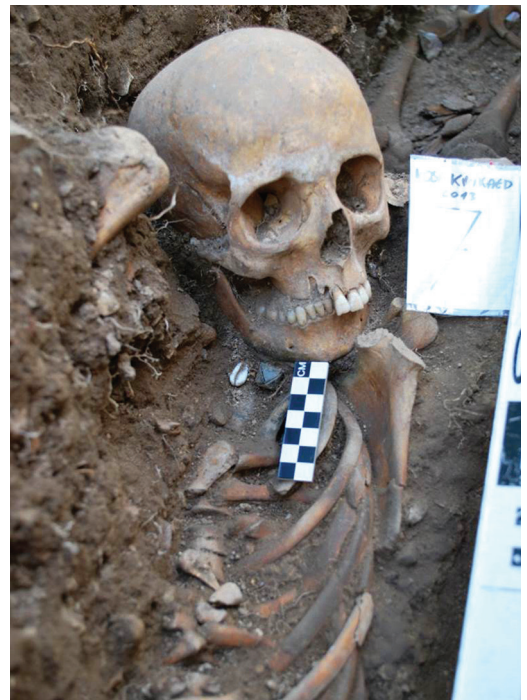
Fig. 9. Medieval juvenile burial (no. 7) with a necklace.

The most remarkable burial (no. 7, Fig. 9) belonged to a juvenile<sup>6</sup> who was wearing a necklace consisting of seven cowry shells, eight bells and one very poorly preserved *Biser*-type bead (AI 7119: 4). The cowry shells can be dated from 13th to the 18th century, *Biser*-type beads found in Estonia belong to the find complexes dating from 13th to 16th cen-

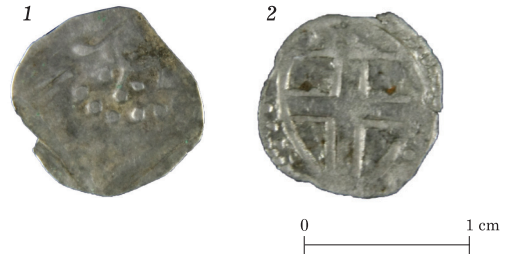
Fig. 11. Rare coins from Kose churchyard.

1 – Gotlandic coin, struck before 1220,  
2 – Livonian Order, Tallinn, seestling,  
ca. 1363/64–68(?).

Besides the finds from the historical period two Gotlandic pennies (*ca.* 1140–1210/20) struck before the Christianisation of Estonia were also brought to light in Kose (Fig. 11: 1). It is very interesting because so far no prehistoric coins are known

From the perspective of coin history in Livonia the most unique find from Kose is undoubtedly the earliest type of *seestling* (Fig. 11: 2), which was minted in Tallinn by the Livonian Order (ca. 1363/64–68) – the first such coin to reach Estonian museum collections. Until now that type has been found only in Finnish churches (Nemirowitsch-Dantschenko & Pärn 1980, 76; Leimus 2001, 79). Rare coins were also seven *scherfs* struck in Tallinn during the reign of Wolter von Plettenberg (1494–1535), Master of the Livonian Order.
