Archaeological monitoring at Väike-Turu and Kauba streets in the Old Town of Viljandi

Andres Tvauri

Arvi Haak

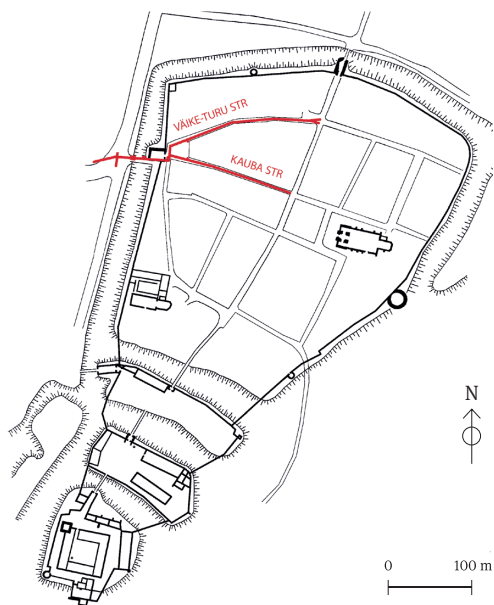
Fig. 1. Trench documented during the monitoring works at Väike-Turu and Kauba streets.

In 2014, archaeological monitoring at Väike-Turu and Kauba streets was carried out in connection with the renovation of water and sewerage pipelines (Fig. 1). The trenches were located in the central part of the present-day street. Earthworks were monitored in the area of approximately 800 m²; the depth of the trench was up to 2.4 m, width 1,5–2,2 m. The thickness of the cultural layer varied from 0.9 m up to at least 2 m. Monitoring was carried out and the report compiled by Andres Tvauri (Tvauri 2014), Arvi Haak helped with data about earlier archaeological research in these streets.

Arheoloogiline järelevalve Viljandis Väike-Turu ja Kauba tänaval toimus seoses nende tänavate rekonstrueerimisega, mille käigus vahetati välja tänavate alal olevad vee- ja kanalisatsioonitrassid ning rajati sadeveekanalatsioon (jn 1). Enamikus trasside ulatustes kulges rajatav kaevis tänava keskel, piki olemasolevaid torustikke, kuid oli varasemast veidi sügavam ja laiem. Kaevetöödega avatud ala pindala oli umbes 800 m². Kultuurikihi paksus uuritud alal ulatus 90 sentimeetrist kuni vähemalt 2 meetrini.

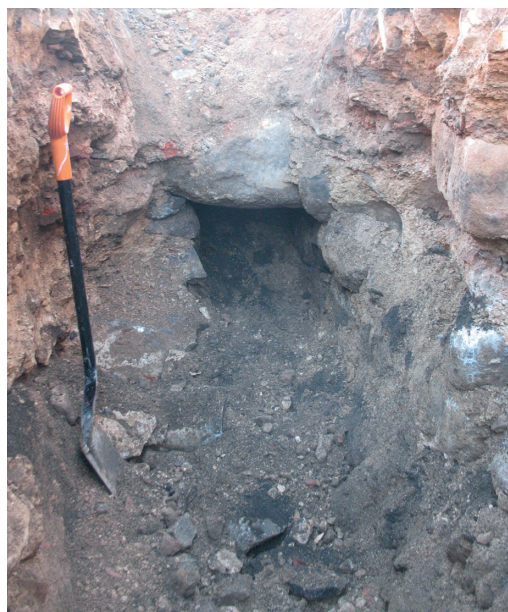
Fig. 3. Gutter in the southern wall of the *zwinger* of the Riga Gate. View from the west.

Inside the remains of the wall, a closed gutter was situated along the wall, i.e. in approximately east-west direction (Fig. 3), declining towards west. The bottom and sides of the gutter were laid of granite stones and pieces of bricks, the top was covered with large flat granite stones. The inner measures of the gutter were 60 cm in height and 50 cm in width. The bottom of the gutter was situated 1.7 m below the current street level, it was covered with a 30 cm thick layer of grainy brown soil containing a few pieces of bricks and animal bones. The gutter was measured with a rod to continue diagonally from the southern trench wall outside the trench towards west (i.e. downstream) at least for 5 m. Towards east the gutter continued for 5 m and then curved roundly to the north, out of the pipeline trench. As the remains of the wall obstructed the installation of the pipeline, the wall was dismantled along with the gutter inside it. The top of the gutter was removed and the location of the gutter documented (Fig. 4). At the curve of the gutter, on top of the soil covering its bottom, a fragment of a redware jug covered with green glazing was found¹, dating from the 16th – 18th centuries. It is possible that the gutter represents a drainage for wastewater, rainwater or surface water that was built inside the southern wall of the *zwinger* of the Riga gate in the same direction with the wall.

Müürijäänuse sees paiknes piki müüri kulgenud suletud veekanal (jn 3), oletatavasti reo-, sadevee- või kivevenduskanal, mis oli laotud maakividest ja tellisetükkidest. Kanali põhi alanes lääne suunas ning seda kattis 30 cm paksuselt sõre pruun muld. Kanal jätkus kaevise seinast lääne suunas vähemalt 5 m võrra. Müürijäänus koos selles paikneva kanaliga lammutati, mille käigus eemaldati kanali kividest lagi ja dokumenteeriti kanali asend (jn 4). Kanali põhja katva mullakihi pealt leiti punaseks põlenud savist roheline glasuuriga tassi katke, mis pärineb 16.–18. sajandist.

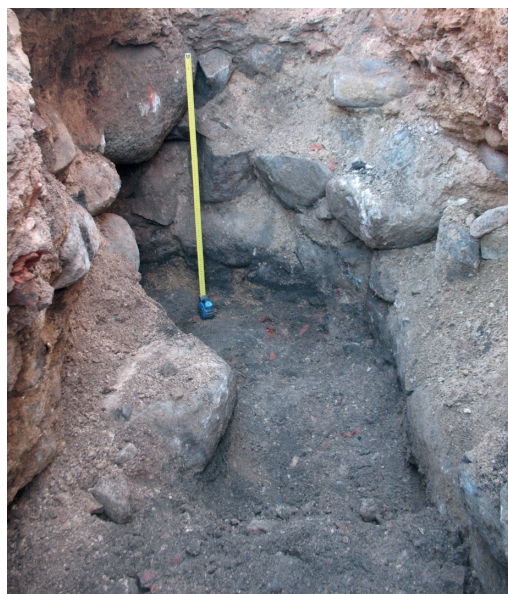
Fig. 4. Gutter in the southern wall of the *zwinger* of the Riga Gate after the removal of covering stones.

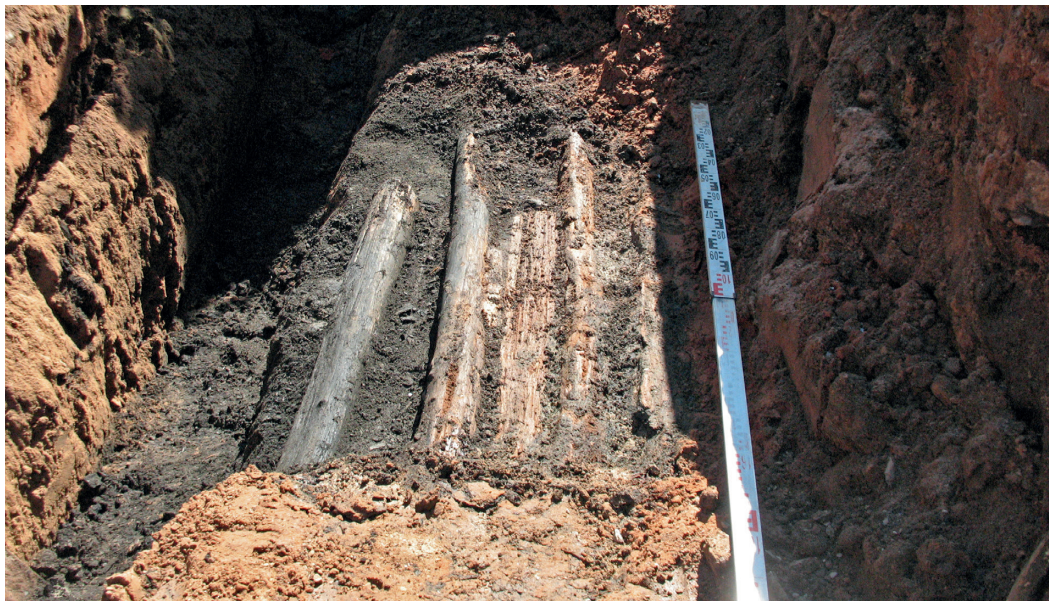
Fig. 5. Logs situated under the medieval cobblestone pavement in the eastern part of Kauba street. View from the west.
Jn 5. Keskaegse tänavasillutise all paiknevad palgid Kauba tänava idaosas. Vaade lääne poolt.

In the trench, in some places on top of the organic rich medieval layer some 1–1.5 m long logs placed loosely and in a sporadic way were discovered (Fig. 5). The diameter of the logs was 10–15 cm. Most logs were placed along the direction of the street, in one section in front of the building at Väike-Turu 2a some logs were crossing the street. Logs were found adjacent to Väike-Turu 2a and Väike-Turu 6 plots, at Kauba street in the sections adjacent to Kauba 2 and Lossi 13 plots. As there was decayed wood on top of the organic-rich medieval layer elsewhere in the trench, it can be assumed that the logs had been placed to the same depth throughout both streets. In Viljandi, similar logs in the same stratigraphic context have earlier been found at Munga street (Valk 1990; Tvauri & Metsoja 2014a, 6). Most likely, it was not a pavement layer in its own right, but a sub-base for the cobblestone pavement. On top of the logs or, where logs are missing, on top of the organic-rich medieval layer lies a sandy bedding of

cobblestone pavement. The position of the logs differs from that of the medieval log pavements discovered in the towns Tartu and Pärnu (e.g. Veldi 2006; Tvauri & Bernotas 2007, 172, figs. 9, 10; Tvauri 2011, 182; Heinloo & Vissak 2012, 163) where the logs are laid crosswise the street and tightly next to each other. In Viljandi, the remains of wooden logs situated crosswise the street were documented at Lossi street, where the existence of a wooden pavement was presumed (Heinloo this volume).

Orgaanikarikka keskaegse kihi peale on mõnedes kohtades kaevise alal hõredalt ja ebakorrapäraselt laotud maha 1–1,5 m pikkusi ning 10–15 cm läbimõduga palgijuppe (jn 5). Enamik palke paiknes praeguste tänavate suunaliselt, Väike-Turu tänava idaosas olid mõned palgid asetatud ka tänavaga risti, lisaks leidis samas kihis ka mujal kõdupuitu. Võib oletada, et palgid olid paigaldatud sellele sügavusele kogu mõlema tänava alal. Samasuguseid puidujäänuseid sarnases stratigraafilises kontekstis on Viljandist varem leitud ka mujalt. Tõenäoliselt on tegemist kõrgemal paikneva tänavasillutise aluse, mitte sillutise endaga, kuid Lossi tänaval on oletatud ka puitsillutist. Palkide või orgaanikarikka kultuurikihi peal lasub punase liiva kiht, millele on laotud munakivisillutis, mis paikneb tänapäevasest teepinnast 50–110 cm sügavusel.
