Investigations in Helme: medieval chapel ruins, earlier timber shrine and churchyard

Heiki Valk

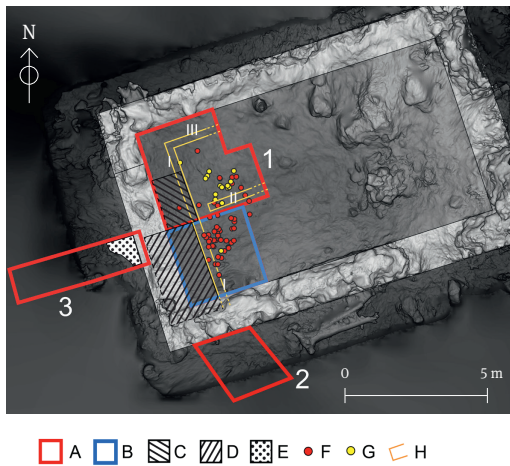
Fig. 2. Helme chapel ruins: trenches and main excavation results. A – trenches of 2019, B – trench of 2018, C – stone platform, D – cross-beam shrine: charcoal layer on sand, E – charcoal layer outside the shrine, F – mid-13th – mid-14th century offered coins, G – beads, H – log beds.

From the dark soil also 14 tiny yellow seed beads with the diameter of 2.5–4.5 mm (Fig. 2: G; 9: 2) were found, in addition to the single item from 2018. The beads, dispersed in an area of ca. 1.4 × 2 metres, occurred likewise coins, in different depths. Since the beads were very small (going through sieve eyes), poorly preserved, soft and often getting disintegrated when touched, their actual number has probably been bigger. Similar character and the same distribution area indicate their origin from the same necklace. The dispersed location of beads and their main concentration outside the distribution area of coins does not enable to regard them as offered items, but rather as remains of a broken necklace. In addition, from the same context a pin of a tiny penannular brooch (Fig. 9: 1), as well as fragments of another similar pin and a spiral finger-ring came to light.

Immediately east of the stone platform a trace of a log (log I, Fig. 2: H, width 17–18 cm) filled with brownish disturbed clayish loam came to light. The log, lying parallel to the west-ern wall of the chapel had partly been pressed into dark grey soil – the layer with coin offer-ings. The southern part of the same log had formed the eastern border of the burnt shrine studied in 2018. The log ended ca. 70 cm before the northern wall of the stone chapel. Its total length had been at least 6 metres – the southern end was cut by the foundation of the chapel wall. The log trace could not be followed in the southern trench, its end had been destroyed by digging the foundation ditch.

In addition, the traces of two other logs, II and III (Fig. 2: H) were unearthed in the dark grey soil in the bottom of the trench. They both were perpendicular to log I, following the direction of the northern and southern walls of the stone chapel. The bed of log II was sep-arated from that of log I by a ca. 60 cm wide gap, continuing into the eastern wall of the trench, but the trace of the western end of ca. 25 cm wide log III merged with that of log I. The function of logs II and III remained unclear, maybe they served as beams for a wooden floor east of the shrine. From the bottom of the trace of log II a Gotlandic penny from between 1220 and 1280 and an early penny of Tartu prince-bishopric (Table 1, nos 2 and 13) were found. The coin which dates the construction time of the timber shrine may have been deliberately placed under the log.

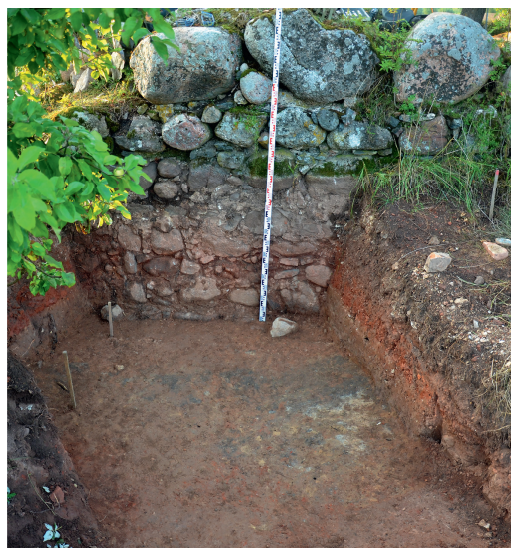
Fig. 3. Trench south of the Helme chapel ruins, with two construction stages of the stone chapel and remains of the grey intact soil in the foreground.

South of the chapel an area of ca. 7.3 m² was opened near the western end of the building (Fig. 3). The top part of the ground consisted of a 60–75 cm thick layer of disturbed soil and demolition debris. From that layer four 17th century coins were found: a Swedish 1 öre minted

After removing the debris and soil it became evident that the wall of the stone chapel had been built in two stages (Fig. 3), differing from each other by the size of the stones, as well as by the working experience of builders. The first stage of the wall stretched until ca. 1.05 m from the pre-construction ground level. This part of the wall was made of rather small granite stones (diam. ca. 20–40 cm), placed irregularly, sometimes carelessly and in upright position. The foundation ditch stretched only up to 2–3 cm from the wall. Approximately on the ground level of its construction time the wall had a 10–15 (mostly 12) cm wide socle. The second stage of the wall was made of big granite rocks. Two lower horizontal rows were made of stones 35–50 cm in diameter, but the rocks of the third row were very large – some of them even over a metre long. The wall had preserved until the height of 2.4 m from the top of the socle.

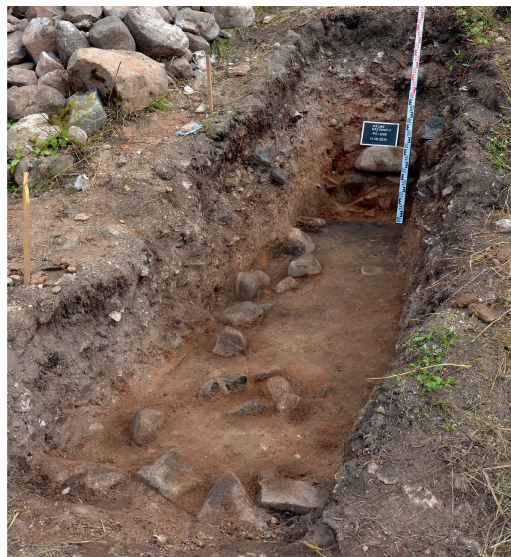
Fig. 4. Trench west of the Helme chapel ruins with remains of the fallen and burnt shrine near the wall of the chapel.

The western trench (ca. 5 × 1.3 m) began ca. 1 m west of the inner side of the chapel – in the area where the outer side of the wall was expected to appear (Fig. 4). The trench ended where the hill of debris, rising for ca. 1.5 m above the level of the surrounding field, gradually merged with it.

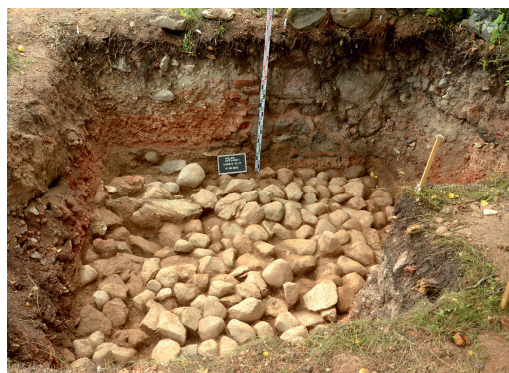
Fig. 5. Trench in the north-western corner of the Helme chapel and floor basement of the stone chapel.

North of the trench of 2018 an area of 14.1 m² was opened (Fig. 5). Firstly, it was dug until the bottom, then the profile from between the trenches of different years (1.5 m²) was removed.

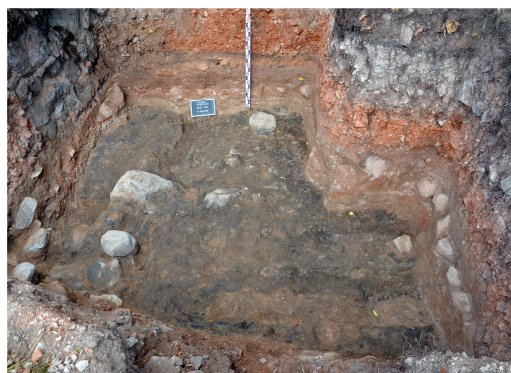
Fig. 8. Dark 13th–14th cc. cultural layer under the floor of the Helme stone chapel.

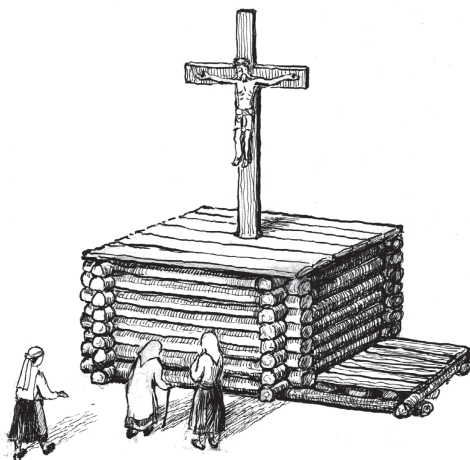
Fig. 10. *The first phase of the shrine in Helme around 1250 AD.*

Jn 10. *Helme pühamu algsel kujul, 1250. aasta paiku. Re-construction by the author, drawing by Mari-Ann Remmel / Autori rekonstruktsioon, joonis Mari-Ann Remmel*

The excavations of 2018 and 2019 showed that the core of the shrine was a cross-beam build-
 ing with no entrance – a postament measuring ca. 2–2.5 m in the east–west and 3.5–4.5 m in the north–south direction (Fig. 10). The sacral centre to which offerings were made – proba-
 bly a wooden crucifix or cross⁵ –, stood on top of the structure. As no coins were found from the area of the building, the inside of which was covered by a 3–4 cm thick layer of clean yellow sand, the structure had to be too high for casting tiny bracteate pennies to its top. The low, ca. 25–30 cm high platform on stone basement might have been meant for the key person of rituals.

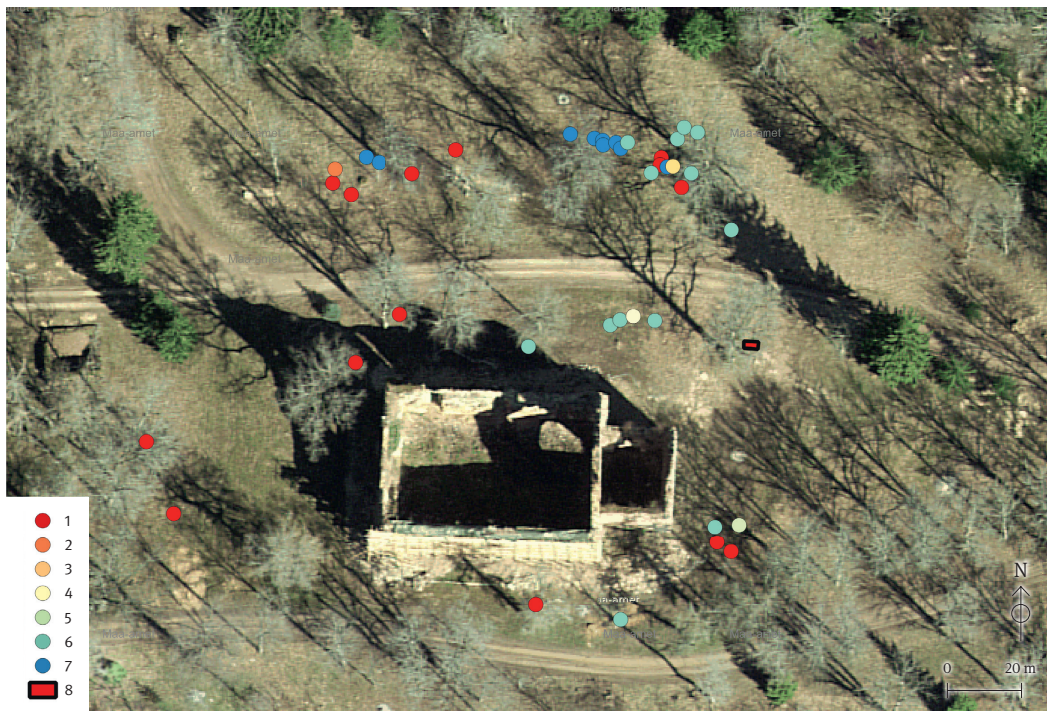
Fig. 14. Distribution of metal detector finds around the parish church of Helme. 1 – coin, 2 – mount, 3 – button, 4 – belt fastener, 5 – strap ending, 6 – brooch, 7 – ring, 8 – trench.

The number of finds in most part of the former churchyard was considerably low. Exceptionally, three areas of high find concentration which yielded most of the finds appeared north of the church (Fig. 14). The uneven concentration of finds in the churchyard and big contrast with find density in the churchyard of Nõo (see Valk & Kiudsoo, this volume) must specially be outlined: it indicates thorough looting of the area by illegal treasure hunters, except for the three limited areas noted above.
