# Archaeological studies in the Cistercian monastic complex in Padise

**Villu Kadakas**

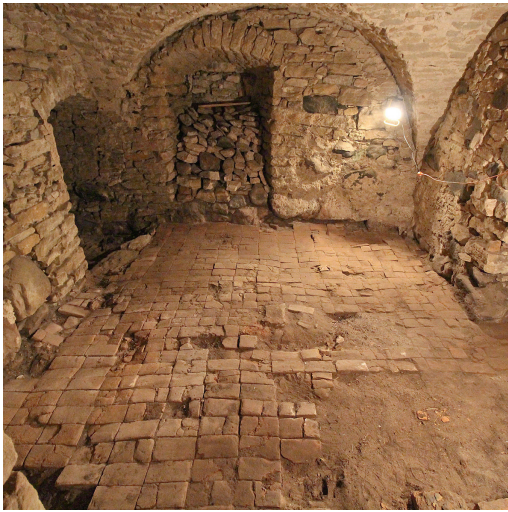
Fig. 2. Tile floor in a basement under the supposed parlatory.

The floor level in most of the basement rooms of the northern and eastern ranges was brought deeper by 10–20 cm, in some cases even more. The top of the floor level was covered with soil containing various debris, but extensive remains of brick or limestone floors had been discovered in the test pits of 2010 in several rooms. In all the basement rooms of the eastern range brick floors were uncovered and recorded (Fig. 2). These consisted of a wide variety of wall bricks as well as square thin floor tiles of different size. It is likely that most of this material has been used secondarily, after initial use in some main floor rooms of the former monastic complex or the new manor house from the late 18th century. Based on finds from the soil below the floors it can be concluded that all the brick floors were laid not before the 19th century. However, some of the used material, especially the square floor tiles might originate from

older periods. It cannot be excluded that some of the square floor tiles originate from the monastic period, although there is no evidence about the use of such unglazed tiles in Padise in the Middle Ages. No glazed or otherwise decorated tiles were found in the basement rooms of the eastern range. A large part of the brick floor could be preserved and exposed *in situ* in the basement room under the chapter hall. The late date of the brick floors is a clear evidence that the basement rooms of the former monastic complex had not been neglected but were intensively used for storage and even reconstructed to some extent during the 19th century.

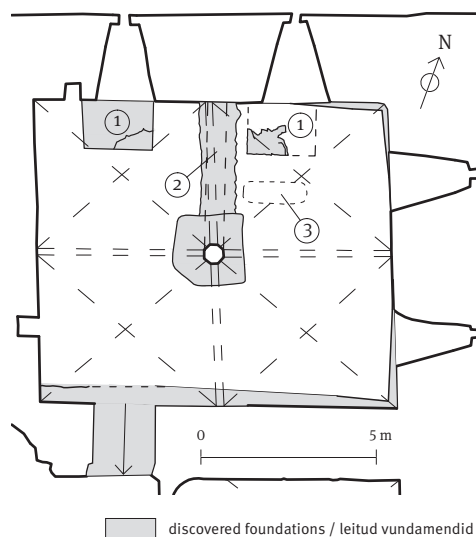
Fig. 3. Plan of the undercroft chapel. 1 – foundations of altars, 2 – foundation of partition wall, 3 – site of a burial.  
Jn 3. Kelderkabeli plaan. 1 – altarite vundamendid, 2 – vaheseina vundament, 3 – haua asukoht.

Among all the basement rooms the easternmost one of the northern range, under the eastern part of the church deserves special attention (Fig. 3). Considering the rib vaults and a carved masonry pillar, exceptional in the basement storey of the monastic quadrangle of Padise, and especially the carved remains of consecration crosses in the plaster of the walls, this room has been estimated to have been an unconventional undercroft chapel in the monastic period. Raam supposed that the undercroft chapel was necessary to accommodate the side altars which did not fit into the unconventionally small church of the fortified quadrangle (Raam 1988, 59; Alttoa 2012b, 63).

Raam (1958, 61) has described here some stones as preserved evidence of one of the altars. A rectangular foundation ( $2.0 \times 1.37$  m) of a structure built next to the northern wall, in front of the western window has been visible in its full extent for at least two decades, but it is not known when it was fully uncovered. During the excavations of 2019 the western half of an identical foundation was discovered in front of the eastern window of the northern wall (Fig. 3: 1). The foundations of more altars were searched for in vain, as much of the upper soil under the chapel has been disturbed during the Early Modern period.

An 80–90 cm thick foundation of a partition wall was recorded, running between the pillar and the northern wall, situated between both altar remains (Fig 3: 2). This wall still stood about 2 m high on the earliest photos from the 1920s, e.g. by Nikolai Nyländer (Tuulse 1942, Abb. 184; TÜKAF, s B-60-42<sup>3</sup>), but was demolished, as a presumably post-monastic element during later restoration work. However, screens or partition walls between side-altars dividing these into separate chapels were not uncommon in the Late Medieval churches (Rodwell 2012, 164–165). Therefore, it cannot be excluded that this particular wall was not an Early Modern addition, but from the monastic period. Remains of other, similar partition walls were searched for in vain. Two altars with a partition wall which formed two separate chapels, are depicted in the eastern end of the undercroft chapel of the other Cistercian monastery in Estonia – Kärkna, on a disputed reconstruction plan by Reinhold Guleke (1896, Plate IV, VI & VIa; Alttoa 2012a, 35).

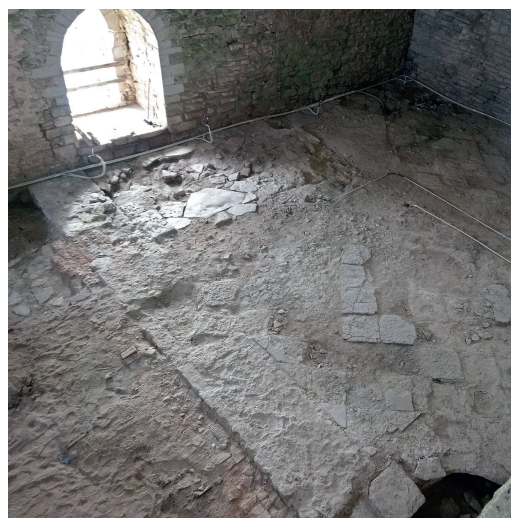
**Fig. 5.** The floor of square limestone slabs, foundations of a tiled stove, a partition wall and the mantel chimney in the western part of the church.

In the western part of the church a 1 m thick partition wall (Fig. 4: 9; 5) was uncovered next to the portal of the lay brothers (Fig. 4: 4; 5). It divided the western vault from the rest of the church into an almost square hall (ca. 9.3 m) with a huge mantel chimney (ca. 3.8 × 2.0 m) in the corner (Fig. 4: 10; 5). Most of this hall interior is still covered with a floor of square limestone slabs, which were uncovered from a thin layer of debris (Fig. 4: 12; 5). The size of the slabs (52–53 cm) corresponds to one ell of Tallinn. These remains of the floor have been known for decades, but have never been documented, but rather ignored as an Early Modern addition to the church.

Traces of a narrow doorway were recorded in the middle of the partition wall. Remains of a winding mural (ca. 0.7 m) staircase leading downstairs, were recorded within the northern end of the partition wall (Fig. 4: 11; 5). The lower part of this staircase in the basement room has been demolished decades ago, but its foundations were uncovered in 2019. A rectangular foundation (1.5 × 1.5 m) of red bricks of a tiled stove or a fireplace was recorded on the eastern side of the partition wall next to the kitchen (Fig. 4: 13; 5). The room directly to the east of the partition wall had been covered with a floor of red bricks of which two rows had been preserved next to the partition wall.

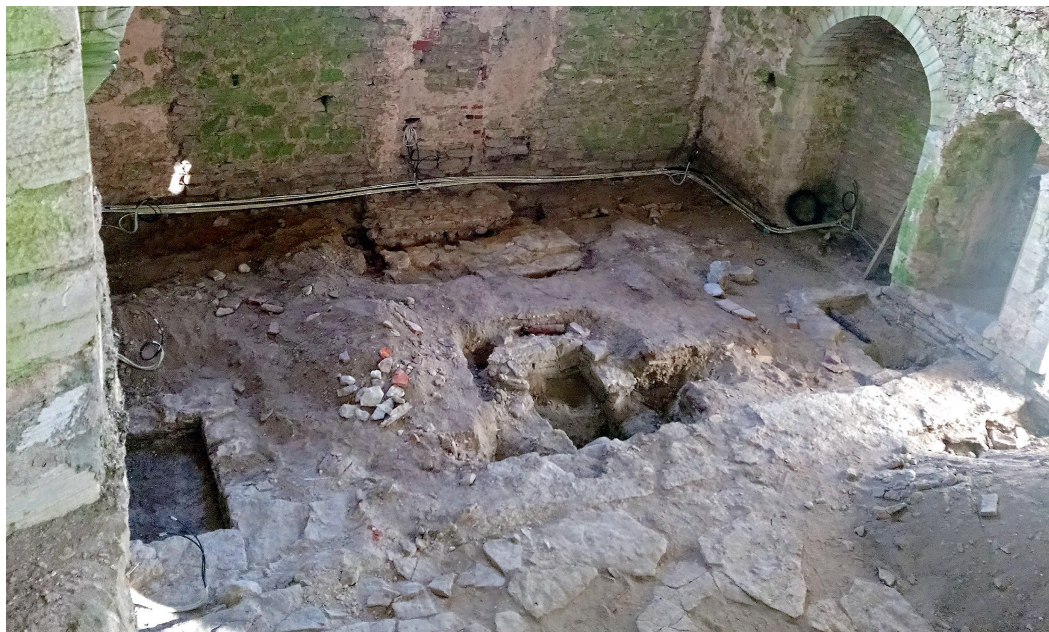
**Fig. 6.** Three burial vaults, foundations of a tiled stove, the main altar and a partition wall in the eastern part of the church.

In the eastern part of the church, between the choir monks’ portal and the sacristy portal, a foundation of a rather thin (ca. 0.8 m) partition wall was uncovered (Fig. 4: 8; 6). Extensive remains of a floor of irregular

Next to the eastern wall of the church, on the symmetry axis, a rectangular, ca.  $1.2 \times 2.6$  m foundation was discovered. After preliminary enthusiasm, it appeared not to be a foundation of the medieval main altar but rather of an Early Modern tiled stove (Fig. 4: 13; 6). Nevertheless, the rectangular foundation of the altar ( $1.8 \times 2.6$  m) was discovered under it, set 1 m off the eastern wall (Fig. 4: 6; 6). This location is in accordance with the medieval tradition of the Cistercian monks to move in a procession through the back of the altar when receiving the Holy Communion (Kinder 2002, 172). No foundations of side altars were discovered, but some may lay hidden deeper than was excavated. All the side altars did probably not fit into the undercroft chapel, because in 1448 more than a dozen was mentioned to exist in Padise (Alttõa 2012a, 47).

As a surprise, three large boxes of limestone were discovered under this partition wall (Fig. 4: 7; 6). These resemble the burial vaults, which are common in parish churches, usually covered with a limestone grave slab. A narrow test pit was dug into the middle one, which revealed no human bones neither in the filling debris nor at the bottom. Nevertheless, it seems most likely that these have been burial vaults. The inner size (on the average  $1.1 \times 2.0$  m, ca. 1.2 m deep), is fit for one coffin. Probably the vaults have been looted and filled with demolition debris after removing the grave slabs.

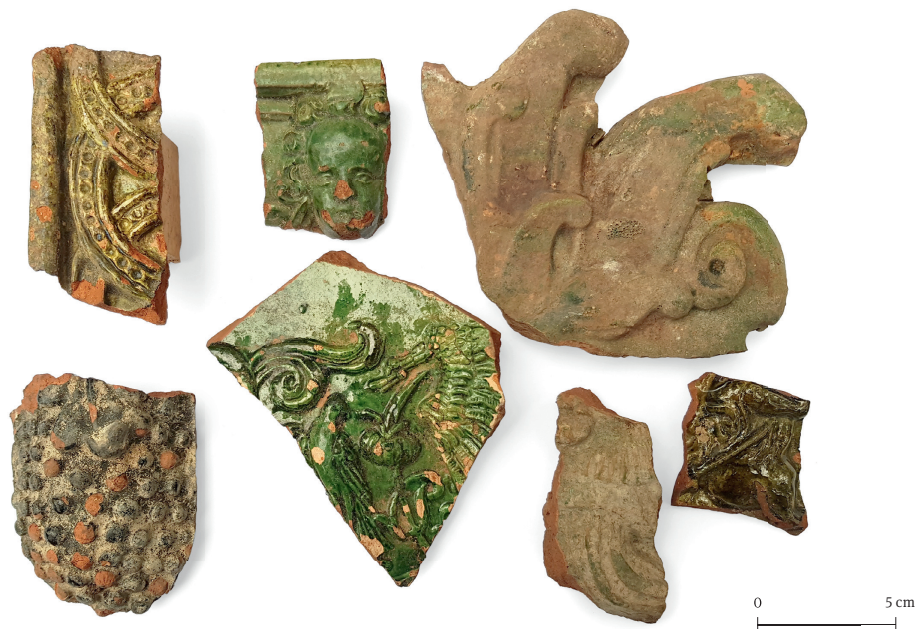
**Fig. 7.** A selection of 17th century glazed stove tile fragments.

Fragments of various glazed stove tiles were discovered in the rooms of both the main and the basement floor (Fig. 7). Most of the stove tile fragments in the basement rooms have probably been brought there together with demolition debris, although some foundations and chutes indicate that at least some basement rooms had a stove or a fireplace at some moment. A lot of panel tile fragments in the rooms of the main floor – dwelling rooms in the private manor period – were gathered close to the discovered stove foundations. The few stove foundations correspond to the smoke chutes, still preserved inside the walls or chimneys, depicted on the Early Modern engravings. It is likely that earlier tiled stoves were replaced on the same foundation with new ones as time passed, at least until the fire of 1766. Among the new fragments there are a few with Renaissance style motifs (mostly low relief floral patterns), and with monochrome green or black glaze. Most represent the late 17th and 18th century Baroque style stoves with abundant plant ornamentation, with monochrome black or white glaze. In the case of most of the stoves, only a few fragments could be collected, but

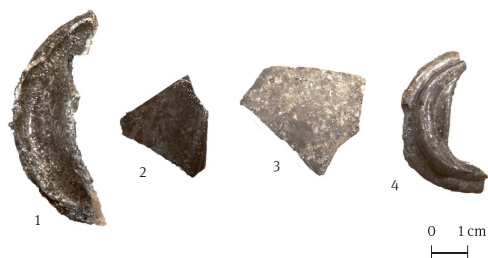
**Fig. 8.** Fragments of glass vessels. 1 – of medieval beaker, 2 – of square case bottle, 3 – beaker rim from the middle burial vault, 4 – foot of early Roemer.

In terms of medieval finds relating to the monastery, the base of a 14th–15th century beaker was discovered in the basement of the northern range. A rim fragment of an undecorated beaker potentially from the same period was discovered in the filling soil of the middle burial vault in the church. Although the rest of the glass artefacts from the house remains found in the bottom of the moat were later, a small poorly-preserved body fragment of a beaker with an applied rib was found here, generally dated to the 14th–15th century (Fig. 8: 3).

Square case bottle fragments were discovered also from within the Padise monastery complex both from the westernmost basement room of the northern range but also from the eastern range. A potentially early 17th century Roemer base (Fig. 8: 4) was found from the westernmost room as well. Further evidence of alcohol consumption on site during the 17th–18th century period comes from fragments of lead crystal goblets and onion-shaped wine bottles from the basement rooms of the eastern range. A small squat colourless hand-blown medicine bottle was also found here. It is notable that no drinking vessel fragments from this period were found from the first floor though a heavy lead crystal footed bowl discovered from the monastery may be from the late 18th century.

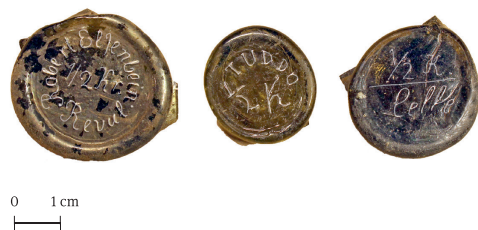
**Fig. 9.** Seals from Robert Elfenbein Reval, Tudu ja Lelle.  
**Jn 9.** Robert Elfenbein Reval, Tudu ja Lelle pudelimärgid.  
 Photo and retouch / Foto ja retušš: Monika Reppo

Due to the sheer size of the collection, conclusions can be drawn in terms of glass production in Estonia but also glass consumption in the manor in the mid-19th century. Bottles from at least four different glass factories were present – Lelle (Eidapere), Vändra, Tudu and Robert Elfenbein Reval (Fig. 9). All are represented by bottles with seals from the early 1860s. Regionally speaking, the former two factories are situated near Pärnu in western Estonia, Tudu in eastern Estonia and Robert Elfenbein Reval produced bottles in Tallinn in northern Estonia. The discovery of bottle seals of Robert Elfenbein Reval is notable as none have been published – neither from Tallinn nor elsewhere in Estonia. It is unclear when he operated. The private purchase of the plot and building at Tartu Road plot 752 A, Tallinn in 1857 could

potentially signify the start of production. Robert Elfenbein's factory was put on auction in November 1863.<sup>9</sup> These dates clearly correspond with the rest of the dated bottle seals.
