Valjala hill fort in Saaremaa

Marika Mägi

INTRODUCTION

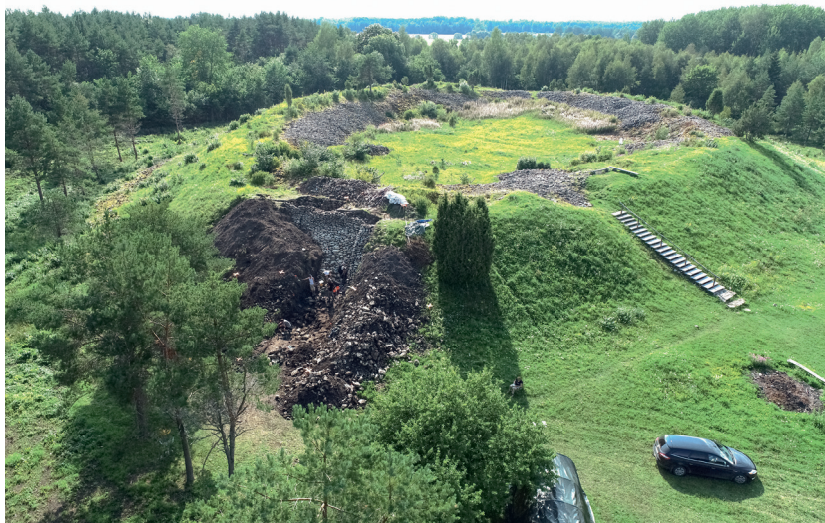
Fig. 2. Valjala hill fort in 2023. Aerial view to trenches D, F and J.

Trenches D and F were opened in 2022. F was widened in 2023, the new area was called trench J. Trench K was opened next to D in 2023, but reached deeper inside the rampart, and also covered about twice as big an area as D, which was made possible by the use of tracked excavator-loaders. The total area of the excavations was about 145 m². They embraced the outer slope of the big rampart and part of its flat top. The trenches were not fully excavated, but stopped at certain stages of uncovered structures, e.g. when the dry-laid stone wall was cleaned out. On the top of the rampart, the excavations were stopped at the depths of 70–80 cm from the ground level, where the same layer of loose stones seemed to continue deeper towards the inside of the rampart (Fig. 2).

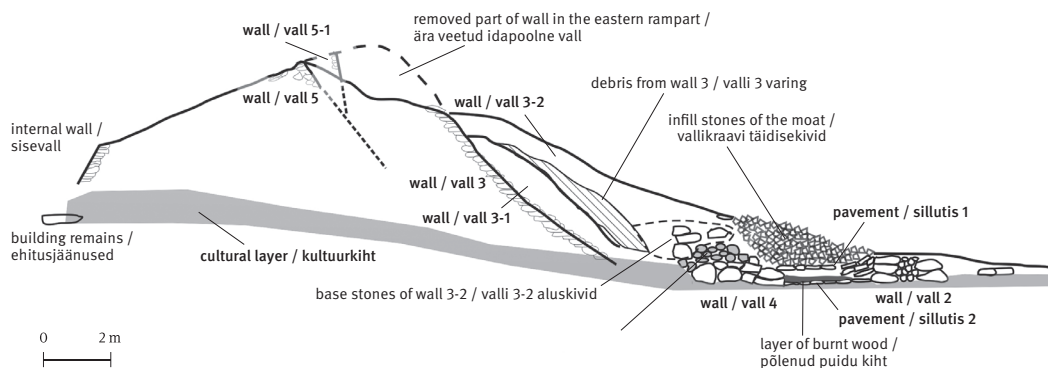
Fig. 3. Schematic plan of different fortification structures at Valjala hill fort.

The construction phases of the great rampart of the hill fort are numbered in the order in which they were excavated, i.e. phase A is the latest, phase B the one before, etc. Some of the phases, which were not stratigraphically related, may have been contemporaneous (Fig. 3).

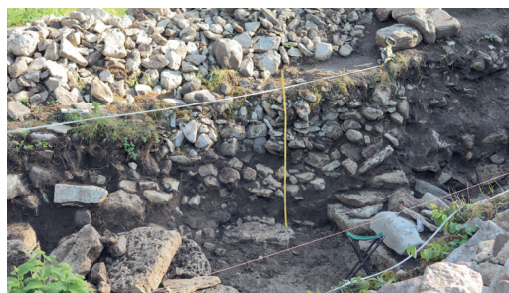
Fig. 4. Depression or moat in the southern profile of trench D.

Between the big rampart of the hill fort and wall 2 there was a depression, probable dry moat, that was filled with loose stones 10–20 cm in diameter (Fig. 4). The stones had apparently fallen from the higher part of the rampart and were visible on the surface before the excavations. Further excavations clearly showed that any activity on the top of the rampart easily ended with smaller stones rolling down the slope. The belt of loose stones, still visible in many places today, is particularly evident in early 20th-century photographs of Valjala hill fort. Among the loose stones filling the depression were also slabs that originated from wall 2, as well as areas with no stones that probably marked the places where wooden parts of wall 2 had collapsed.

Ehitusjärg A oli kõige hilisem. Suure valli jalamist vahetult väljapool paljandus kaevandites K ja D 2 m laiune kivivall, vall 2, mis oli jälgitav ka Lidari kaardidel ning GPR horisontaalõigetel (jn 3). Vallist 2 suure linnuse poole oli hiliseimas ehitusjärgus 2,8 m laiune ja u 1 m sügavune süvend, tõenäoliselt kuiv vallikraav. Süvendi põhi oli sillutatud paeplaatidega (sillutis 1). Hiljem täitus süvend valli harjalt varisenud kividega (jn 4, 5).

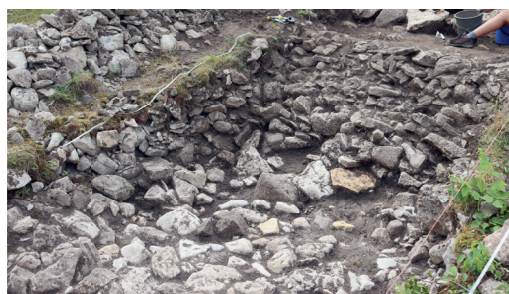
Fig. 5. Slope of the depression, built of small limestone slabs. Construction phase A, trench D.

The 1.3-m-high wall of the depression that was closest to the big rampart was built of small limestone slabs, laid at an angle of about 45° in a horizontal but irregular position (Fig. 5). At the higher end of the slope, there was a horizontal area about 1–1.5 m wide, covered by limestone slabs. The zone of the slabs ended where the clayey soil forming wall 3-2 started.

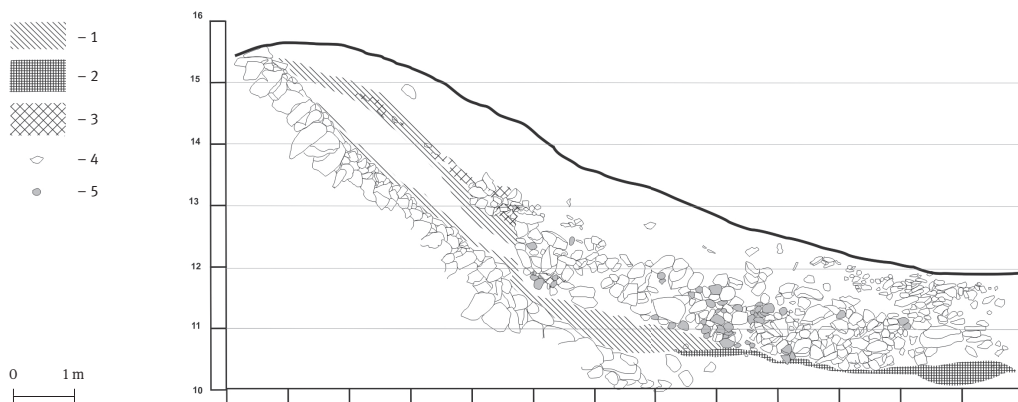
Fig. 7. Northern profile of trench K. 1 – clayey layer, 2 – layer with pieces of charcoal, 3 – wooden remains, 4 – limestone, 5 – granite stone.

The earliest earthwork, wall 3-1, covered the outer face of stone wall 3 from the lowest point of the regular stones to about 6 m up the rampart. It was at most 1 m thick and, as shown in excavation K, consisted almost entirely of clayey soil. As far as is known so far, there is no evidence of a cultural layer (charcoal, finds) in the infill of wall 3-1, as was characteristic of wall 3-2. Wall 3-1 was covered with a thin layer of clay (Fig. 7).

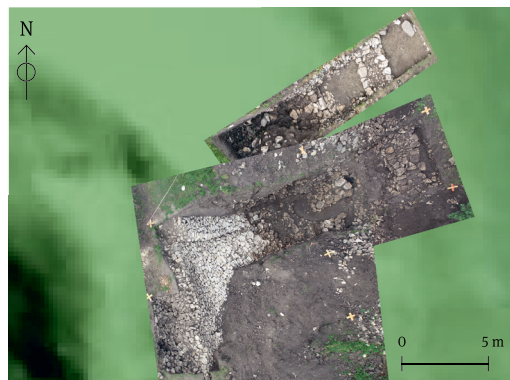
Fig. 8. The lowest layers in trenches D, F, K and J. Georeferenced drone photos.

Also seeming to be part of the same construction phase was a line of larger slabs about 1 m from the foot of stone wall 3, which was revealed in excavation K (Fig. 8). Stratigraphically, the probable building remains unearthed outside wall 2 in trench D in 2022, as well as wall 1 and most of the cultural layer outside the hill fort (Mägi *et al.* 2023), may have been constructed simultaneously. According to Aita Kustin, the remains of the buildings in the inner yard of the fort were found at a depth of about 1 m below the base of the stone rampart (Kustin 1963). It can be assumed that at least some

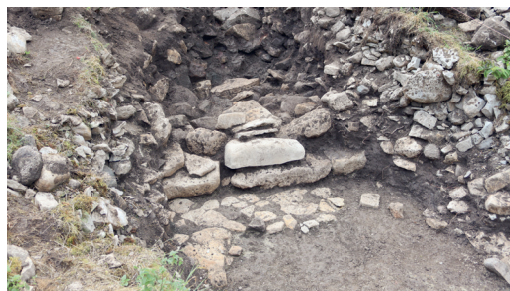
Fig. 9. Wall 4 and pavement 2 in trench D.

A well-preserved pavement 2 was exposed on the outside of wall 4 in trench D, 30 cm deeper than pavement 1 (Fig. 9). It consisted of limestone slabs densely packed with light greyish yellow clay. On top of the pavement was an intense burnt layer, up to 20 cm thick, with large

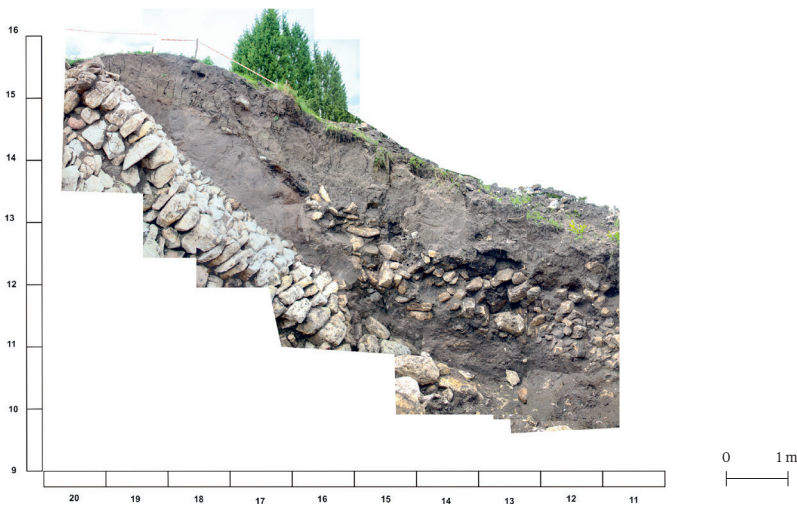
Fig. 10. Profile of walls 3, 3-1 and 3-2, trench K.

The embankment of Valjala fortress was piled in two stages, separated by a clear layer of debris (Fig. 10). The debris layer was not uniform everywhere, but consisted of clusters formed by stones bound together by clay, usually accompanied by remains of unburnt wood, mainly pinewood.¹ The wood debris was also visible in some profiles and consisted mainly of 3–4 cm thick planks, which in one case had been attached to a 10 × 10 cm squared log. The stones and wooden remains probably came from the upper part of the large rampart (wall 3) of the hill fort, which had begun to collapse by the time of construction phase A. The layer of collapse partly extended over the top of wall 4, and was therefore later than the construction phase B.

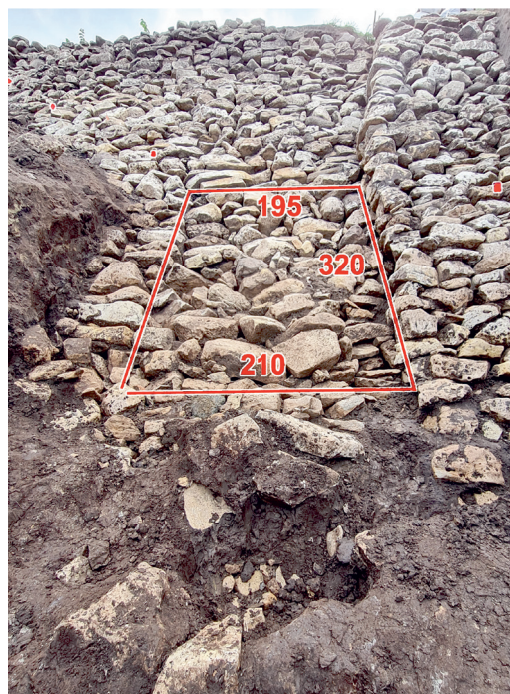
Fig. 11. Presumable built-in gateway in wall 3.
 Jn 11. Arvatav kinniehitatud väravakoht vallis 3.
 Photo and drawing / Foto ja joonis: Marika Mägi

In the masonry, a regularly protruding part of the stone wall was revealed, which extended from the top to the foot of the rampart. A second, but much smaller protruding part stuck out along the southern side of the wall, about 2 m from the first one. In the lower part, the latter was clearly visible as a crack in the masonry of the rampart – here, the lower part of the stone wall, up to the height 3.2 m, had been originally laid separately, i.e. the stones were not bound. Starting from the height of 3.2 m, the masonry was regular, all stones bound with each other. One can presume that these features indicated a built-in gateway (Fig. 11). It is likely that the original rampart had been lower, extending vertically only to the height of the gateway. At some point the gateway was blocked up and the rampart was built higher all round. It seems that the northern wall of the gateway had originally extended further outwards, forming the protruding part of the wall, which continued higher up the rampart. Another possibility is that the rampart was originally built full height, and the gateway, which was about 3.2 m high and 2.1 m wide at the bottom, was supported by beams and led through the stone rampart.

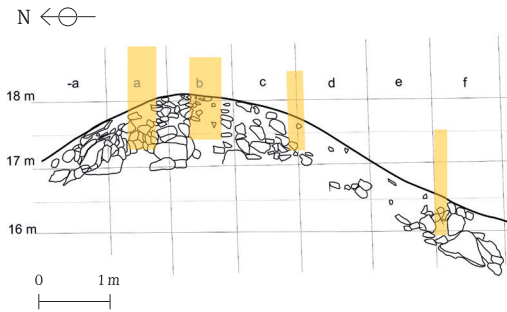
Fig. 12. Eastern profile in trench M, with post places marked on the drawing.

an earthwork with single stones and some large postholes (Fig. 12). The construction phase D in the upper part of the rampart in trench M had consisted of massive wooden posts and boxes made of horizontal beams, the inside of which had been filled with soil and a few stones. Since a collection of stones was uncovered in the lower part of trench M, it can be assumed that the somewhat lower stone wall 3 was also present in the southern side of the hill fort, although this is not confirmed. In any case, the soil rampart 3-2 that consisted of cultural layer seems to have existed here, too, as indicated by some metal finds.

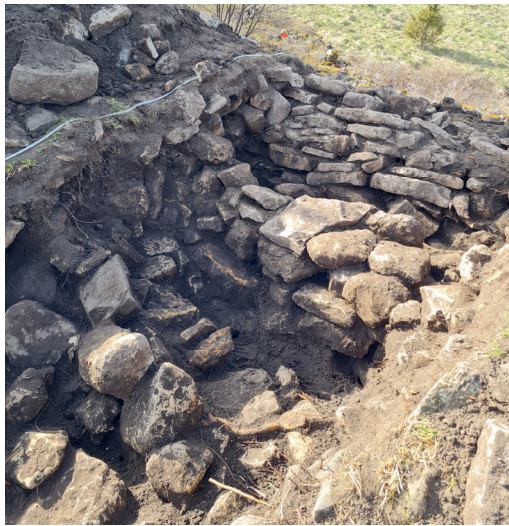
Fig. 13. Walls 5 and 5-1 in trench M.

Excavation M uncovered wall 5, built of regular limestones (Fig. 13). It resembled wall 3, but was located about 3 m closer to the inner courtyard. The slope of the part of

Mingil ajal laoti vastu valli 5 välisserva täiendav, peaaegu püstloodne kivivall 5-1 (jn 13). Kahe kividest valli vahel olid nüüd puitkonstruktsioonid, võib-olla palkidest palissaad (jn 12). Vallidest 5 ja 5-1 väljapoole jääv osa kindlustisest erines linnuse lõunaosas sellest, mis tuli välja idapoolsetes kaevandites. Siin ei ulatunud hilisem kivivall kuigi kõrgele ning kindlustise ülemine osa oli ehitatud puidust. Säilinud postiaugud osutavad ilmselt mulla ja väheste kividega täidetud rõhtpalkidest kastidele. Pole kindel, kas valli alumine osa oli kunagi olnud laotud ka kivimüüriina, kaevand M nii kaugele ei ulatunud.

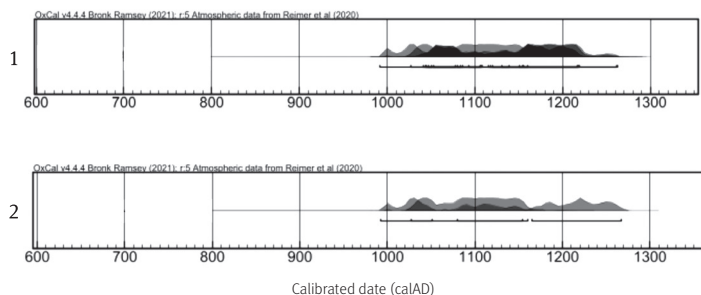
Fig. 15. Stackplot of calibrated ^{14}C dates from construction phases D and F at Valjala hill fort. 1 – from construction phase F, 2 – from underneath wall 1.

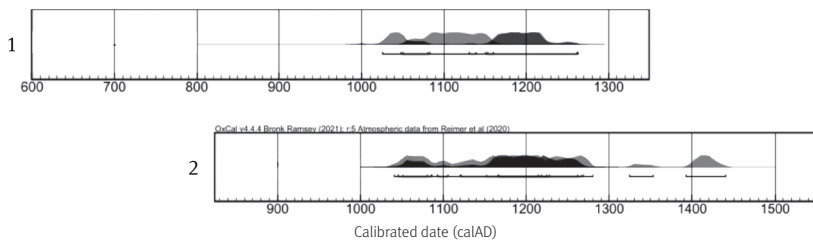
Fig. 16. Stackplot of calibrated ^{14}C dates from construction phase A at Valjala hill fort. 1 – from the infill of wall 3-2, 2 – from cultural layer between walls 1 and 2 and outside wall 1.

^{14}C samples made from charcoal found from the infill material of wall 3-2, as well as some finds, date the cultural layer forming the wall predominantly to the second half of the 12th and the first half of the 13th century (Fig. 16: 1). Considering that the cultural layer used for erecting wall 3-2 was gathered from the surroundings of Valjala hill fort, ^{14}C results from the area outside the main hill fort can also be taken into account (Mägi *et al.* 2023, fig. 3). Calibrated data put in a stackplot created in OxCal program highlighted the mid-11th century and the period from mid-12th century until the 1270s as the most likely occupation periods, although one sample indicated even later time (Fig. 16: 2). It is in a good correlation with artefacts found during different excavations in and outside Valjala hill fort (see <https://osiliana.eu/en/valjala-hillfort/>), as well as the infill material that was used for re-fortifying wall 1 (the second building phase; Mägi *et al.* 2023). However, occupation around the hill fort had probably stopped some time before the soil was gathered for erecting wall 3-2 and re-fortifying wall 1. The possibility that it happened in the very end of the 13th century, in the middle of the 14th century, or in the early 15th century, as indicated by one ^{14}C sample (Poz-156085; Mägi *et al.* 2023, fig. 3) cannot, therefore, be excluded.
