Archaeological investigations at Kuressaare castle and the harbour storehouse

Garel Püüa

ARCHAEOLOGICAL INVESTIGATIONS AT KURESSAARE CASTLE

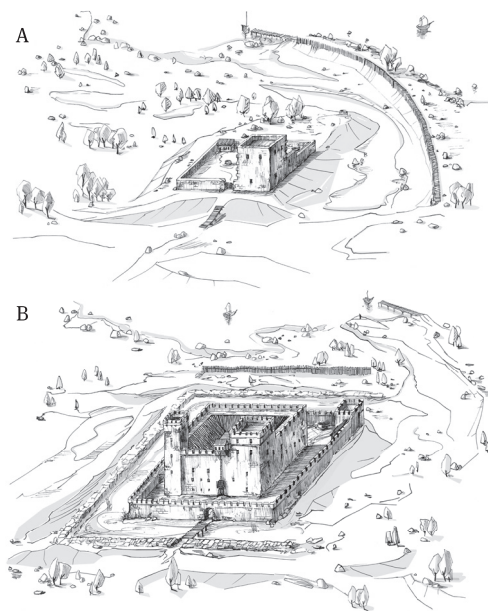
Fig. 3. Reconstruction attempts of the original Kuussaare stone castle, built in ca. 1328–1345 (A) and a *Konventhaus* that was erected in the second half of the 14th century (B).

Jn 3. Kuussaare algse (ehitatud u 1328–1343) kivilinnuse (A) ja 14. sajandi teisel poolel püstitatud konventihoone (B) rekonstruktsioonikatsed.

Based on the field examinations conducted from 2010 to 2014, Kuressaare's original stone castle was a simple regular (43×43 metres) *castellum* (Alttoa & Püüa 2013, 64). A defence tower with living quarters named Sturvolt was similarly built in the northern corner of the curtain wall (Fig. 3A). Several buildings were probably erected in the courtyard. A small auxiliary building was constructed on the southwest side of Sturvolt (Figs 1, 3A). Construction

A wall built of limestones and field stones using lime mortar running northeast–southwest that intersects with the *Konventhaus* came to light from the east side of the *Konventhaus*'s gate (Fig. 1: 3). Its thickness was measured as 1.8 m. A section of that same wall was seen in the course of pipeline work that was carried out in 1993–1995 (Sepp 1996, 4–5). The wall was built against the inner side of the 1st curtain wall and probably protected the road leading to the *Konventhaus* in the 1st outer bailey, and the gate of the *Konventhaus* (see Fig. 3B).

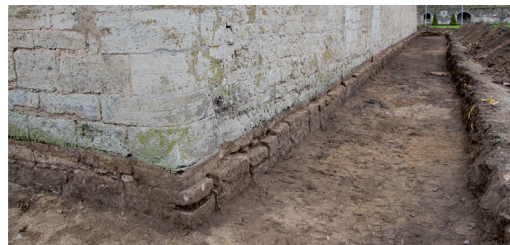
Fig. 4. View of the protruding foundation wall built of unhewn limestone on the southwestern side of the *Konventhaus*.

Jn 4. Vaade konventihoone edelaküljel eenduvale murtud paekivist alusmüürile.

A 15 to 30 cm plinth protruding from the wall at an elevation of 4.25 to 4.6 m a.s.l. on the northeast, southeast, and southwest sides of the *Konventhaus* was cleaned in the course of the investigations. This tallies more or less with the current ground surface elevation (Fig. 4). Only unhewn stones have been used in the lower part. On the other hand, blocks with chiselled surfaces are the material used above in the walls of the *Konventhaus*.

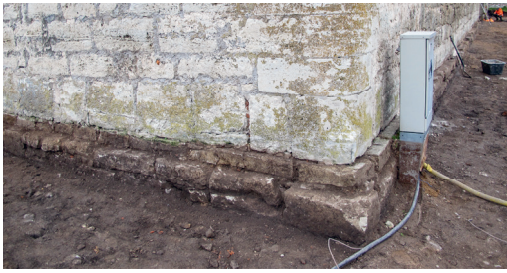
Fig. 5. Southern corner of the Konventhaus. The transition from the right-angled foundation wall to the rounded exterior corners of the Konventhaus with concave facets resembling a pyramid takes place without any intermediate articulation.

Jn 5. Konvendihooone lõunanurk. Üleminek täisnurkselt alusmüürilt konvendihooone nõgusate tahkudega püramiidi meenutavatele ümardatud välisnurkadele toimub ilma igasuguse vaheliigenduset.

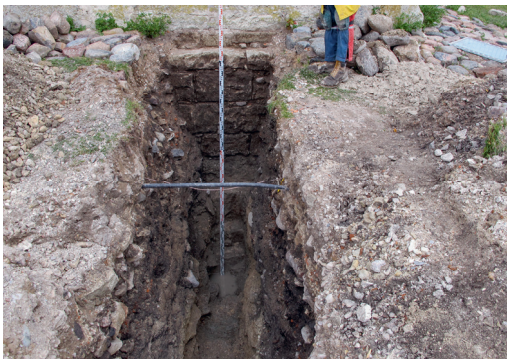
Fig. 6. In excavation XIV from 2012, the southwestern side of the Konventhaus was supported by a previously existing wall that was nearly three metres tall, which protruded in stepped fashion from the wall of the Konventhaus.

Jn 6. 2012. a kaevandis XIV toetus konvendihooone edelakülg varasemale pea kolme meetri kõrgusele müürile, mis eendus astmeliselt konvendihooone seinast.

pavement laid around the protruding foundation wall was approximately 120–140 cm lower than the *Konventhaus*'s wall made of blocks with chiselled surfaces.¹ Based on find material, the medieval courtyard ground surface of the 1st outer bailey remained at the same elevation in the 17th century. Thus, the wall made of unhewn stones was not the foundation of the *Konventhaus* hidden beneath the surface soil, but rather a visible socle zone that extended to a height of nearly 140 cm. The transition from one material to the other is without any kind of intermediate articulation (Fig. 5). Thus, it is unlikely that this is an intentional contrasting of wall textures from the time of the construction of the *Konventhaus*. Instead, the nearly 3-metre-high socle zone² likely originates from a wall that was built earlier and it is evidently the curtain wall of the *castellum* (Fig. 6).

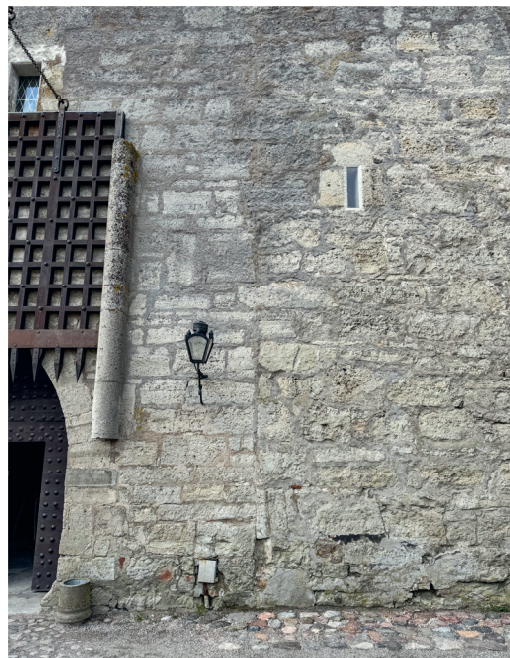
Fig. 7. The vertical joint on the northeastern side of the *Konventhaus* between Sturvolt Tower (on the right) and the wall of the *Konventhaus* extends to the lantern. The binding stones protruding from the tower's corner can be seen higher up. The upright limestones placed at the tower's corner near the ground surface suggest that the eastern corner of Sturvolt was restored after the *castellum* wall had been demolished to a lower height.

Jn 7. Püstvuuk konvendihoone kirdeküljel torni Sturvolt (paremal) ja konvendihoone seina vahel ulatub lanternani. Kõrgemal on näha torni nurgast eenduvaid sidekive. Maapinna lähedal torni nurka paigutatud püstised lubjakivid viivad mõttele, et Sturvolti idanurk on pärast kastellimüüri madalamaks lammutamist taastatud.

How tall might the *castellum*'s curtain wall have been? Massive binding stones, which were already put in place at the time of the tower's construction, can be seen at the eastern and western corners of Sturvolt. The northwestern and northeastern walls of the *Konventhaus* were later connected to the binding stones extending out from Sturvolt's wall surface that were meant for anchoring the wall of the next construction stage. There is no contact between the tower and the adjacent wall on the northeast side of the *Konventhaus* above the current ground surface to an extent of about 3.5 metres. The binding stones appear beside the gate at an elevation of 8.3 m a.s.l. (Fig. 7). Upright limestones placed at the tower's corner near the ground surface suggest that Sturvolt's eastern corner was restored to the height of the first binding stone (from the gate) after the *castellum* wall had been reduced in height through partial dismantling and before construction of the *Konventhaus*'s wall. This could be indicative of the completed height of the northeastern side of the *castellum* wall. However, this is only a hypothesis.

Sturvolti ida- ja läänenurgas on näha massiivseid sidekive, mis on paika pandud juba torni ehitamise ajal. Hiljem on Sturvolti seinapinnast välja ulatuvate ja järgmise ehitusetapi müüri ankurdamiseks mõeldud kivihammastega liidetud konvendihooone loode- ja kirdesein. Konvendihooone ees ehk kirdeküljel puudub praeguse maapinna kohal umbes 3,5 meetri ulatuses kontakt torni ja külgneva müüri vahel ning sidekivid algavad värava kaare kõrgusel (jn 7). Maapinna lähe-

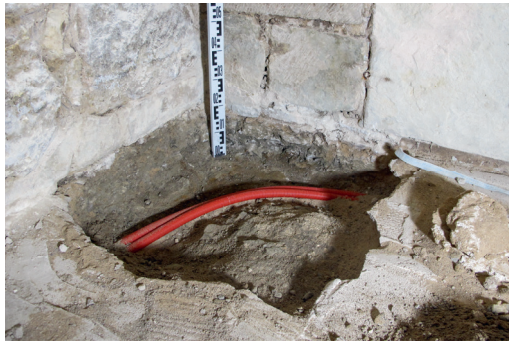
Fig. 8. Test pit no. 19. The foundation of the interior side of the room's northeastern wall (the *Konventhaus*'s exterior wall, on the right) beside the gate is at an elevation of 3.22 m a.s.l. The room's original floor was situated at more or less the same elevation as the current floor.

Jn 8. Šurf nr 19. Ruumi kirdeseina (konventihoone välissein, paremal) sisekülg värava kõrval on vundeeritud kõrgusel 3,22 m ümp. Ruumi algne põrand asus praegusega enam-vähem samal kõrgusel.

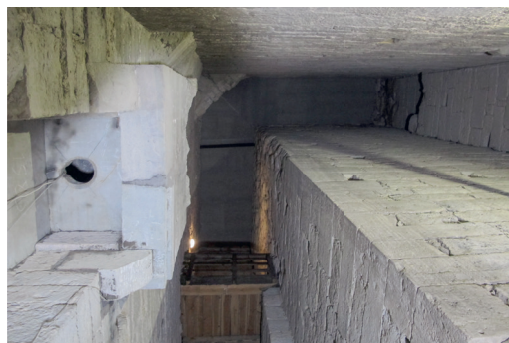
Fig. 9. The isolation shaft surrounding Pikk Hermann Tower (on the right). One of the toilets opening up into the shaft can be seen on the left. Even nowadays as well, access to the tower is by way of a wooden bridge, the base of which is at a height of 9.7 m.

Jn 9. Tornii Pikk Hermann (paremal) ümbritsev isolatsioonisaht. Vasakul on näha ühte šahti avanevatest käimlatest. Pääs torni kääb ka tänapäeval puidust sil-la kaudu, mille põhi asub 9,7 m kõrgusel.

Two shafts (Fig. 2: 14–15) were dug in room no. 110 on the inner side of both outer walls of the isolation shaft surrounding Pikk Hermann Tower. An isolation shaft that runs through all storeys separates Pikk Hermann from the rest of the rooms of the *Konventhaus*. The only access to the tower was by way of a drawbridge from the historical main storey. A nine-metre-high cellar room without any openings forms the first storey of Pikk Hermann. This room is accessible only by way of a hatch situated above. Even now, the only entrance to the five-storey tower is at a height of 10 m from the ground surface and leads to the tower's second storey (Fig. 9). The tower's three upper storeys are supplied with fireplaces. They were apparently meant as the last refuge if enemies gain entry into the main castle. Several dry toilets opened up into the shaft, which was also used as a dump for trash, into which food waste was thrown.

From this, the question arises of how the toilet shaft was emptied. It would have been easiest to do that by way of an opening connecting the room to the outer bailey and the moat. Archaeological investigations gave no indication of such an opening. The original clay floor of the rubbish shaft is at its current elevation (about 2.7–3 m a.s.l.) and the room has been emptied of the waste in the course of previous restoration work.

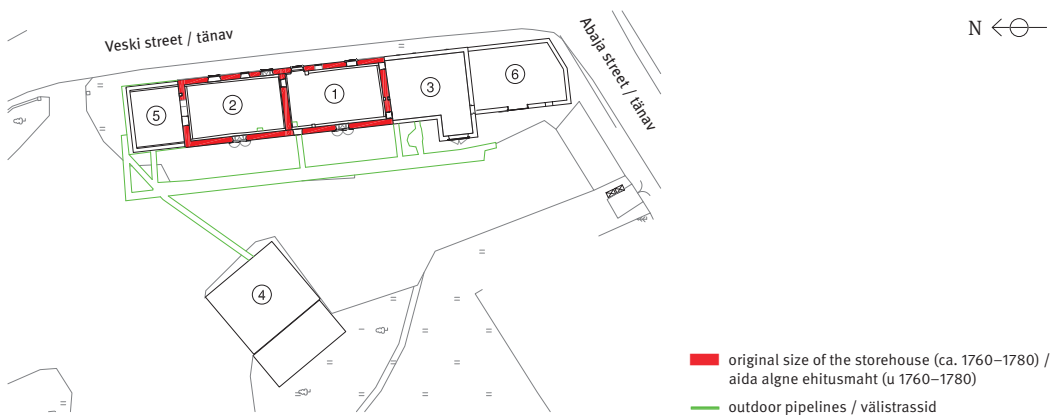
Fig. 11. Diagram of the various construction stages of the harbour storehouse. 1 – room no. 1, 2 – room no. 2, 3 – steam mill, 1870, 4 – former oil storehouse, about 1927, 5 – office, 1932, 6 – annexe, 1951–1958.

Jn 11. Sadama kaubaaida erinevate ehitusjätkude skeem. 1 – ruum nr 1, 2 – ruum nr 2, 3 – auruveski, 1870, 4 – endine õililadu, u 1927, 5 – kontor, 1932, 6 – juurdeehitis, 1951–1958.

The storehouse with a gable roof that was built on the shore of Tori Inlet originally consisted of two large rooms (Figs 11: 1, 2; 13), primarily for storing grain that was to be exported from Saaremaa. The oldest surviving wall sections of the storehouse were built of unhewn limestone, where the binding agent is clay mortar, characteristic of Kuressaare.

The Estonian ETK office moved into the newly completed building in 1933 (Fig. 11: 5). Another part was added to the building on the south side of the storehouse in the interval 1951–1958 and it was extended to Abaja Street (Fig. 11: 6). The building was sold to a buyer from the private sector in 1993.

The previous floors were removed in two rooms of the older part of the harbour storehouse (Fig. 11: 1, 2), and digging proceeded 50–60 cm deeper than the existing wooden floor (at an elevation of 2.04 m a.s.l.). The dimensions of the floorboards that were removed were mostly 430 × 16.5–21 × 6 cm. The relatively well-preserved floor could already have been built together with the steam mill at the end of the 19th century. Timbers that were prevalingly in secondary use (burned, cut in pieces) were used as foundation beams. Part of the previous stone floor had been removed to enable the installation of those beams (Fig. 15).

A test pit with a surface area of approximately 0.7 m^2 was dug in the northwestern corner of room no. 1 (Fig. 11: 1). It turned out that an approximately 30 cm thick cultural layer that predates the construction of the storehouse had been partially preserved beneath the stone floor. Finds originating primarily from the 18th century were obtained from that layer (SM 10946: 2–6), among others a *denga* copper coin from the reign of Empress Elizabeth I (Yelizaveta Petrovna, 1741–1762) originating from 1751 (SM 10946: 3). The presumably natural clay layer began in room no. 1 at an elevation of 1.25 m a.s.l.

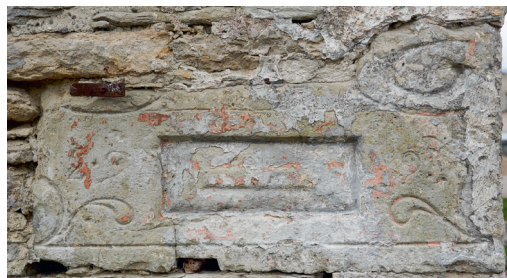
Fig. 12. Hewn stone inscribed with the year 1663 placed upside down in the northeastern corner of the harbour storehouse wall.

Jn 12. Sadamaaida kirdenurgas tagurpidi seina müüritud raidkivi aastaarvuga 1663.

laid the basis for this opinion nearly 140 years ago (Körber 1887, 3). The dating of the storehouse is based on an ashlar marked with that year, which was found in a wall of that building. This has dominated in later academic literature (Blumfeldt 1934, 818; Miller 1959, 265–266; Künnapu 1996; Basihhina & Hansar 1999, 11 & 43; Püüa 2018, 306; Altkoa *et al.* 2019, 261). Upon closer examination, it can nevertheless be said that the ashlar bearing the date, which was laid upside down in the wall at the northeast corner of the storehouse, is more likely secondary and was added to the building later (Fig. 12).

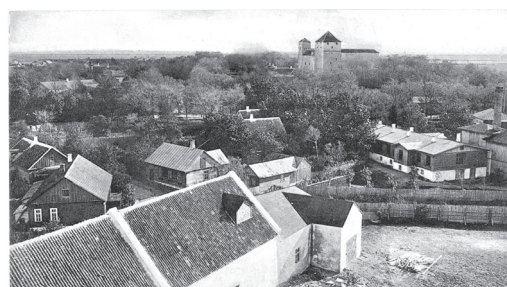
Fig. 13. View of the southern part of the harbour storehouse (below), of the new mud baths (on the right), and the newly renovated Konventhaus in ca. 1912.

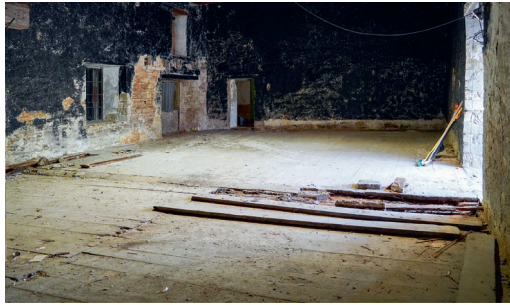
Fig. 14. The wooden floor preserved in room no. 2 might originate from the 19th century.

Jn 14. Ruumis nr 2 säilinud puitpõrand võib pärineda 19. sajandist.

The stone floor was less worn in the northern part of room no. 2 and unlike the rest of the room, the later plank floor was situated in the east-west direction (Fig. 14). A test pit with a surface area of approximately 0.4 m^2 was dug adjacent to the western wall of room no. 2 (Fig. 11: 2). It turned out that an approximately 30 cm thick cultural layer that predates the construction of the storehouse had been preserved beneath the stone floor in this room as well. Finds originating primarily from the 18th century were obtained from the cultural layer beneath the stone floor (SM 10946: 20–30), including a *denga* copper coin from the reign of Elisabeth I (Yelizaveta Petrovna) (1750, SM 10946: 20). The presumably natural clay layer began at an elevation of 1.3 m a.s.l.

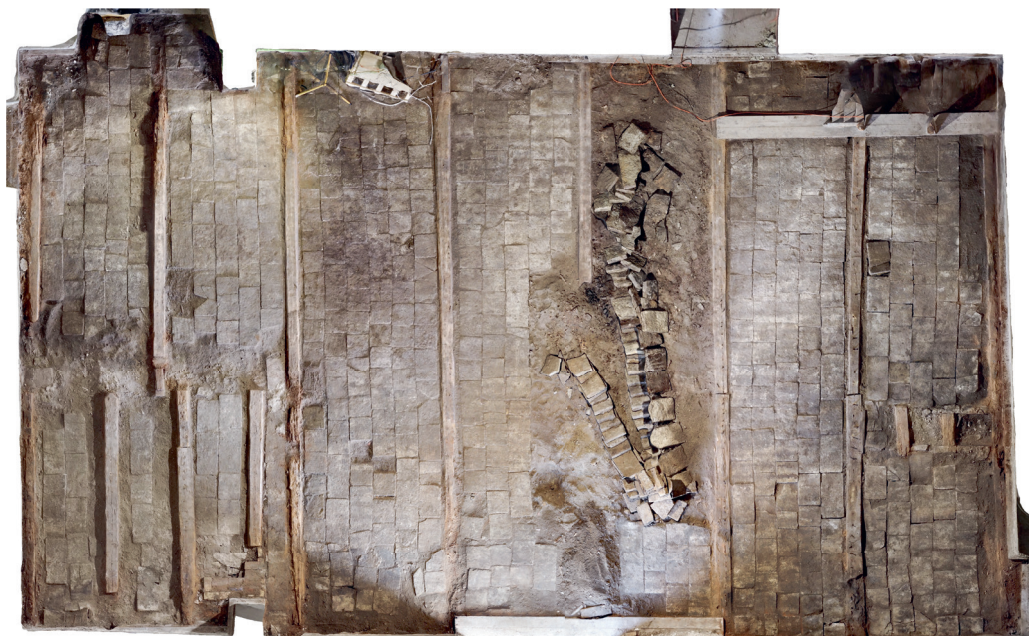
Fig. 15. View of the original 18th-century stone floor of room no. 1 in the harbour storehouse (dimensions 8.9×15 m, ceiling height 5.15 m) that intersects with the foundation beams of the later 19th-century plank floor. Veski Street is at the upper edge of the photograph.

Jn 15. Vaade sadamaaaida ruumi nr 1 (mõõtmed $8,9 \times 15$ m, lae kõrgus 5,15 m) algele 18. sajandi kivipõrandale, mida lõikavad hilisema 19. sajandi laudpõranda aluspalgid. Veski tänav jääb foto ülemisse serva.

In both rooms, there was a 5–10 cm thick layer of sand mixed with soil beneath the plank floor covering the storehouse's probably original limestone floor, which was laid at the end of the 18th century. The filler layer contained a few animal bones and artefacts dated to the 17th–18th centuries (SM 10946: 7–19). As a rule, the dimensions of the floor slabs were 33 × 33 × 7–9 cm (one foot), 33 × 65–67 × 7–9 cm (two feet), and their bottom surface was rough and unhewn (Fig. 15).

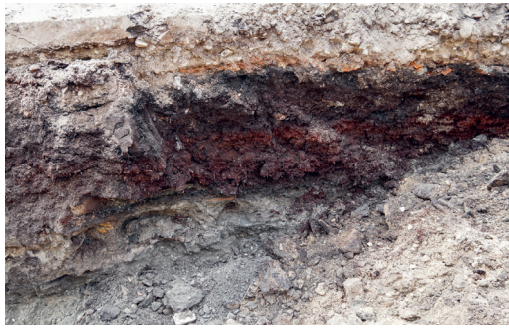
Fig. 16. A 60–70 cm thick dark reddish layer saturated with tanning agent is visible beneath the gravelly courtyard fillings. This was found throughout the property.

Jn 16. Kruusaste hoovitäidete all on näha 60–70 cm pak-sust tumedat-punakat parkimisaine kihti, mida leidus kogu kinnistul.

A sewerage and stormwater pipeline was installed on the western side of the harbour storehouse. The depth of the trench dug for this purpose was 130–150 cm (Fig. 11). A layer containing sawdust and tree bark mixed with dark reddish tanning agent associated with the operations of the Wildenberg leather factory at the end of the 19th century and the start of the 20th century was found in all places beneath the present-day gravelly courtyard fillers (Fig. 16).

The tanning agent layer was thicker in the southern part of the property (up to 70 cm), decreasing to 20 cm in the northern part of the property. As a rule, this had settled on a mixed layer of clay that contained coal, wood, lime mortar, and pieces of roof tile and bricks. It also contained a few fragments of
