# Archaeological investigations at Lossi Street 13, Tartu

#### Rünno Vissak

From 25 April to 28 November 2023, archaeological excavations took place in Tartu at Lossi Street 13, in an area of 515 m<sup>2</sup>. The previous investigations conducted in 2022 on the same site were carried out to the depth required for construction and reached deposits from the 18th century, partially exposing the upper parts of the walls of buildings preserved in the ground. Initially, the deeper layers were planned to be preserved under the new building. However, due to project changes, most of the site needed to be fully explored in 2023, down to the natural ground.

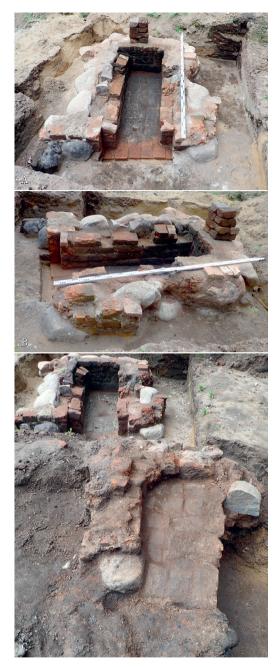
- Fig. 9. A Oven 1, opening of the hearth and the fire chamber floor. View from the east, B Oven 1, the southern wall with three furnace flue openings. View from the north, C Ovens 1 and 2. View from the east.
- Jn 9. A Ahi 1, kolde ava ja põhi. Vaade idast, B Ahju 1 lõunasein kolme lõõriavaga. Vaade põhjast, C – Ahjud 1 ja 2. Vaade idast.

The hearth of Oven 1 was oriented east-west, with the opening of the hearth facing east (Fig. 9). The measurements of the oven, taken from the lower stones, were 245 cm east-west and 206 cm north-south. The length of the hearth, measured from the interior walls, was 167 cm, and the width was 56 cm. The walls of the hearth remained intact up to the height of 54 cm from the bricks laid on the hearth floor, i.e. up to five brick courses. The bricks of the hearth measured 7.5–9 × 14–15.5 × 30–32 cm. In this case, as well as with the other ovens, there is a high possibility that the bricks used originated from the walls of some earlier buildings and were reused in the ovens.

opening of the hearth was set back by half a brick on the eastern side, suggesting a possibly closable hearth opening, although there were no traces of, for example, door hinges.

The hearth of Oven 2 was also oriented east-west, with the opening facing east (Fig. 9C). The outer sides of the oven were partially destroyed on both the north and south sides, while the base of the hearth and its western and southern edges were better preserved. The measurements of the oven, taken from the surviving lower stones, were 150 cm east-west and 137 cm north-south. The length of the hearth, measured from the interior walls, was 107 cm, and the width was 60 cm. The measurements of the bricks in the hearth floor of Oven 2 were  $9.5-10 \times$  $15 \times 31$  cm and  $10 \times 14 \times 30$  cm. A post-medieval redware tripod with a yellowish-green glazed interior surface and a grooved exterior surface was found in the ash layer in front of the hearth mouth.

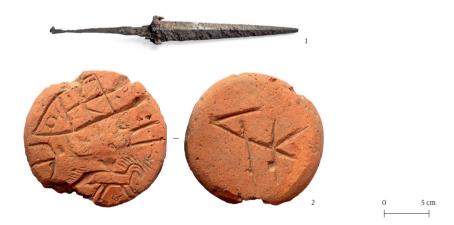
**Fig. 12.** A ballock dagger with a double-edge blade (1) and a brickware lid with carved fish and horse images on the upper side and master's mark on the bottom side (2).

half of the 16th century is a ballock dagger with an evenly tapered double-edge blade and a metal plate between the blade and the hilt drooped towards the blade (Fig. 12: 1). The wood-en part of the hilt is not preserved. The blade is relatively short, only 16 cm, and the hilt is 10.5 cm long.

Some fragments of brickware lids were found. Among these finds the most notable is the 15th–16th century lid with a chip-carved fish and (probably) a horse image on the upper side and a master's mark on the bottom side (Fig. 12: 2a–b). The handle has been broken off. The rim is diagonal, the bottom side is not blackened and there are no traces of smoke or fire. The diameter of the lid is 14.5 cm. The fish and animal motif on the lid can be interpreted in favour of the version that such lids were used in food preparation and meant to cover tripod pots.
