ARCHAEOLOGICAL
FIELDWORK
IN ESTONIA

2006

ARCHAEOLOGICAL INVESTIGATIONS AT THE TOOLSE ORDER CASTLE

Tõnno JONUKS and Kahrut ELLER

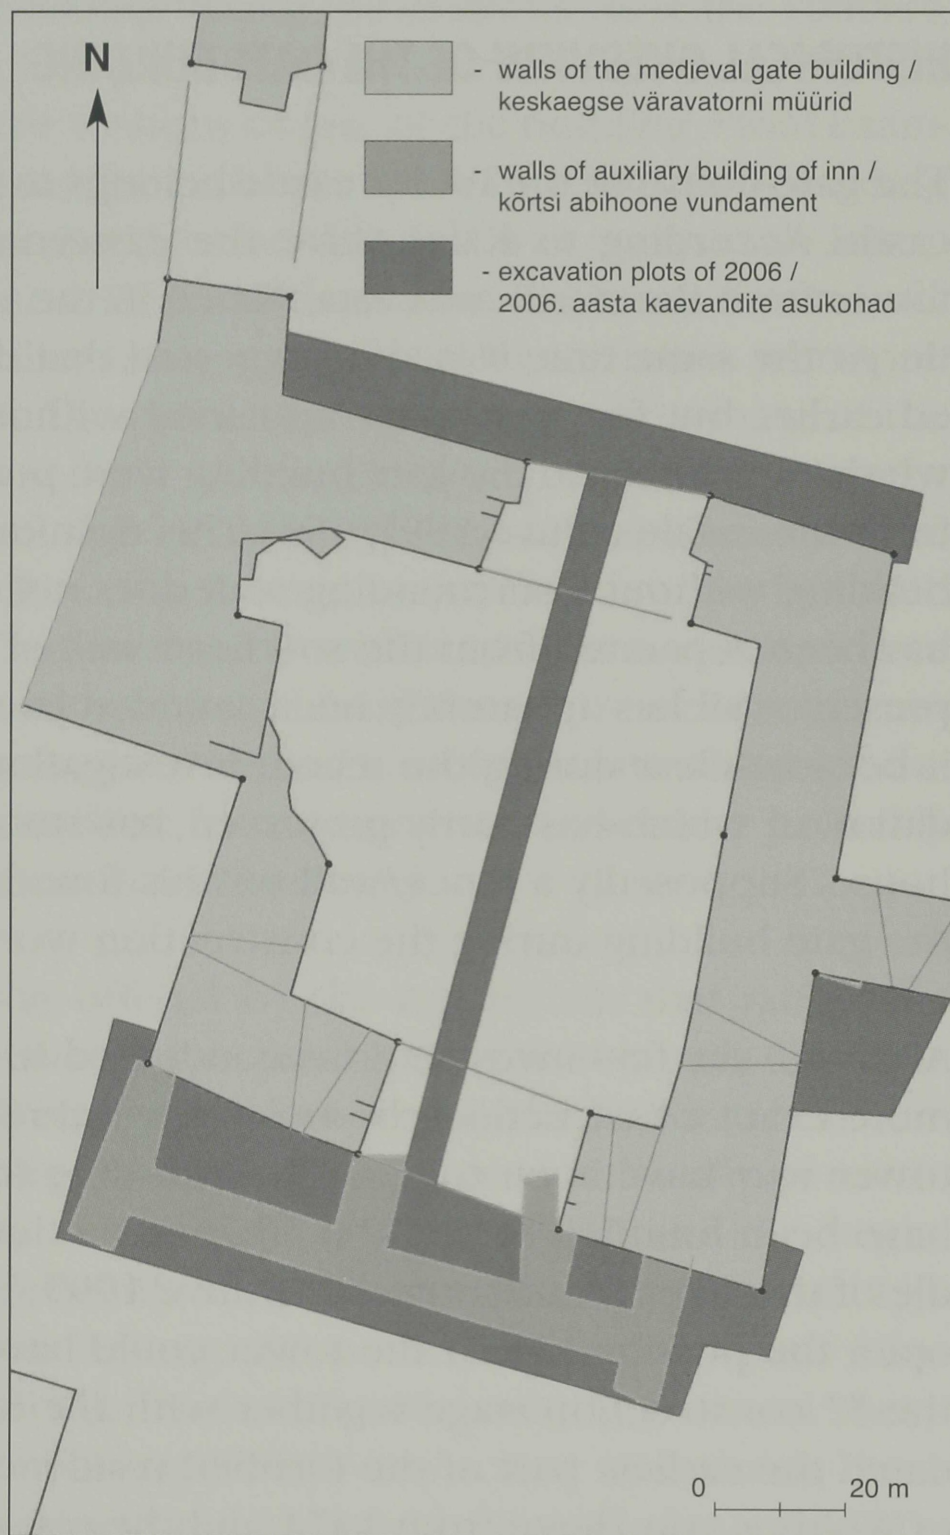
Fig. 1. Excavations and walls in 2006 in the gate building of Toolse Order Castle.

The investigations of 2006 that were initiated because of the need for the conservation works, concentrated on one of the latest construction stages of the castle, the easternmost gate tower (Fig. 1). The facades of the walls of this part of the castle were most heavily damaged and in order to prevent future collapses, conservation works were scheduled to start there. In the course of the works the outer facades of the gate house were opened up to the foundation height, a trial trench was excavated across the gate building and a test pit was dug on the eastern side of the building. At the same time all the openings connected with the gate house – both the embrasures as well as the canals for the bolt beams, were cleaned and documented.

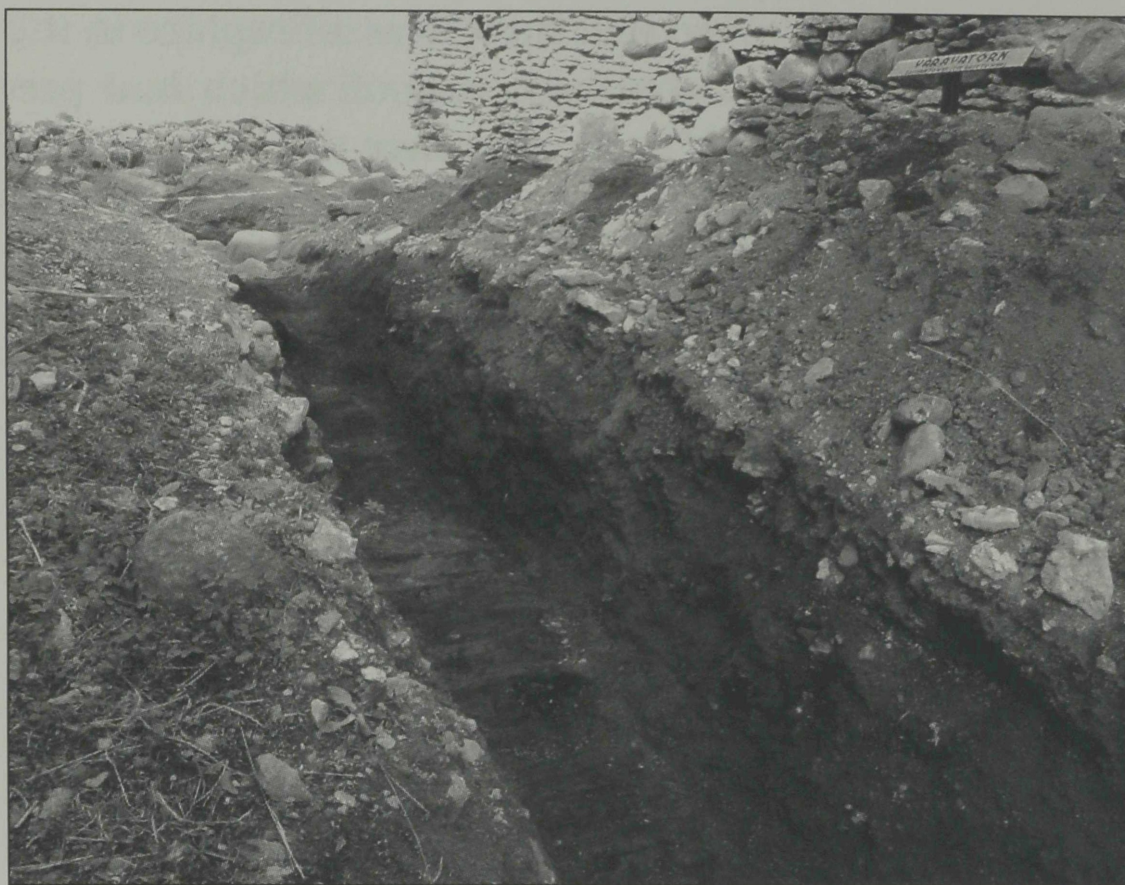
Fig. 2. Timber floor and cultural layer dated to the 16th – 17th century in the test trench.

Below a very homogeneous 30–40 cm thick layer everywhere in the trench a floor laid of boards and slimmer rods was unearthed (Fig. 2). Due to the thick cultural layer rich in organic remains on the floor the boards and rods were very well preserved. Only in some places on the floor fire damages were detected. The floor had been laid very evenly and the fluctuations of the floor did not exceed 5 cm for the 12 m long trench. Whereas the floor had been pre-

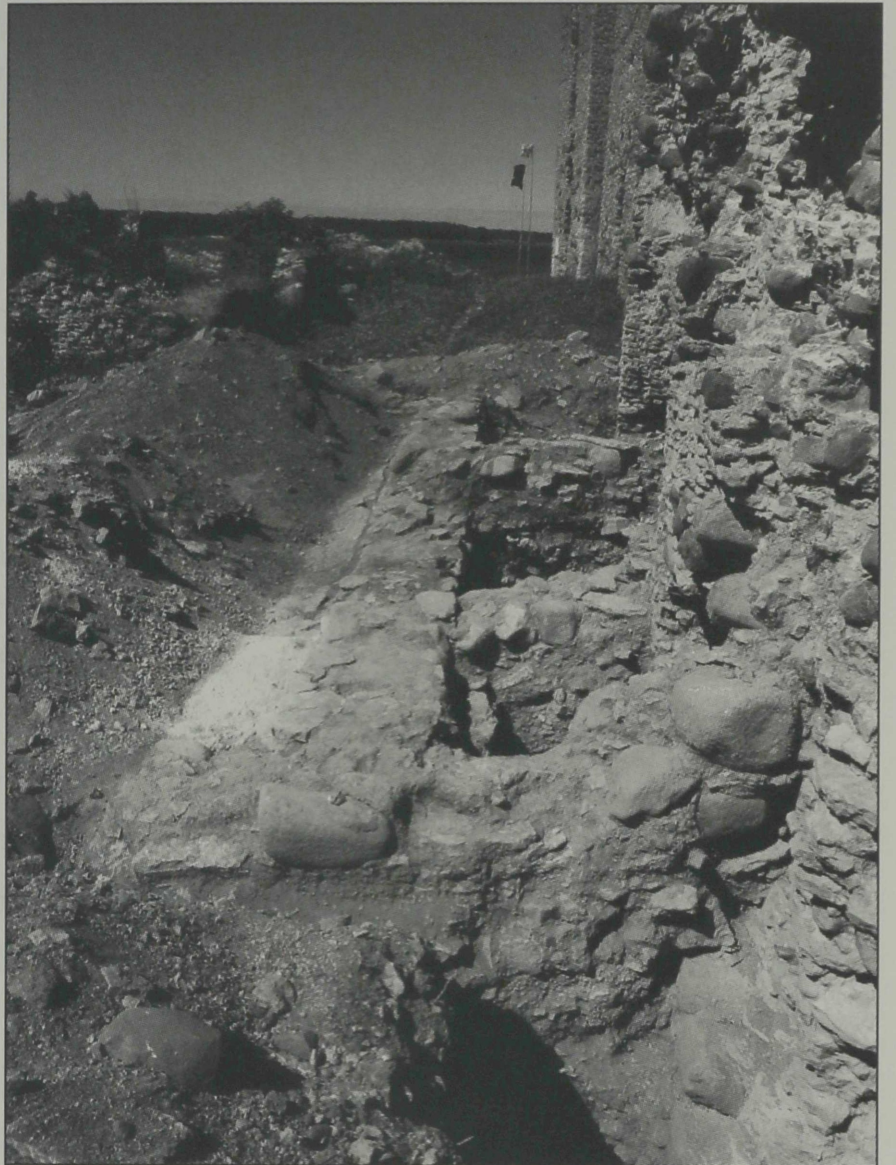
Fig. 3. Foundation of the auxiliary building of the tavern on the southern side of the gate building.

The foundation of an auxiliary building of a tavern was unearthed in the trench of the southern side of the gate house (Fig. 3). In places it had a very carefully, in places a haphazardly, laid foundation which had probably supported a wooden building. The auxiliary building clearly dates from a later time than the ruins of the inn that have preserved until today. Also earlier layers had been conserved

The walls of the inn have been joined with clay and thereafter covered with lime plaster. After the completion of the tavern an auxiliary building has been erected on its eastern side. The foundation of the auxiliary building was made of stones and joined with clay, but the main part of it was made of timber. The building had a floor made of limestone slabs. Whereas the slabs were relatively big they could not have originated among the stones from the castle (like several of the construction stones of the inn and its auxiliary building were). Suitable construction material was probably broken from the castle ruins nearby, but new stones were brought for the floor slabs. The ground plan of the auxiliary building could be tracked already on the ground where the foundation of the construction could easily be followed.

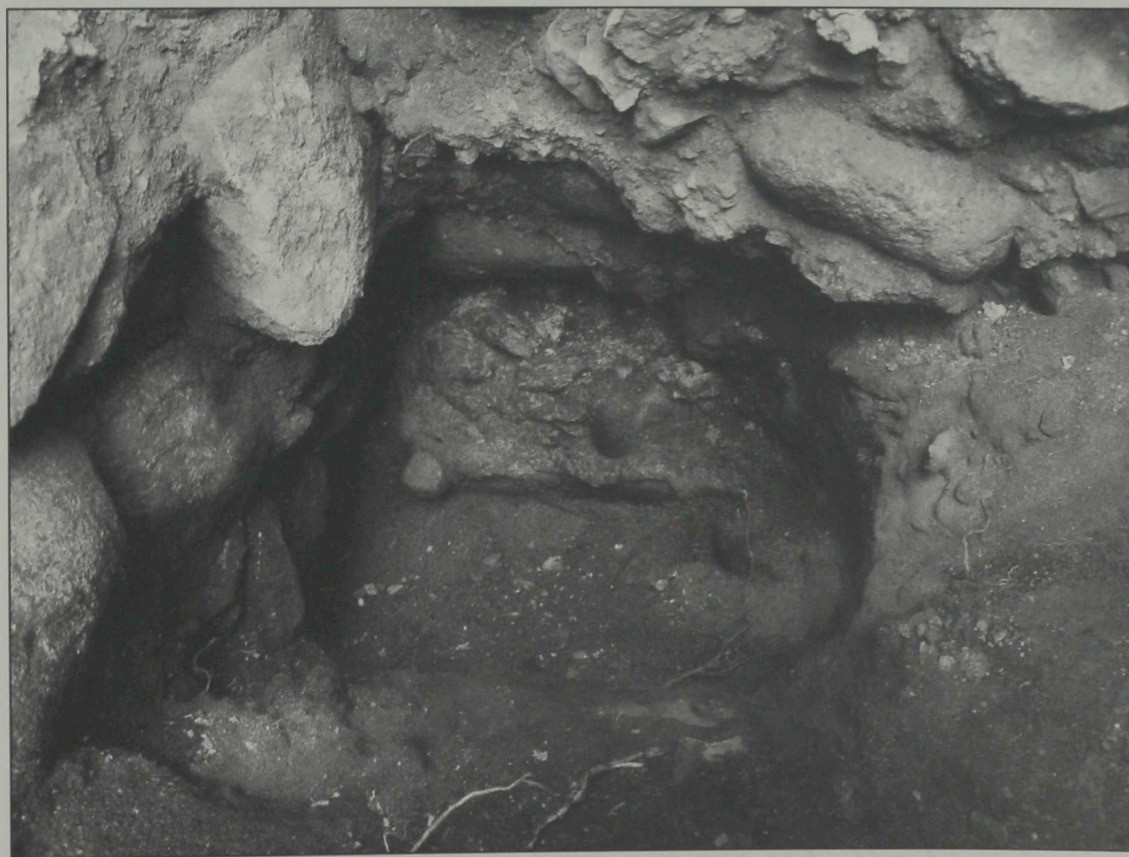
Fig. 4. The foundation of small pebbles joined with abundant lime mortar in the test-pit on the eastern side of the gate building.

From the construction-historical standpoint of medieval castles the test-pit in the corner of the gate tower and the forecourt was the most informative. An earlier foundation was discovered under the southern wall of the forecourt in the bottom of a 3 meters deep test-pit (Fig. 4). The foundation remains consisted of smaller pebbles and were joined with plenty of yellow lime mortar. The foundation was clearly distinguished from the walls of the gate house as well as the southern wall

of the forecourt. Since no bigger stones had been used, it could hardly be described as a basis of a stone wall. More likely it may be a stone foundation for a log-wall that initially surrounded the castle area and was later replaced with a stone wall. Based on the crack found in the eastern wall of the gate building also Kaur Altoa (2004) has suggested the existence of an earlier wall that ran straight through the gate house.
