Archaeological studies in the church of Haljala

Villu Kadakas

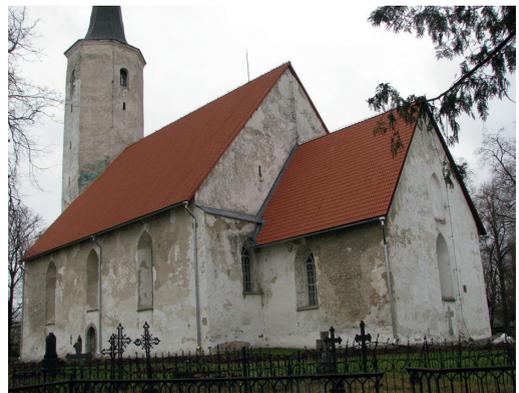
Fig. 1. Haljala church from south-east.

The rural parish church of St. Maurice in Haljala (Germ. *Halljall*) is situated in the western part of the historic province Virumaa, ca. 12 km north-west from Rakvere, the historic capital of the province. The church (Fig. 1) has been standing on a strategic location, on the crossroads where once met the historic roads from Tallinn to Narva and from Rakvere to the northern coast, also to Toolse, the medieval harbour of the province.

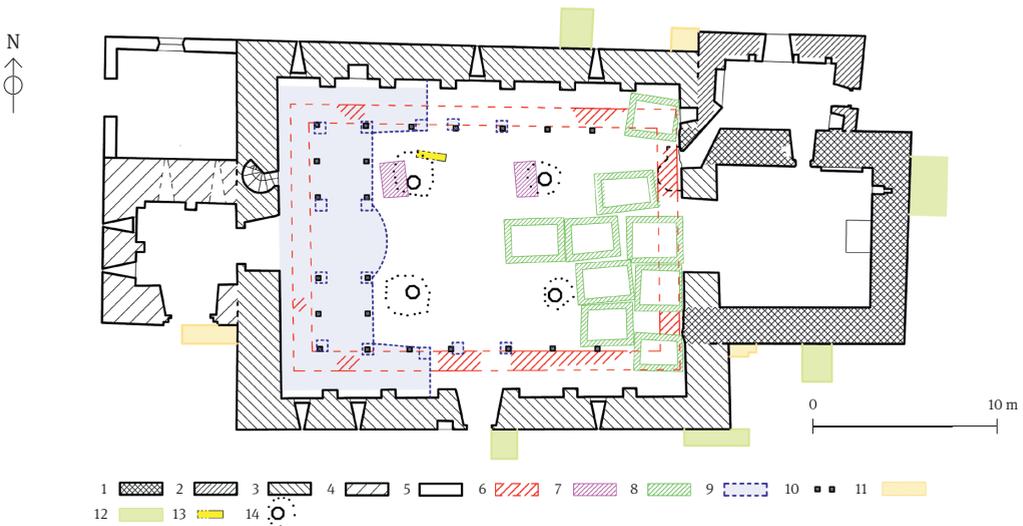
Fig. 2. Plan of Haljala church. 1 – building stage I: chancel, 2 – building stage II: sacristy, 3 – building stage III: nave, 4 – building stage IV: western tower, 5 – early modern additions, 6 – remains and reconstruction of the walls of the earlier nave, 7 – foundations of side altars, 8 – burial chambers, 9 – discovered post foundations and reconstruction of the extent of the earlier organ gallery, 10 – posts of the existing gallery, 11 – test pits of 1959, 12 – test pits of 1987, 13 – burial with timber coffin, 14 – pillars with the extent of their foundations.

The archaeological research in Haljala church (for a short summary in Estonian, see Kadakas 2017) was undertaken because of the replacement of the rotten timber floor with a new stone floor in the nave (Figs 2–3). Ca. 25–30 cm thick layer of upper soil, consisting of various demolition and construction debris, mixed burial soil and remains of the recent timber floor was removed. It was decided to remove the upper soil, which had been contaminated by fungus, to keep the contamination from spreading and to provide a solid base for the new floor. Some small-scale test pits were dug deeper with the aim to get a basic idea about the underlying deposits and to find remains of a previous church. In the eastern half of the nave a ground penetrating radar (GPR, fieldwork organised by Kaarel Orviku and Hannes Tõnisson, Institute of Ecology, Tallinn University) was used to locate the stone walls of a supposed previous church.

Building history of Haljala church has been thus far most thoroughly studied by Estonian art historian and church archaeologist Villem Raam. According to him the present church has been built in several stages during the 15th century. He has concluded that the church was planned as a whole at one time but built in three mayor stages. At first, ca. 1430–1440, the chancel with the sacristy was built, probably in the third quarter of the 15th century the three ailed nave in a form of a hall church was added, and finally in the end of the century the western tower was erected (Fig. 2: 1–4;

Raam 1997). The four eight-sided pillars of the nave support nine cross vaults (Figs 2–3). The interior of the nave lacks any dressed masonry details except the western portal with a pointed arch and simple geometric forms. The southern portal of the nave is thought to be a secondary breakthrough of uncertain time. The tower portal is not positioned in west as customary, but in the southern wall, supposedly in order to avoid direct shooting through both doors. The lower part of the remarkably high tower (*ca.* 34 m) has a rectangular, the upper part an octagonal plan. The building has been brought into connection with Tallinn's school of late gothic masonry. The baroque pulpit was built next to the northern side of the chancel arch in the 1730s (Raam 1997).

The lower part of the side walls of the nave and the tower is partitioned into large segment arched niches (Figs 2–3). Three niches of both side walls, located asymmetrically, have a narrow loophole-like splayed window which has been closed in the interior. These windows have been interpreted as a unique system of embrasures, meant for using light firearms. The church functioned also as a signal tower and an outpost for the castle of Rakvere (Tuulse 1945, 235–238; see also Alttõa 2003, 53–54).

In 1959 some test pits were dug outside the building (Fig. 2: 11), in the corners between the chancel, the nave and the tower. The sequence and chronology of the building parts was specified: 1. chancel, 2. sacristy, 3. nave, 4. tower (see above) (Raam 1959, 21–28).

In 1987 four additional test pits were excavated outside the church wall in order to specify, how much soil, which had accumulated during the centuries around the church, could be removed (Fig. 2: 12). Specifics about the foundations were documented. Raam came to a

Limestone walls of nine rectangular burial chambers were discovered in the eastern part of the nave (Figs 2: 8; 3; 7). These are all similar to each other, with 30–40 cm thick walls, on the average ca. 1.5 × 2.5 m large. The chambers must have gone out of use in the 1770s due to the laws of 1771–1772, that ordered to stop burying the dead inside churches (Polnoye 1830, 409, 500, 691). These have been filled with soil and debris by the end of the 19th century. The last grave slabs which once covered the chambers were probably removed and the chambers filled, when the timber floor was made. In 2016 the plan contours of the chamber walls were cleaned for documentation but the filling debris was not studied. Only in some cases the building sequence of neighbouring chambers could be established but no data was got to understand the absolute chronology. The chambers on the central axis are probably older than the peripheral ones. The chambers which once belonged to the manorial estates of the parish, probably come from a wide range of time: 15th–18th centuries. Most likely the earliest burial chambers are not located in the nave but in the chancel. Therefore, it is doubtful if any of the discovered chambers comes from the Middle Ages. Several small fragments of limestone grave slabs from various periods were found among the debris, but none of these is large enough to identify or otherwise bring into connection with a discovered chamber.

The four octagonal pillars (Figs 2: 14; 3), which have been built of one piece dressed limestone blocks, have large, more than 2 m wide foundations with approximately the same shape. It appeared that some fragments of similar octagonal dressed limestone details have been used for building the foundations as well. This peculiar situation could be explained in various ways. Some octagonal blocks originally meant for pillars could have broken during manufacturing already and used just for foundations. It is also possible that the pillars themselves have been built of reused octagonal blocks already. This possibility is supported by the fact discovered during the excavations that the four pillars are built of blocks of two different sizes.² It suggests that the blocks of one size standard, either the smaller or larger ones, come from some older building and have been reused for erecting the present four pillars. This issue needs analysis of comparative material of other churches with octagonal pillars.

Remains of two side altars – elements typically removed after Reformation – were discovered on the western sides of the northern pillars. Only foundations, of ca. 1.2 × 1.9 m size, have been preserved (Figs 2: 7; 8). Both have been positioned not in parallel to the walls but askew as are also the pillars. It cannot be excluded that the southern pillars had side altars as well but nothing has

GPR showed signals of possible foundations which run in the east-west direction on several lines. After removal of the upper soil, several groups of erratic boulders, laid without mortar, appeared only in two narrow zones, located 1–2 m from the both present side walls (Fig. 2: 6). A group right east of the southern portal is especially long: *ca.* 6 m (Fig. 9). This group has a long straight northern edge, the preserved southern edge is much shorter. This group of boulders forms a 1.0–1.2 m wide foundation. There is no reason to suggest that a structure, which would need such a foundation, has existed in the interior of the present church. Therefore, it must be older than the present building. Smaller groups of erratic stones were discovered from an area located 1–2 m from the present northern side wall as well. Also some boulders were recorded near the eastern wall, preserved between the burial chambers and under the pulpit. There are almost no erratic stones in the rest of the nave. Probably the groups of erratic stones were the foundations of a previous nave. Only the location of its western wall remained problematic, because

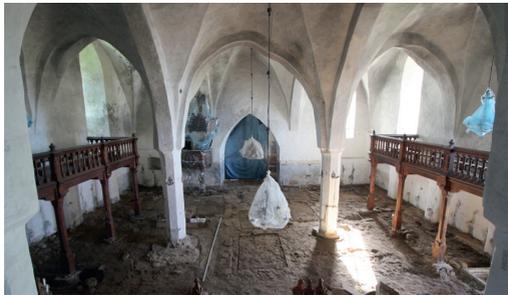
Fig. 3. Interior of Haljala church nave from the organ gallery.

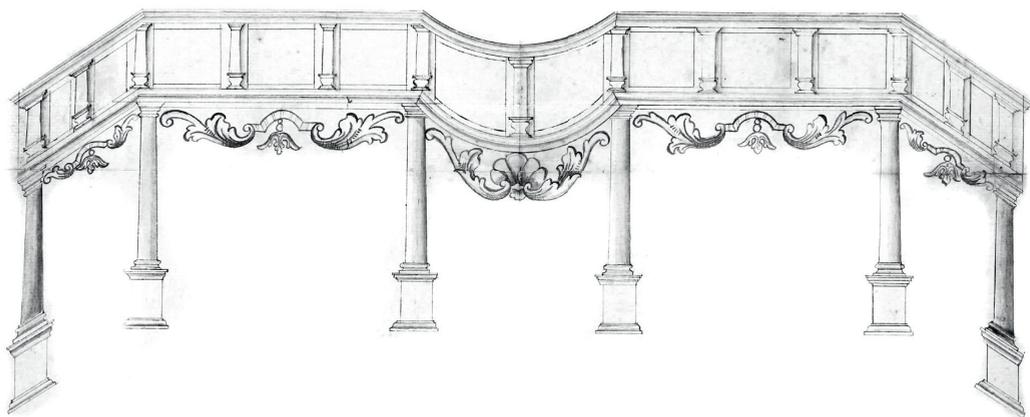
Fig. 4. Drawing of the previous organ gallery from 1757.

Very little visual information exists about the nave interior prior to the late 19th century reconstruction. A drawing of a baroque style gallery from 1757 (Fig. 4), a schematic plan of burial chambers from the middle of the 18th century (Fig. 5), and one photo from the 1880s or 1890s survive (AM.8534.5645).

During the excavation some small uneven, more or less rectangular or even square foundations were discovered. The axonometric drawing from 1757 (Fig. 4) depicts an organ gallery on six posts resting on rectangular bases, but has no context depicted. Therefore, it is not easy to bring this image into connection with the nave plan, even with the discovered foundations, especially because part of the old foundations has been reused to support the post of the new gallery. Despite several irregularities, most of the discovered foundations can be brought into connection with the posts of the organ gallery, depicted on the drawing of 1757 (Fig. 2: 9). It appears that the old gallery has probably had an extra row of columns in the west, which have not been depicted. Judging by the size of the foundations, the square bases of the posts could not have been wider than 0.6 m. The northernmost and the southernmost rows of the foundations have been positioned not in parallel to the side walls but at a slight angle: the short side galleries were slightly wider in the west than in the east. This deviance is in accordance with the 1757 image. What could be taken as poor axonometry at first glance, might have been an intended deviance.

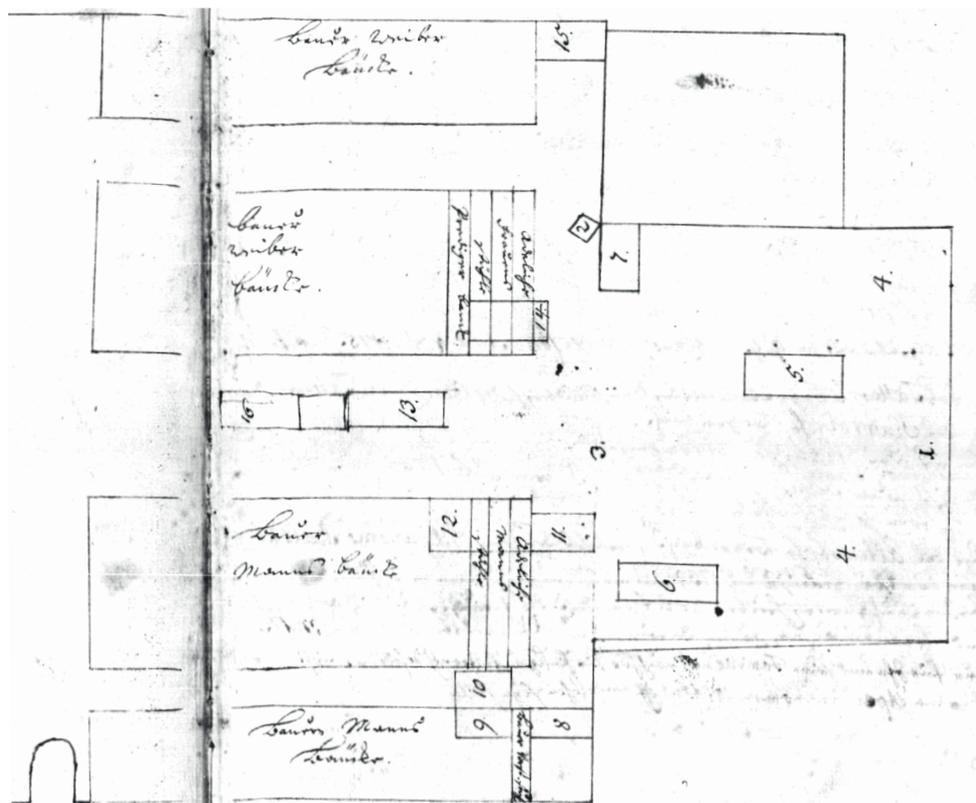
Fig. 5. A schematic plan of the pews and burial chambers from the middle of the 18th century. Eastern part. 1 – altar, 2 – pulpit, 3 – crucifix, 4 – burial places of pastors, 5–16 burial chambers of manors of Haljala parish: 5 – Aaspere, 6 – Kavastu, 7 – Kavastu, 8 – Idavere, 9–10 – unmarked, 11 – Metsiku, 12 – Tatruse, 13 – Karula, 14 – Vihula, 15 – Sauste, 16 – Vanamõisa.

As an exception in Estonia, a schematic map of the burial chambers of Haljala church has preserved from the middle of the 18th century (Fig. 5). Based on this, most of the discovered chambers can be brought into connection with the manor names marked on the plan. Some which cannot, might have been built later or had fallen out of use by the mid-18th century already.

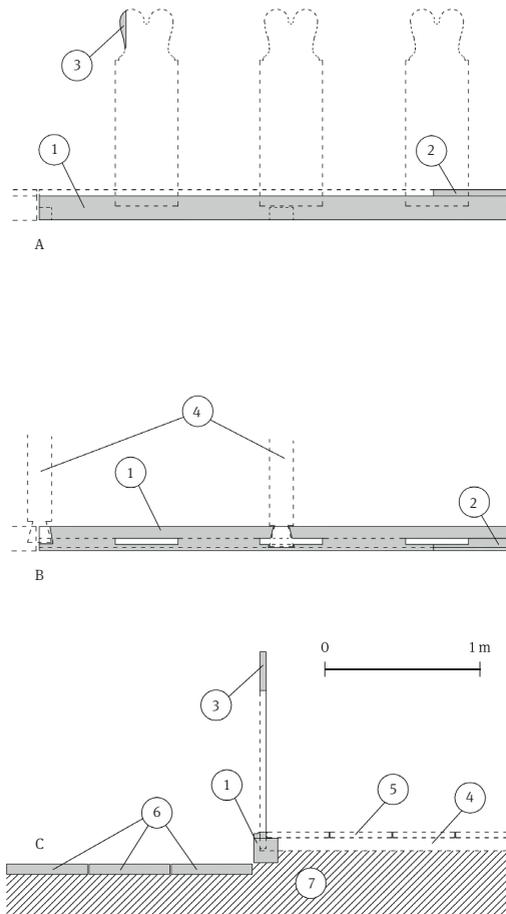
Fig. 6. Reconstruction attempt of the previous pew system: A – side view with pew ends, B – plan, C – section, 1 – preserved edge beam with dovetail joints for crossing joists and rectangular joints for pew ends, 2 – profiled corner strip fragment with wear marks between the pew ends, 3 – preserved fragment of supposed pew end, 4 – crossing joist with dovetail joint, 5 – floor boards under the pews, 6 – limestone floor slab, 7 – soil.

Among the rotten underlay beams of the existing floor some reused material was found. Several edge beams of pew platforms were discovered and documented (Fig. 6: 1). The beams have rectangular hollows for attaching 4.5 cm thick, 40 cm wide pew ends, with ca. 54 cm distance from each other. One fragment of timber possibly comes from a decorated upper part of a simple rustic pew end (Fig. 6: 2) from the 17th or 18th century. By the time of the interior reconstruction of the end of the 19th century, the middle walkway had different – rectangular pew ends (AM.8534.5645). Unfortunately, no edge beam or floor slab could be recorded in its original place. One can get an idea of the system of pew platforms of Haljala church from a schematic plan of the burial chambers from the middle of the 18th century (Fig. 5). There were central walkways on the main east-west axis and on the line of the south portal on the north-south axis.

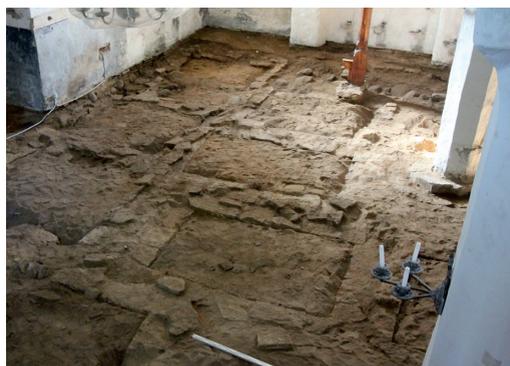
Fig. 7. Burial chambers in the eastern part of the nave. View from north-west.

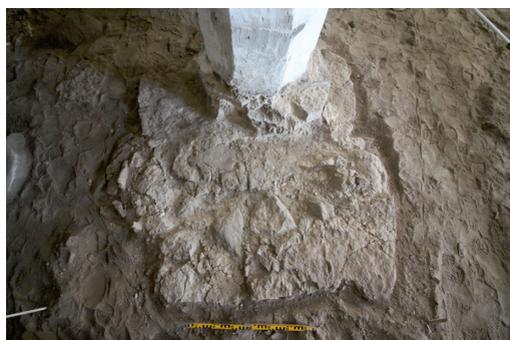
Fig. 8. Foundation of the side altar on the western side of the north-eastern pillar.

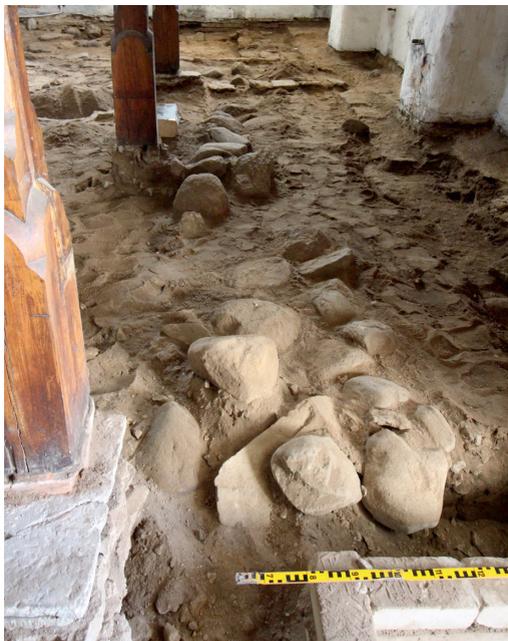
Fig. 9. Foundation of the southern wall of the previous church nave. View from west.

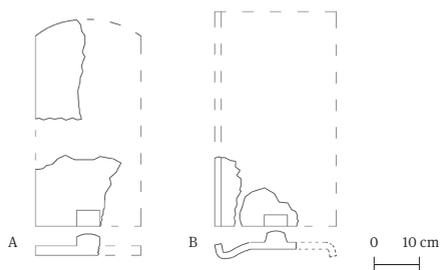
Fig. 10. Reconstruction of the roof tile types: A – beaver tail, B – *Kremptziegel*.

The removed soil contained a large mass of roof tile fragments. Two types could be identified: tiles of beaver tail type (Fig. 10: A), with surface glazed in three different tones and peculiar

very large flat tiles with a curved edge, called in German *Kremptziegel* (Fig. 10: B). The glazed tiles could be gathered from the upper layer of soil which was also present in the upper filling in the burial chambers and was completely removed. Therefore, it looks like the beaver tail tiles come from the last historic stone roof, probably from early modern period. The *Kremptziegel* tiles were scattered in a deeper layer, which was not excavated but reached in several test pits about 40–50 cm below the floor. In several spots the blackened fragments of *Kremptziegel* were recorded lying as a compact layer mixed with a lot

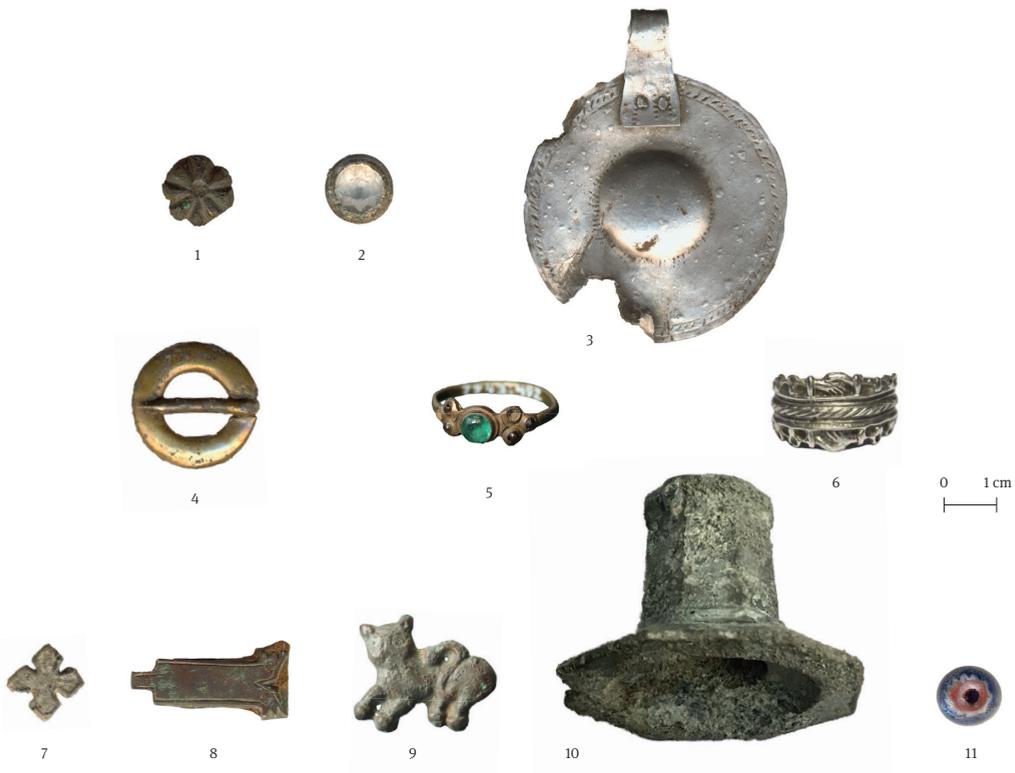
Fig. 11. Various medieval and later artefacts.

There are a lot of small medieval and early modern artefacts or fragments identified, which are in most cases difficult to date with accuracy: from clothing 3 buttons (Fig. 11: 1–2), from movable inventory: two bottoms of blown glass bottles, a piece of a clay pipe, three lead bullets and a sherd of a redware tripod pot. A round pendant of thin sheet silver from the second half of the 15th or the first quarter of the 16th centuries (Fig. 11: 3), two small round brooches (Fig. 11: 4), a ring with seven glass gems (Fig. 11: 5), a ring with entwined hands (Fig. 11: 6), six various belt mounts or book bosses (Fig. 11: 7), a clasp of sheet brass, from a hook-clasp fastening (Fig. 11: 8), typical for the 15th century books with wooden board binding (Szirmai 1999, 251–258), and a mount with a figure of a cat (Fig. 11: 9), a piece of wall chandelier (Fig. 11: 10), a glass bead (Fig. 11: 11) deserve attention in this category.

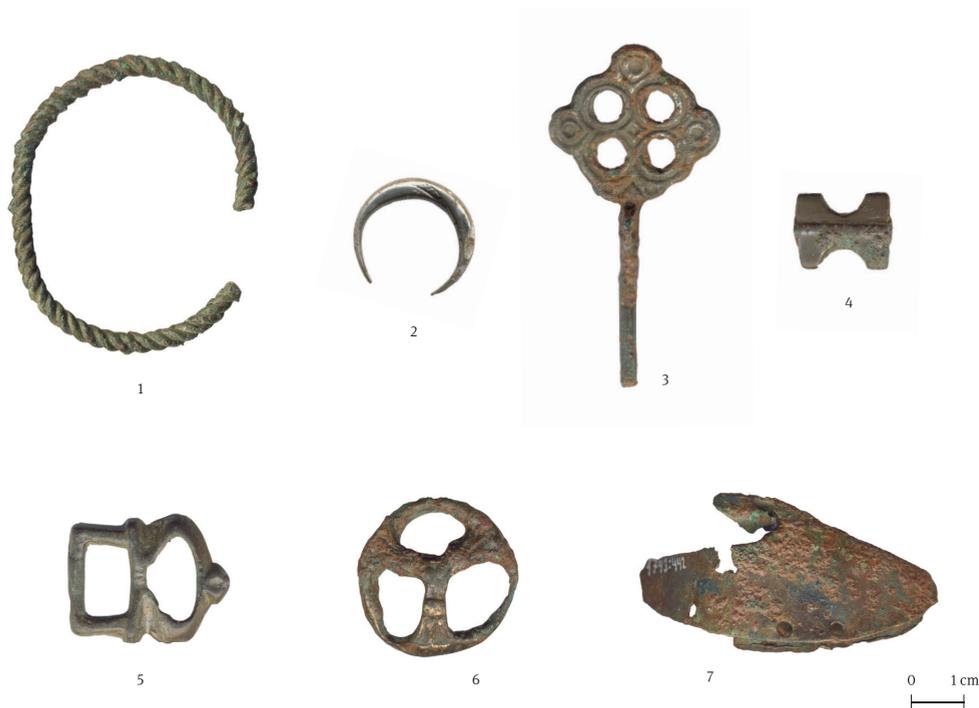
Fig. 12. Finds from the 11th–13th century.

About 20 artefacts, mostly of copper alloy, stand out as a separate group, dating from a period of Late Iron Age (in Estonia 11th–12th centuries) or the beginning of medieval period (13th century). Among copper alloy jewellery there are two braided bracelets (Fig. 12: 1), a ring (Fig. 12: 2), pieces of three decorative pins with cross-shape (Fig. 12: 3), a small chain, two fragments of spiral tube decoration. There are also several copper alloy artefacts from sword or knife belts: a mount (Fig. 12: 4), two belt buckles (Fig. 12: 5), a buckle plate, a three-spoked strap distributor (Fig. 12: 6), also a scabbard chape of a seax (Fig. 12: 7). Some pieces of wheel thrown local pottery probably also belong to this complex. The earliest coin found in Haljala church – a penny minted in Exeter during the rule of king Ethelred II (*ca.* 966–1016 AD) – can also be connected with these early finds.

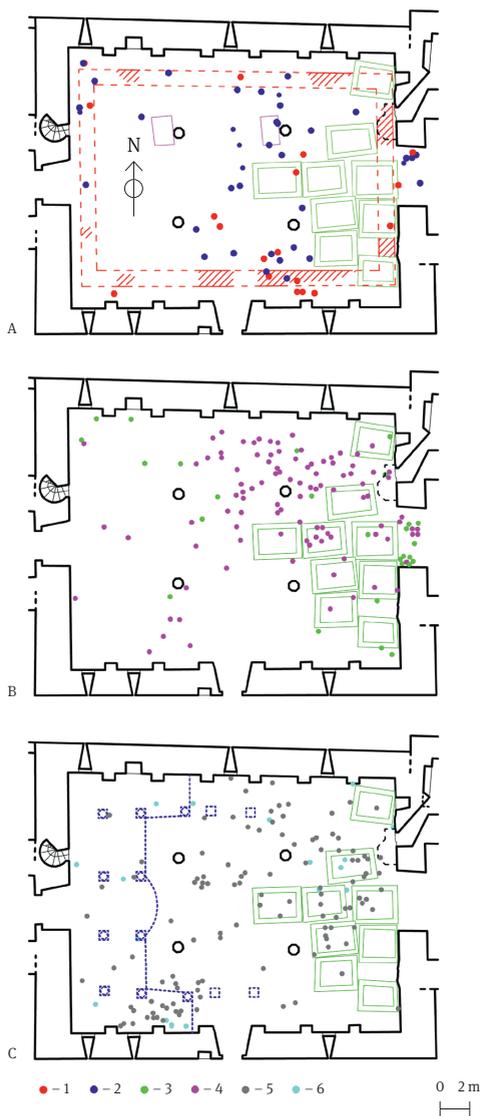
Fig. 13. Distribution of coin finds. A - 1200-1558, B - 1559-1708, C - ca. 1700-1917. 1 - medieval coins before the monetary reform (1200-1422/1426), 2 - medieval coins after the monetary reform (1422/1426-1558), 3 - coins from the war period (1559-1629), 4 - Swedish coins from 1630-1708, 5 - Russian coins of the 18th century, 6 - Russian coins from 1801-1917.

The coins were marked on the nave plan (Fig. 13) to learn if the distribution has some correspondence to architectural elements or if it can be used to describe usage of interior space in different periods. The lack of earlier coins in the area of burial chambers and also in the western part of the middle nave is caused by later disturbances, but in the side naves the layer with coins existed almost everywhere. The few coins from the previous nave period have a small concentration near the southern portal, but these were probably not in their original locations, because some were even located on top of the old nave's foundation (Fig. 13: A). The late Catholic period coins, of which most have probably accumulated into the present church, tend to be distributed mostly in the eastern part of the middle bay. There does not seem to be a clear connection with the discovered side altars nor with any of the wall niches, but 12 coins were located within a 2 m radius from

A concentration of *ca.* 20 late medieval and early Swedish period coins under the chancel arch (Fig. 13: A, B) can be connected with a rood altar although no remains of it were found. This is the only notable concentration of the coins from the period of the wars between 1558–1629. The chantry of the Holy Cross, established in Haljala church in 1485 (Johansen 1933, 344; see above), could be connected with the rood altar.

The coins of the next period – peace under the Swedish rule (*ca.* 1630–1710), are distinguishably distributed mostly in the north-eastern part of the nave (Fig. 13: B). There was no observable difference in the preservation of the soil layer with coins between the northern and southern areas, which would explain the difference in coin distribution. This is the first period when the pew platforms and a pulpit probably existed already. There might be a correspondence of the coins with the pew area. It is not known who used the pews of the north-eastern part of the nave in the 17th century, but on the plan from the middle of the 18th century (Fig. 5) the pews have been divided into two large areas. Pews of the northern part of the nave have been marked for peasant women (*bauer weiber leute*) and of the southern part for peasant men (*bauer manns leute*). Probably this reflects the situation of the 17th century as well. The abundance of 17th and 18th century coins in the north-eastern part of the nave, in the women's area to the contrary of other areas may indicate a more intense habit of offering coins in the church among peasant women. However, it is risky to make conclusions about the social meaning of coin distribution even within a specific church, let alone to make generalizations based on one case. For example, in Finland in some churches most of the coins of specific periods have been located in the northern, in some churches in the southern part of the nave, in some cases in chancel area (Ehrnsten 2013, 39). There is a smaller concentration of *ca.* 30 mostly 18th but also some 17th century coins in an area with a diameter of 5 m in the southern aisle, west of the southern portal. Assuming that the back (*i.e.* western) benches might have been mostly used by peasants of lower social status, it could be supposed that differences of coin abundance on the east-west axis might reflect differences of habits among different social groups of peasants. Shifts of usage of different pew areas in different periods by different social or gender groups are also expectable.
