Archaeological studies of the gatehouse of Virtsu castle

Villu Kadakas

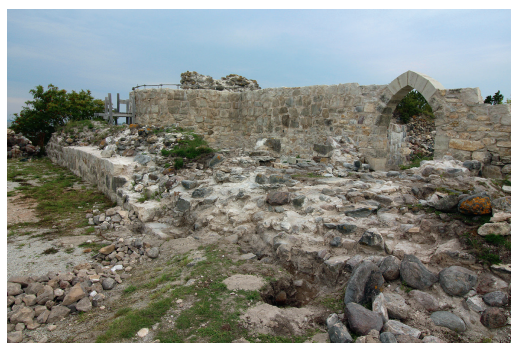
Fig. 1. The ruins of Virtsu castle from the south-east, remains of the gatehouse in the foreground.

The field study took place in August 2018 (for a short summary in Estonian, see Kadakas 2018) in connection with the conservation of walls in the area of the ruined gatehouse (Fig. 1). The purpose of the field study was to get information for the conservation work and to salvage all the information which could be obtained about the almost disintegrated gatehouse. A 5–20 cm thick layer of demolition debris was removed and the remains of the walls were recorded. In addition, some new information about the courtyard was obtained.

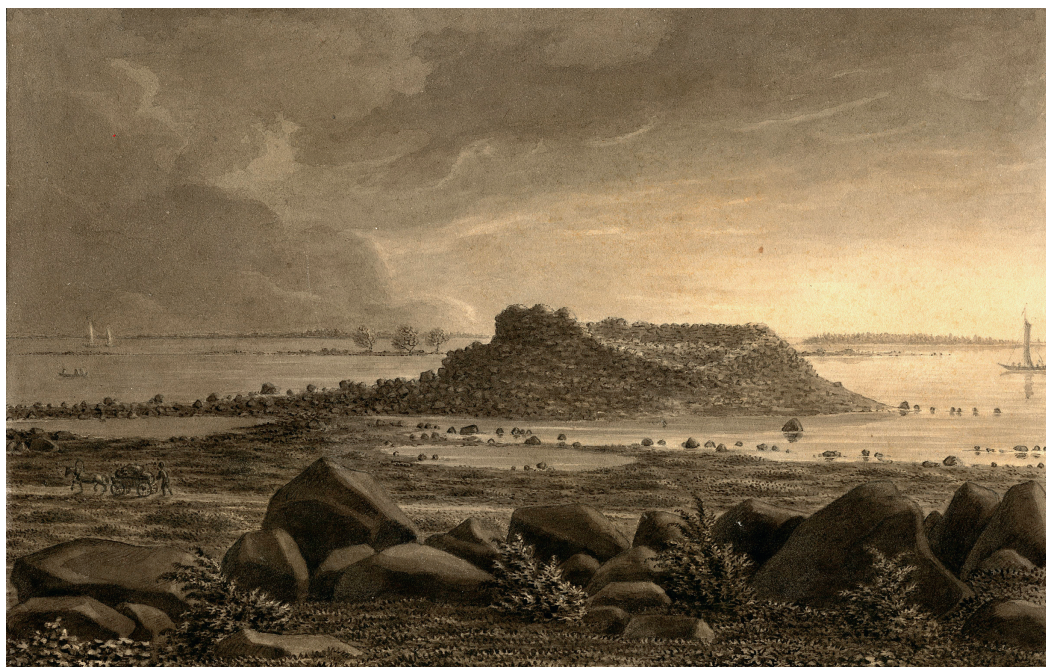
Fig. 2. The ruins of Virtsu castle from the south-east in 1827.

By the time when the castle of Virtsu appeared in the historical images and arose interest in the early researchers, it was fully in ruin, with some low walls standing (Fig. 2). In addition to the alleged demolition, the location on the seashore, the effect of salty water, storms and ice had been devastating.

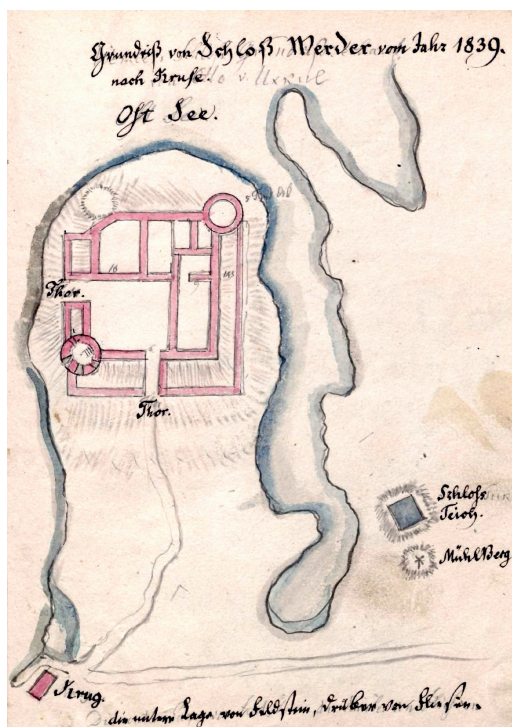
Fig. 3. Plan of Virtsu castle ruins in 1839.

Friedrich Karl Hermann Kruse (1790–1866), professor of history of Tartu University (1828–1853) composed the first known ground plan of the castle in 1839 (Fig. 3). This includes most of the walls known today, although with several inaccuracies. This plan has been preserved as a later addition between the manuscript of Rev. Eduard Philipp Körber (1770–1850), one of the first researchers of the medieval castles of Livonia (Körber 1802, 397). Karl von Löwis of Menar (1855–1930) presented an overview of written history, published his own ground plan and a section, made in 1891 (Löwis of Menar 1914; 1922, 124), after his field study with unknown extent and dates.

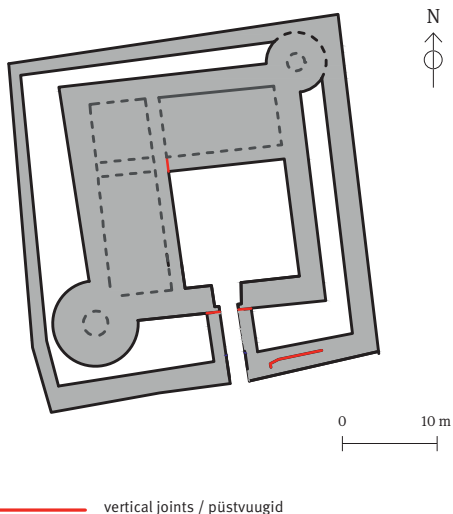
Fig. 4. Plan of Virtsu castle walls.

Inside these chutes, on both sides of the passage, two large rectangular limestone blocks can be observed (Fig. 5: 2; 6: 2, 7–8). The masonry of both side walls of the passage is separated with a vertical joint from the curtain wall of the main castle (Fig. 4; 5: 12; 8), just as Aluve has described. Only these two rectangular blocks reach into the curtain wall, protruding from it like corbels. It seems likely that Aluve interpreted these two blocks as the corbels of the inner drawbridge. However, these corbels lack any cavities for hinges, so that would be difficult to explain how these corbels could have supported a drawbridge. Furthermore, the corbels have been walled up when the side walls of the gate passage had been built against the curtain wall, so that only one surface of a corbel could be observed inside the chute. Obviously, these corbels could have functioned only before building the side walls, in the period of the original gate (see below).

The conclusion of Aluve, that the side walls of the gate passage were a secondary addition towards the two curtain walls, could be confirmed in 2018 only regarding the curtain wall of the main castle. Vertical joints could be observed there (Fig. 4; 5: 12) (see above), but not next to the outer curtain wall. The side walls seem to be built together with the neighbouring sections of the outer curtain wall. Based on these results, it seems that the gate passage has been added to the main castle secondarily, together with the outer curtain wall, the portcullis and the drawbridge. This conclusion is in contradiction with Aluve's previous conclusion, that both curtain walls have been built at the same time. He was able to specify it near the north-eastern round tower (Aluve 1993, 49).

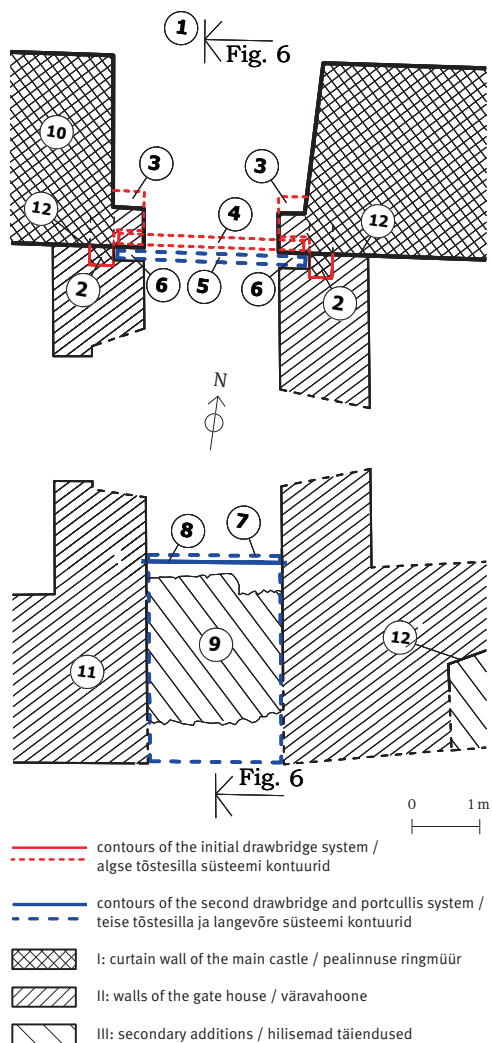
Fig. 5. Plan of the gatehouse remains of Virtsu castle. 1 – inner courtyard, 2 – corbels of the initial drawbridge, 3 – supposed location of the initial gate portal, 4 – supposed location of the initial drawbridge in upright position, 5 – portcullis of the gatehouse, 6 – chute for portcullis, 7 – drawbridge of the gatehouse, 8 – hinge axle of the drawbridge, 9 – filling masonry of the pit, 10 – curtain wall of the main castle, 11 – outer curtain wall, 12 – vertical joint.

From the outer end of the gate passage, from the side walls, two identical small cavities or recesses were found (Fig. 5: 8; 6: 8), which could be interpreted as remains of a hinge system for turning a drawbridge. The small round cavities still have some rust from the iron hinges in them (Fig. 9). These are probably the same cavities which Aluve has described in this area. Usually such hinge cavities are located inside protruding corbels, but in this case there are no corbels – the cavities have been made just into two opposing stones in the side walls of the gate passage. While studying the surrounding masonry, it became clear why Aluve excluded the possibility that this drawbridge could have been lowered outwards. Just ca. 20 cm south of the line of the drawbridge, the surviving masonry of the outer curtain wall (Fig. 6: 9) rises 12 cm above the level of the cavities, so that the drawbridge could have theoretically lowered only halfway, into a slanting position. This obviously forced Aluve to a preliminary conclusion that the drawbridge could have been lowered only towards the inside of the castle, into the gate passage. However, such a solution would have been illogical considering the logic of castle defence, because naturally, such a drawbridge could have been operated only from the outside, by the attackers, not the defenders of the castle. Realising it, Aluve dropped his initial hypothesis, but taking into consideration all the known circumstances, was not able to present a better one.

the curtain wall, under the gate passage (Fig. 5: 9; 6: 9). With the bottom located ca. 1.4 m deeper than the hinges, this cavity was obviously a rectangular pit with a function to obstruct the enemies to get inside. Therefore, originally there was no problem with lowering the drawbridge outwards – the drawbridge covered the pit in a lowered position, which is a normal

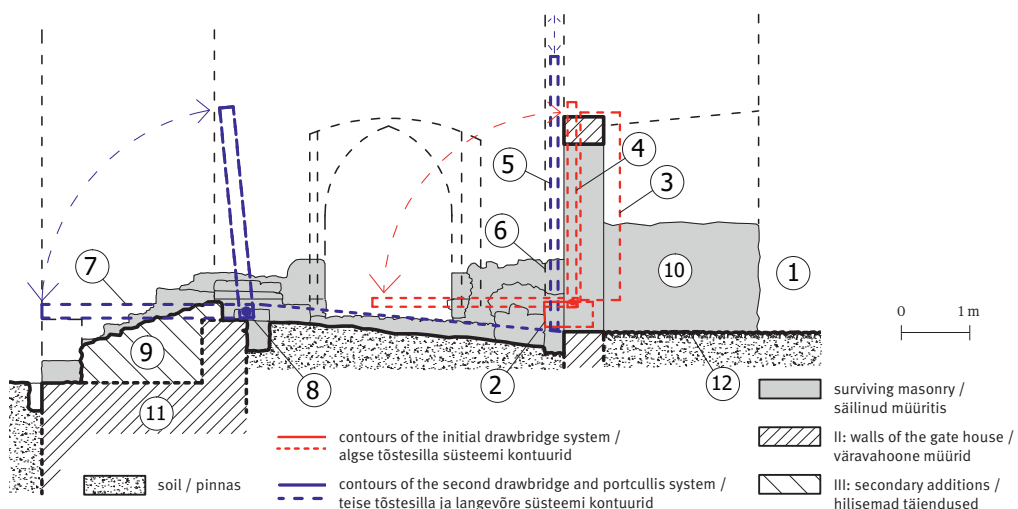
Fig. 6. Reconstructive section through the gatehouse. 1 – inner courtyard, 2 – corbels of the initial drawbridge, 3 – supposed location of the initial gate portal, 4 – supposed location of the initial drawbridge in upright position, 5 – portcullis of the gatehouse, 6 – chute for portcullis, 7 – drawbridge of the gatehouse, 8 – hinge axle of the drawbridge, 9 – filling masonry of the pit, 10 – curtain wall of the main castle, 11 – outer curtain wall, 12 – cobblestone pavement.

In its final form the pavement of the gate passage was inclining towards the courtyard of the castle (Fig. 6). Aluve supposed that the threshold of the outer gate was intentionally located higher than the inner one in order to avoid the sea water to get into the castle (Aluve 1993, 50). The western part of the outer bailey could be accessed from a 2 m wide gate in the western wall of the gate passage, still partly preserved (Figs 5–7). The eastern part of the outer bailey was probably accessed from a narrower opening, a doorway in the eastern side wall (Figs 5, 7). Because of limited recording in the 1970s and poor preservation, the existence of the eastern doorway is not sure, but it seems probable, because the eastern part of the outer bailey probably had to be accessed somehow.

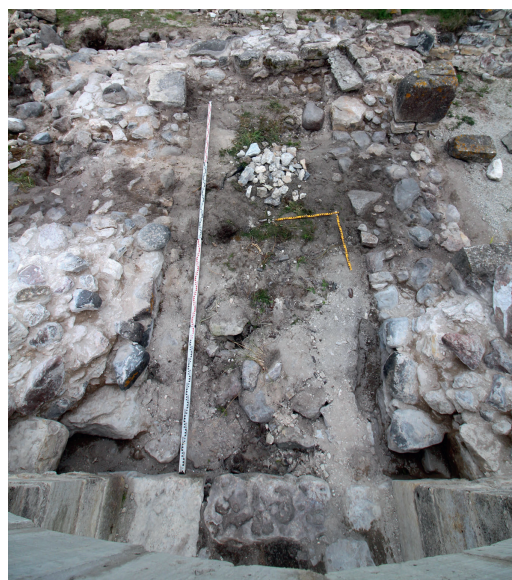
Fig. 7. The remains of the gate building from top of the inner gate portal. Chutes of the portcullis and the corbels of the initial drawbridge on both sides of the portal.

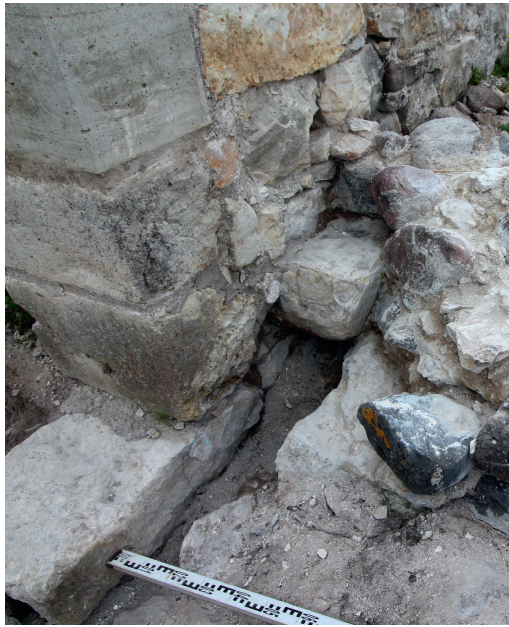
Fig. 8. The eastern chute for the portcullis and the corbel of the initial drawbridge.

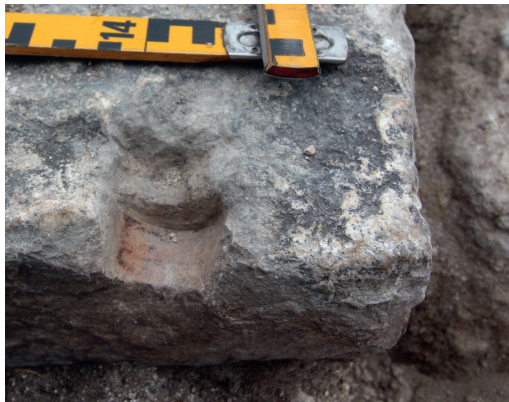
Fig. 9. Recess for the eastern hinge of the drawbridge in the eastern side wall of the gatehouse.
