Archaeological studies at the site of the new Narva border station

Paul Ööbik, Ragnar Nurk and Guido Toos

OÜ Agu EMS, Roosikrantsi 17, 10119 Tallinn, Estonia; paul.oobik@yahoo.com

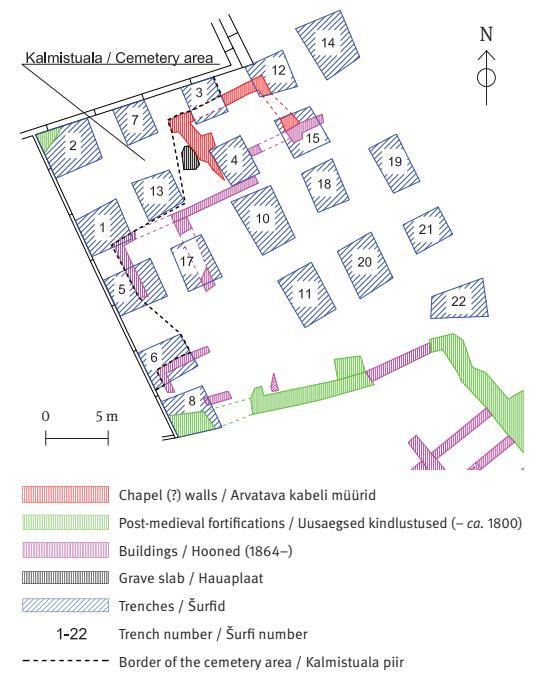
Fig. 1. Situation plan of the trenches dug in 2014 (see Fig. 3 for location).

imately 750 m² where excavations were made (Fig. 1; 3). The new border station was planned to an area, where human activities were known for hundreds of years: it was just west of the medieval town wall and early modern town fortifications were certainly known in the area. Despite that, neither desktop assessments nor preliminary studies were undertaken and human remains and different structures were found during construction work. Thus, archaeological excavations had to be started immediately at the area planned for the post holes of the new building. Parallel to and after the excavations, monitoring work was carried out to identify and locate construction remains, mainly belonging to the fortification system.

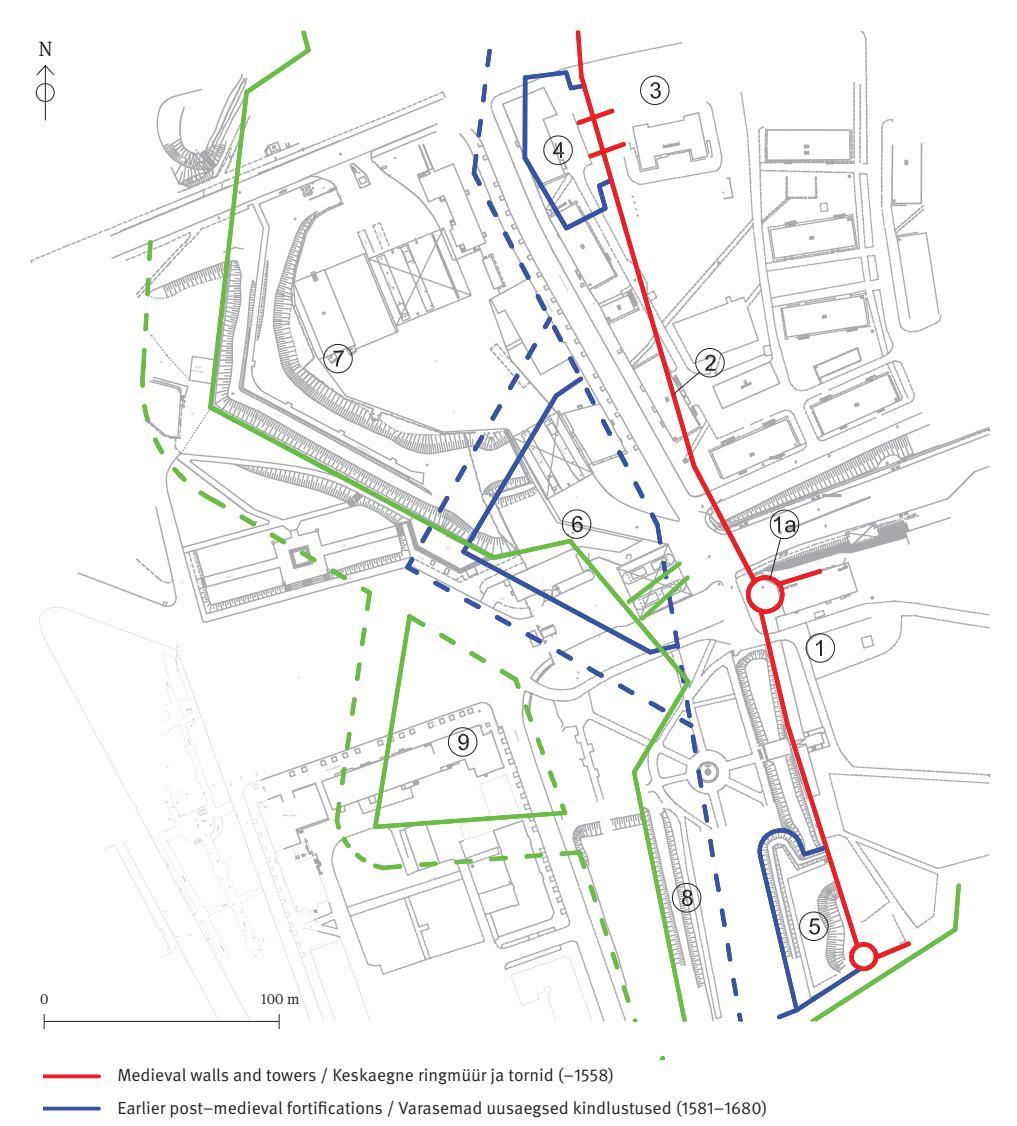
- - Earlier ditch / Varasem vallikraav
- Later post-medieval fortifications / Hilisemad uusaegsed kindlustused (1681–1864)
- 🗕 Later ditch / Hilisem vallikraav

Fig. 2. Schematic reconstruction of the SW-part of the fortifications of Narva. 1 – western bailey of the castle, 1a – NW-tower (Rondelle), 2 – town wall, 3 – Viru Gate, 4 – Old Rampart bastion, 5 – Kristervall half-bastion, 6 – old ravelin (1650s – 1670s), 7 – Triumph bastion (1680s – 18th c.), 9 – new (1st) ravelin (18th c.).

In the present townscape of Narva the research area forms one of the few gaps in the otherwise well preserved zone of fortifications (Fig. 2). The excavations brought to light fragments of various stages of development of the Narva fortifications (Fig. 3). The main research area between the present Peetri square and the Vestervalli street is located in the area in front of the medieval castle and town wall that was complemented with rampart fortifications in the Post-Medieval Period (about the architecture history of Narva in general, see: Karling 1936; Kochenovskij 1991). The general location of the fortifications could quite adequately be predicted already before the excavations, relying upon historical plans, but now their exact placement was recorded, which hopefully helps to plan better future earthwork in this area. Also some construction-technical data was obtained and some surprising wall fragments were found which original function is unknown.

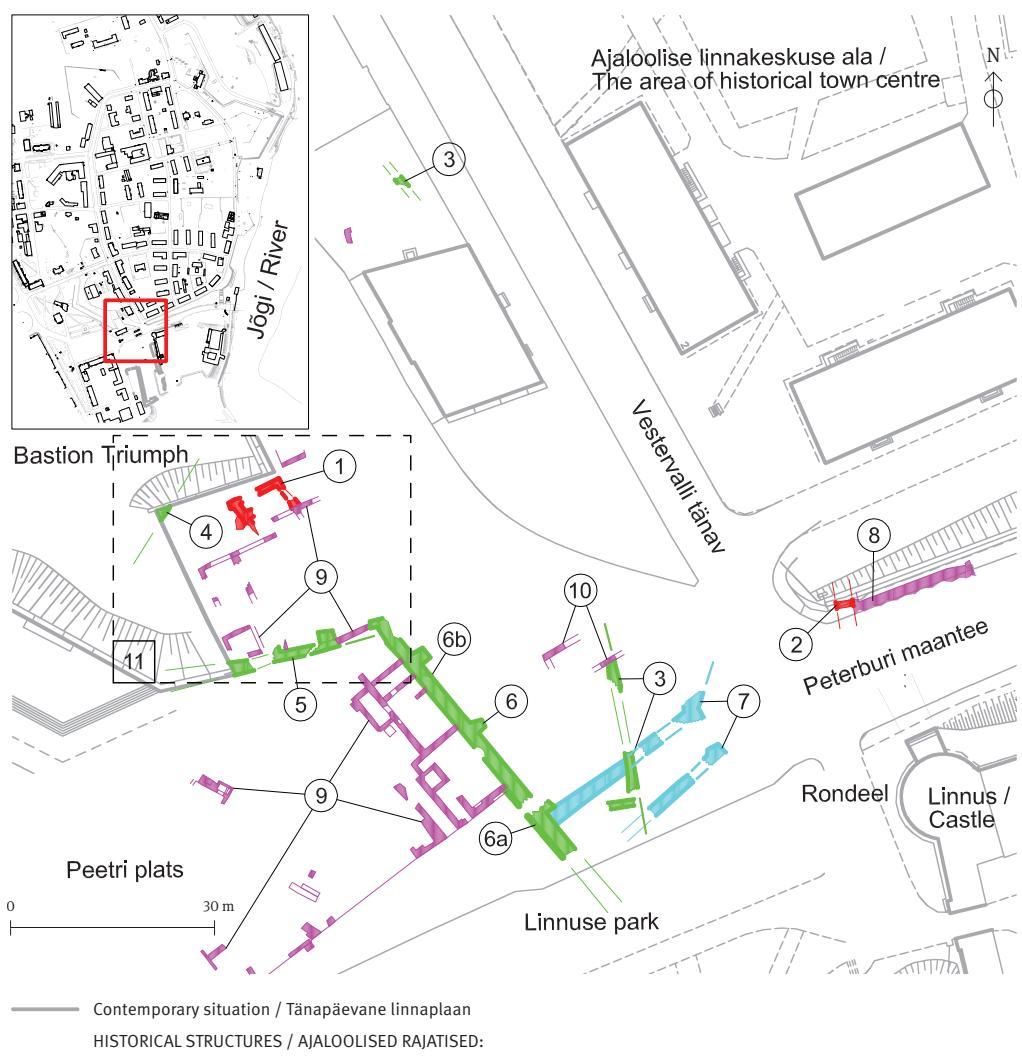
- **Fig. 3.** Situation plan of the wall fragments found from the site of 2014. 1 chapel (?) walls, 2 town wall fragment, 3 wall fragments on the outer bank of the earlier ditch, 4 scarp wall fragment of the earlier ravelin (1650s 1670s), 5 scarp wall of the flank of Triumph bastion (after 1704), 6 scarp wall of the face of Triumph bastion (after 1704), 6a hewn limestone lining, 6b limestone gutter, 7 Peter's Gate, inner façade, 8 building wall against the town wall, possibly earlier than others, 9 pre-WWII buildings (–1944), 10 Soviet period cinema foundations, 11 area shown on Fig. 1.

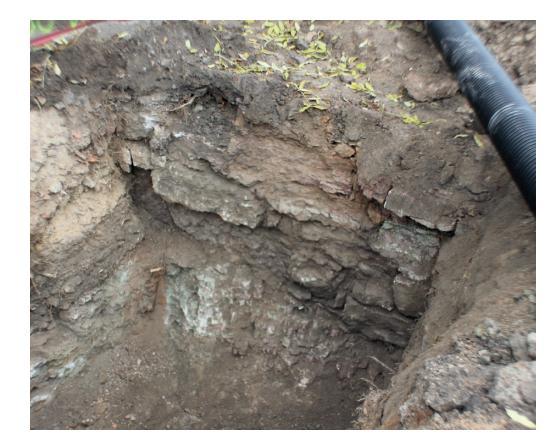
Fig. 4. Town wall fragment. **Jn 4.** Fragment linnamüürist. Photo / Foto: Guido Toos

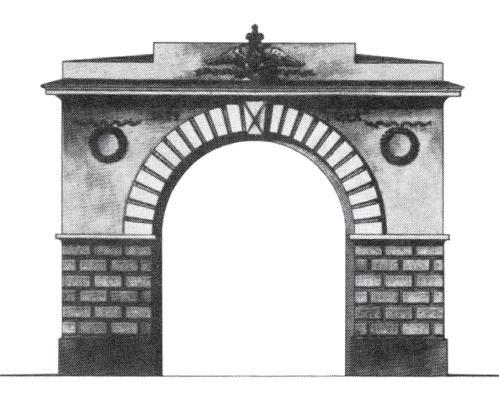
Fig. 5. Outer façade project for the Peter's Gate, 1822. **Jn 5.** Peetri värava välisfassaadi projekt 1822. aastast. (*RGVIA 349-19-4824*. Reproduction from: Kochenovskij 1991, Fig. 1.94)

fortification-engineer Erik Dahlberg. They constitute a part of the new ring of bastions on the northern and western sides of the town, which were naturally less protected and where 6 bastions together with 5 ravelins were to be built. This plan was largely realized. By 1700, when the Great Northern War began, the earthen parts of the new defence constructions on the south-eastern side of the town were basically completed, but the scarp walls were left to be built after the war, i.e. by the Russians, who finally captured the town in 1704, after the second siege. The scarp walls of the bastions on the northern side of the town, built during the Swedish reign, had vaulted galleries in the lower part, designed by Dahlberg (in Narva they served as gun casemates manned with gunmen, and countermines that could be blasted in the worst emergency together with the attackers). In south-eastern section the Russians built scarp walls without galleries. Already in Dahlberg's project one of the two town gates was designed in the middle of the curtain between the Fortuna and Triumph bastions (the other was built on the northern side of the town). Actually the western gate was built by the Russians only in 1822 – it was known as Peter's Gate (Fig. 5). Later, in 1864, the territory of the ring of

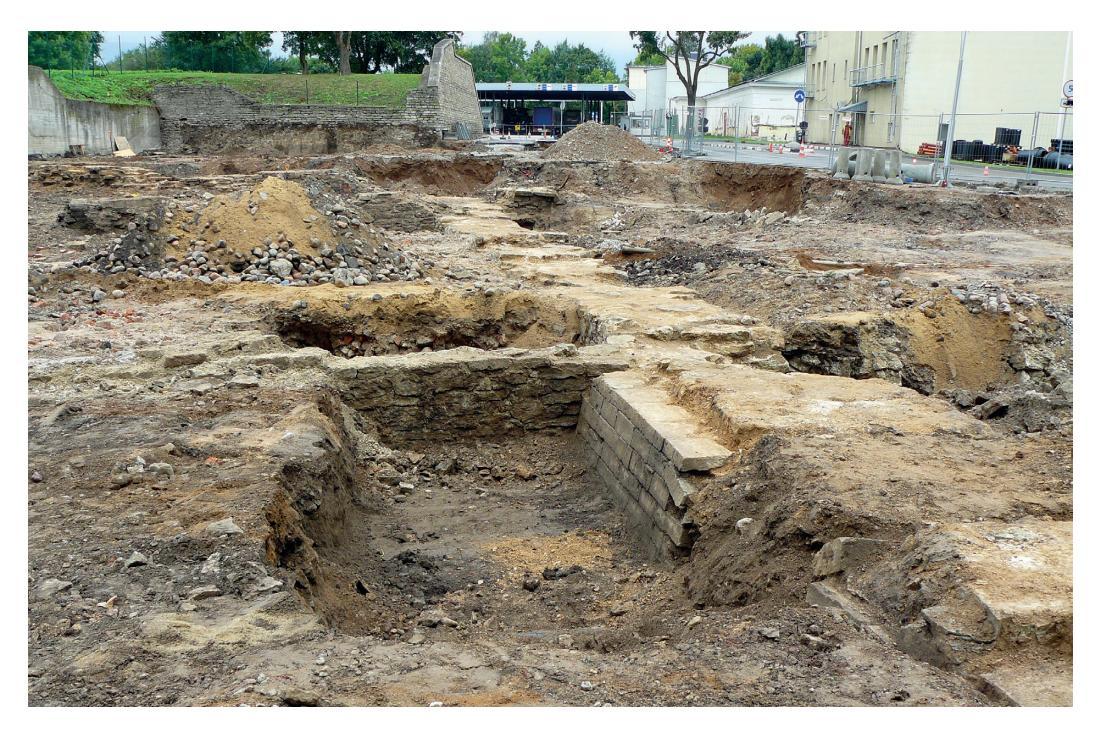
Fig. 6. Scarp wall of the curtain together with its partly preserved outer lining and later annexes. View to the direction of the Triumph bastion.

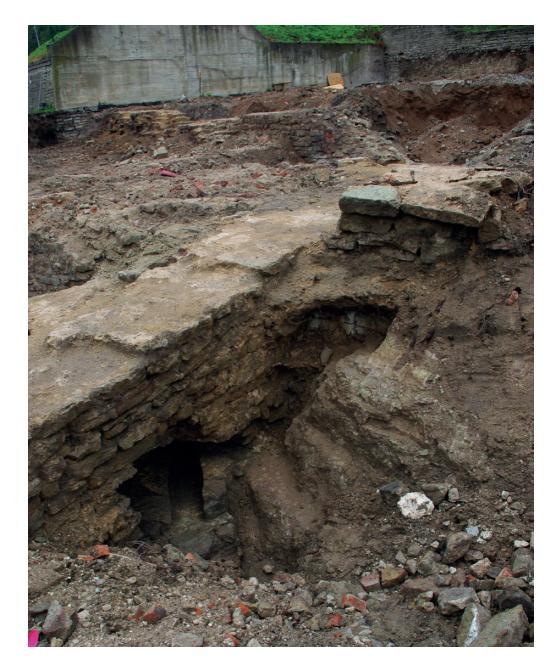
Fig. 7. Gutter visible in the inner side of the scarp wall of the curtain.

the flank and curtain were built in different stages. The preserved part of the flank wall was characterised by the fact that in its lowest part it was built as a cover for the terrace cut in the bedrock, and widened only in the upper part on the inner side. Apparently during the Swedish period the scarp consisted of the limestone terrace in the lower part and the naturally slanting earthen rampart in the upper part. The earthwork of the bastions on the studied site had been destroyed already earlier, and so we were unable to record the profile of soil layers constituting the earthwork. In connection with the construction of the scarp wall the outer side of the fortifications became considerably steeper, and evidently some extra space was gained on the top of the fortification. The walls the Russians built, observed to the height of 1–2 m, surprise with their modest thickness. Relying upon the historical section drawings (RGAVMF 3-25-82, profile 4 – Triumph S-flank (vear 1747); RGAVMF 3-25-189-190, profile 3 - curtain (year 1752)) scarp walls existed in this section in the mid-18th century and their original height was about 5-8 m (the curtain wall was higher for an unknown reason). At the inner side of the scarp wall of the curtain a gutter with limestone walls was recorded, running aslant to the curtain wall and being possibly older than the latter (Fig. 7).

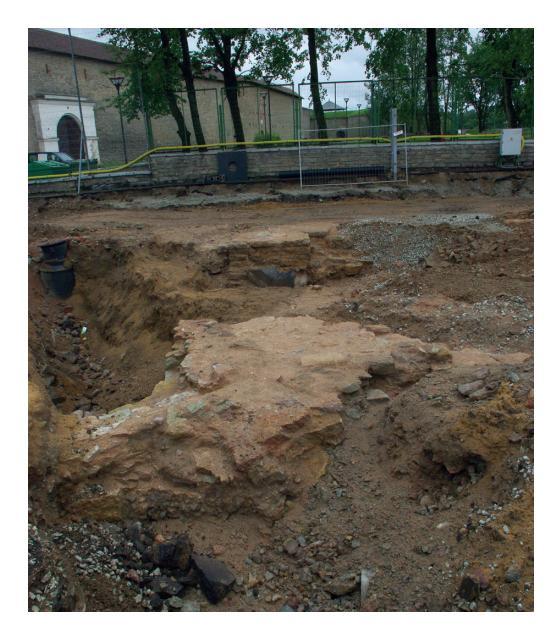
Fig. 8. Wall fragments of the inner façade of the Peter's Gate. View to the direction of the castle.

Lots of fragments of the foundations of both side walls of the Peter's Gate were also discovered (Fig. 8), which extended from the inner side of the curtain up to its scarp wall. The length of the passage that, despite common defence logic, ran completely straight perpendicularly through the curtain wall was measured to be about 29 m and its width was about 6 m – originally the passage had been vaulted (the width of the foundations was about 1.5–2 m). Also some fragments of the soil-supporting side walls of the inner passage to the gate were uncovered. Its walls had been splayed, not parallel, narrowing towards the vaulted part of the gate.

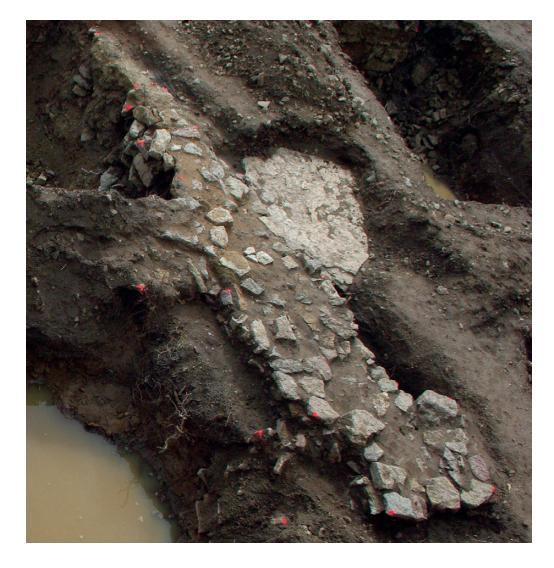
Fig. 9. Possible chapel remains and grave slab in secondary use.
