Excavations at the Great Coastal Gate of Tallinn

Monika Reppo

Villu Kadakas

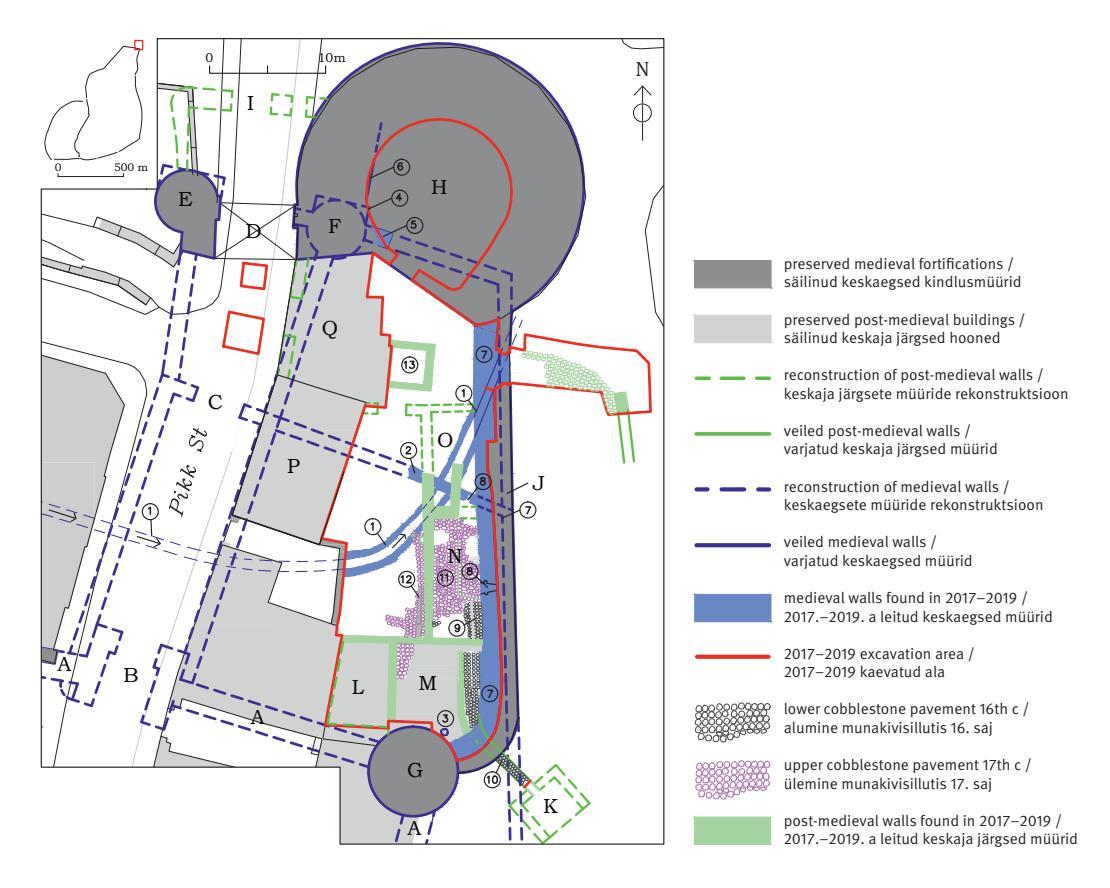
- Fig. 1. Great Coastal Gate complex: research results (2017–2019). A town's curtain wall, B main gate tower, C gate of the first barbican, D gate of the second and third barbicans, E western tower of the second and third barbicans, F eastern tower of the second barbican, G Stolting tower, H Fat Margaret cannon tower, I gate of the fourth barbican, J eastern wall of the museum yard, K cistern from the 1825 plan, L storeroom on the 1858 plan, M toilet on the 1858 plan, N bakery on the 1858 plan, O kitchen on the 1858 plan, P guard house, Q prison house from 1884. Excavated built elements: 1 water channel, 2 first outwork wall, 3 posthole, 4 fragment of the eastern tower of the second barbican, 5 second outwork wall, 6 fragment of an unknown structure, 7 third outwork wall, 8 embrasure, 9 lower pavement, 10 tunnel, 11 upper pavement, 12 foundation of supposed timber house, 13 cesspit of the prison.

A 1 m high fragment of a 125 cm thick limestone wall was discovered on top of the channel, positioned crossways to the channel and Pikk Street (Figs 1: 2; 2). This wall has the same direction and is very similar to the wall which was discovered and demolished in 1979 (Tamm 1979, 24). These were probably parts of the same wall. Soil stratification and artefacts do not enable to date it. However, based on the stratigraphic sequence of the walls and the general context of the gate complex, this wall may be connected with the hypothetical first barbican (Zobel 2014, 126; see above). It is aligned with the spot where the western side wall of the barbican changed its direction, which according to Zobel marks the extent of the first barbican (Fig. 1: C). The discovered wall was probably the northern curtain wall of the first outwork (Germ. Zwinger) which was built on the eastern side of the first barbican. The discovery of this wall is the first material evidence which supports the hypothesis of the first barbican. Furthermore, based on this discovery, it can be concluded that this first barbican was probably equipped with an outwork, a walled enclosure on its eastern side, like the second barbican had later. The new field study did not give any information which could help to interpret the foundation discovered by Plaesterer and interpreted as remains of the 'second gate', i.e. the first barbican in 1924. It could have been e.g. part of a bridge structure above the moat.

A small embrasure-like splayed window was discovered in the eastern part of the wall directly on ground level on the southern side on its eastern end (Figs 1: 8; 2). The 18 cm wide loop faced outside, the north, but curiously only ca. 20 cm above the cover slabs of the channel. It seems as if there was a deep shooting position or a basement room in the north-eastern corner of the first outwork. However, the area directly south of the loophole could not be studied, in order to preserve and expose the walls and pavements within the museum exhibition. This sharp corner of the town defence system was a vulnerable spot and therefore an extra fortification would be expectable. It is possible that this corner of the first outwork was fortified with a similar non-flanking small tower as there was on the north-eastern corner of the main curtain wall, on the spot of the later round tower Stolting. However, the small window is the only indication of such a hypothetical building and the exact function of the window remains unclear.

Only one of the discovered wall fragments could be brought into connection with the hypothetical outwork of the second barbican. A 1.6 m long fragment of a ca. 1 m thick wall was discovered inside the western foundation of Fat Margaret (Fig. 1: 5). Based on this fragment it can be estimated that the wall was positioned perpendicular to Pikk Street, i.e. the gate passage. The wall has lost its extent towards east. However, a vivid robber trench of this wall could be recorded in the natural sand, quite on the line where Zobel had supposed. Nothing was discovered of the eastern wall of the second barbican. It is probably running hidden within the eastern wall of the yard and the tower of Fat Margaret (Fig. 1: J).

At the foot of Stolting tower, a very large posthole (Fig. 1: 3) with the diameter of 64 cm and depth of 120 cm was uncovered. The hole was about 60 cm away from the tower foundation and 80 cm from the tower wall. It had been dug into sandstone. According to Zobel Stolting was built at the very end of the 14th century (2014, 163–165). This posthole could then relate to construction techniques, i.e. belong to the original scaffolding of the tower. It was also established that the footing of Stolting stands very high (+12.55 m) on the very edge of a crumbling sandstone cliff. The upper edge of the sandstone cliff was later covered with additional supportive cladding in order to avoid further erosion of the cliff.

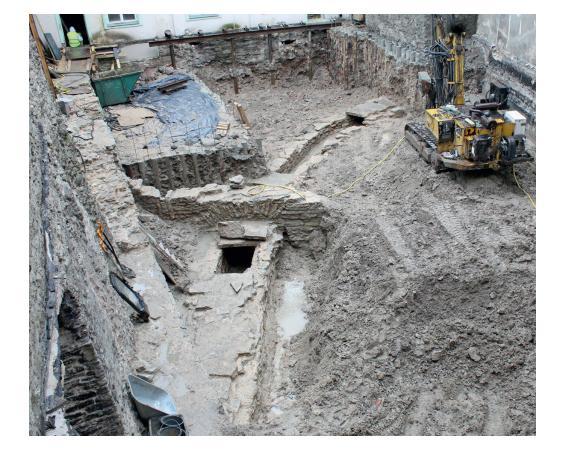
Fig. 2. Medieval water channel, first and third outwork. Jn 2. Keskaegne kanal, I ja III eeskaitsemüür. Photo / Foto: Paul Ööbik

The eastern end of the discovered wall disappears into the yard's eastern wall, so that its continuation cannot be followed (Figs 1–2). Based on general context, it can be supposed that the curtain wall of the first outwork turned abruptly south here and followed the course of the current wall southwards, but is hidden within it as its earliest building stage. Unfortunately, no information about the building time of the first barbican and the first outwork could be obtained. Also, no information was discovered about the demolition time of the wall – if it was demolished right after the construction of the second barbican with the second, larger out-

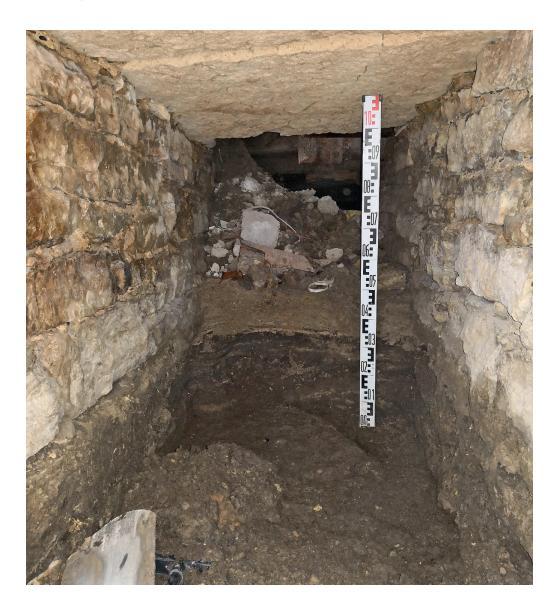
Fig. 3. Internal view of the drainage channel towards the harbour.Jn 3. Kanali sisevaade sadama suunas.

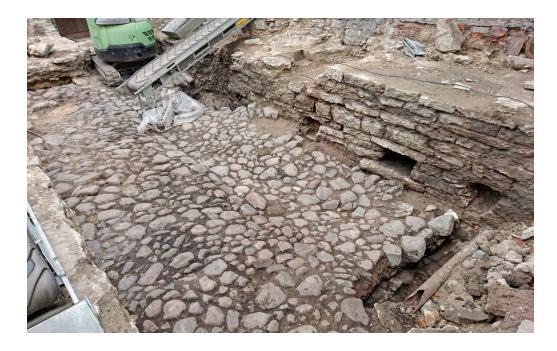
- Fig. 5. Upper pavement and third outwork wall with putlog holes and embrasures.
- Jn 5. Ülemine sillutis tellinguaukude ja laskeavadega eeskaitsemüüri ees.

The inner side of the third outwork wall revealed further evidence of construction techniques in the 16th century. Firstly, putlog holes $(30 \times 30 \text{ cm})$ to support scaffolding were identified both at foundation level but also higher up on the southern end of the wall (Fig. 5). Secondly, it appeared that the inner half of the width of the wall was demolished down to the 18th-19th century yard level (Figs 1: 7; 2) in order to accommodate the auxiliary buildings next to the eastern wall of the yard. This had badly damaged the embrasures in the wall with only the bottom part of their niches surviving (Fig. 1: 8). In one of them, the traces of a supporting beam (30 cm thick) for a breach-loading swivel gun

The upper pavement (Figs 1: 11; 5; 7) is of larger cobblestones than the lower one, laid on the debris layer with the help of some patches of sand to level the area. This pavement was likely laid after the renovations of 1599. In this period, access of the water into the channel described above was blocked. The new pavement also has a gutter running in the middle (Fig. 5), but it is unknown how the rainwater exited the yard. This pavement was also kept clean – only a few artefacts were found. From a sand patch just below the pavement three tobacco pipe fragments (AI 7738: 9–11) were found. Three further fragments were found from the thin organic-rich layer on top of the pavement (AI 7738: 18, 25–26) with glazed redware, pipkin and glazed and painted redware fragments (AI 7738: 24, 27–30, 33). Based on the finds, the pavement was certainly used in the second quarter of the 17th century. Both pavements and the tunnel are preserved largely *in situ* and are on display in the new museum.

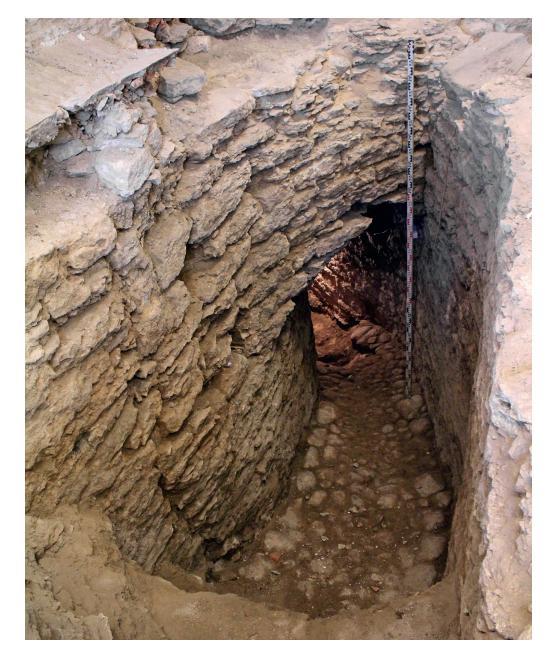
Fig. 6. View of the tunnel towards its southern end. Jn 6. Tunneli vaade selle lõunaotsa suunas. Photo / Foto: Monika Reppo

16. sajandisse dateeriti vastu III eeskaitsemüüri ehitatud väikestest munakividest laotud, lõunasse kalduva renniga sillutis (jn 1: 9; 5). Hoovi kagunurgas asunud renn laskus hoovihoone all 90 cm laiusesse tunnelisse (jn 1: 10; 6). Antud tunnel keeras eeskaitsemüüri all kagusse ja suubus arvatavasti 19. sajandi joonistelt tuntud paaki (jn 1: K; 6). Hoovi pool inimesest kõrgem tunnel madaldub müüri all vaid 90 cm kõrguseks. Kanal juhtis Paksu Margareeta hoovist ära sade- ja sulavee. Sillutisele oli arvatavasti 16. sajandi lõpul ladestunud leiuvaene lammutusrusu kiht. Sellel paiknes suurtest munakividest sillutis (jn 1: 11; 5; 7), mille vahelt ja alt saadi mõni üksik piibukatke. Arvatavasti sai hoov uue sillutise 17. sajandi I poolel. Ka leidus piibukatkeid hiljem sillutisele ladestunud kihis, kuid valdavalt iseloomustas sõjalise funktsiooniga hoovi puhtus ja kord. Mõlemad sillutised ja tunnel on säilitatud in situ.

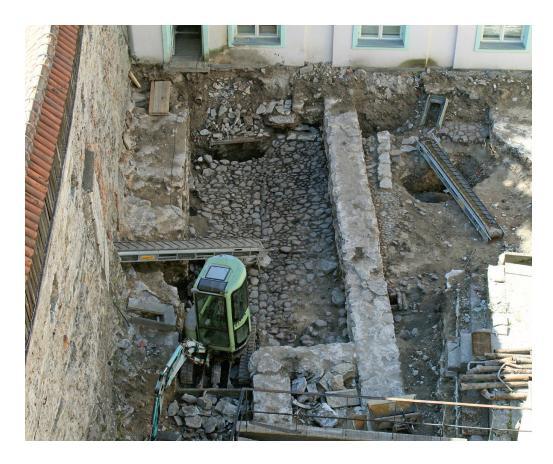
Fig. 7. View of the upper pavement, the southern building and the foundations of the eastern building.
Jn 7. Vaade ülemisele sillutisele, lõunapoolsele hoonele ja idapoolse hoone vundamentidele.
Photo / Foto: Monika Reppo
